# Inspection Report

**One Call Building and Pest Inspections**

**Unit 4/31 Burrai St Morningside , Brisbane , QLD**

### Pest And Building Inspection

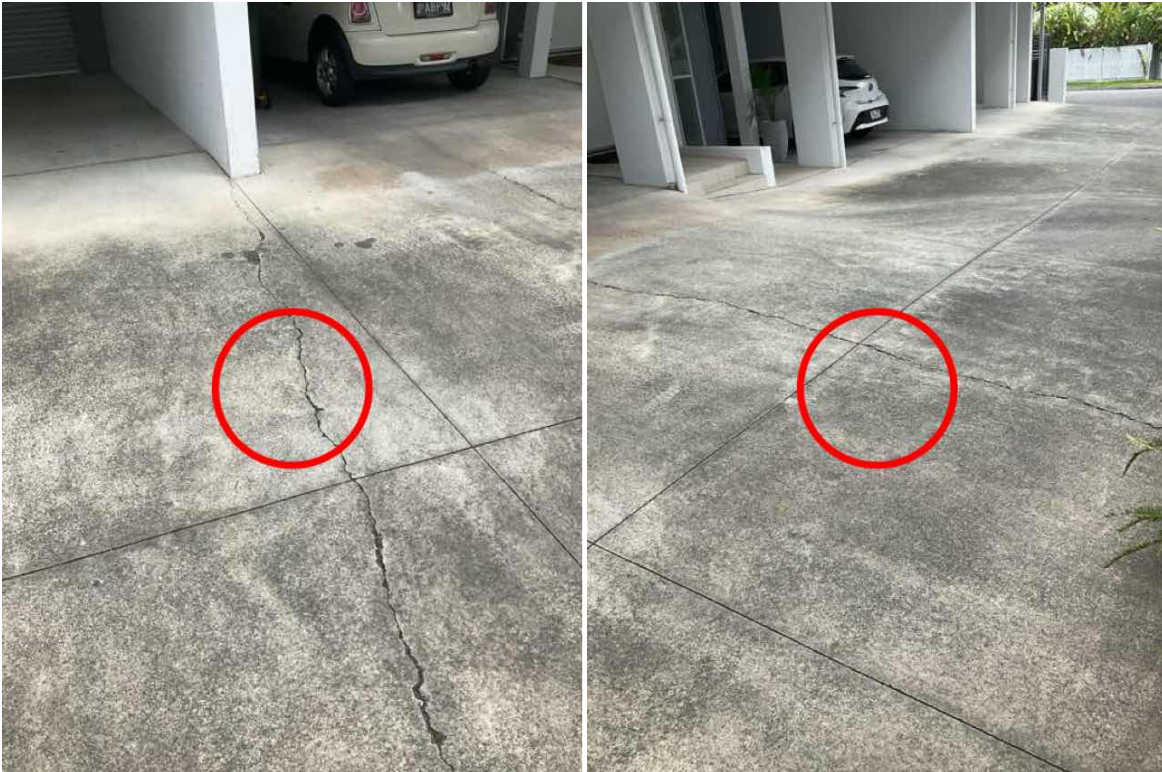
Common cracks were observed on the driveway. Whilst these cracks appeared to be typical at the time of inspection, we strongly recommend you monitor these cracks and if worsening occurs contact a concreter for further advice.

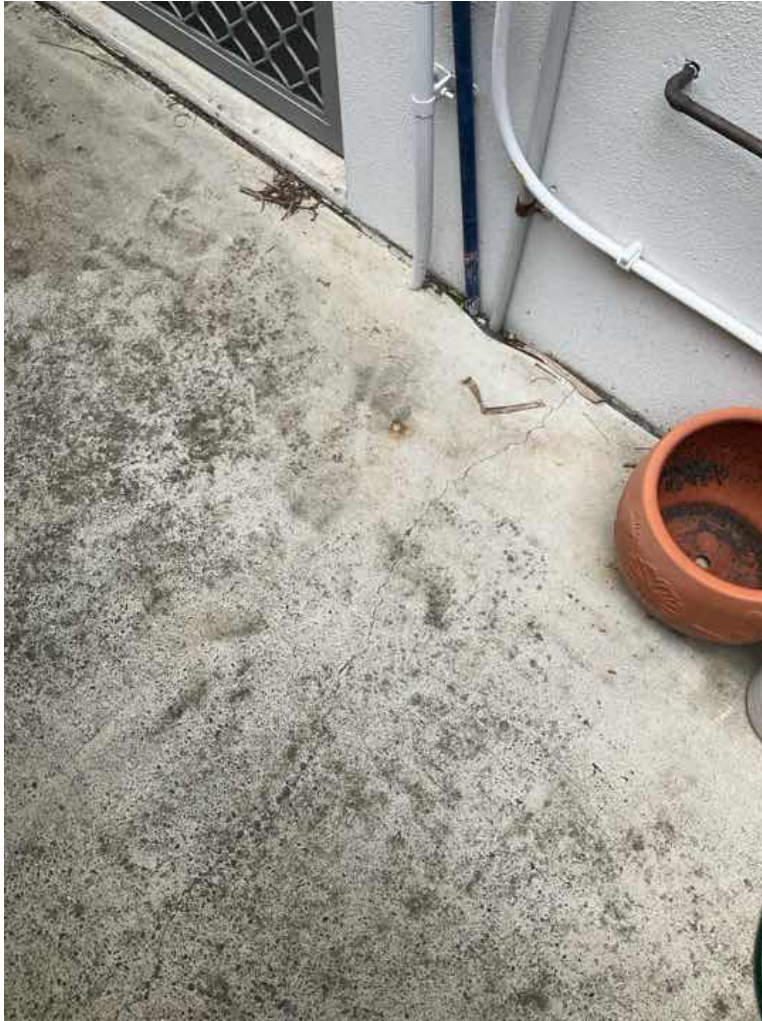
The paths around the home are in a serviceable condition for the age of this dwelling with no major defects visible.

Common cracks and settlement were observed on paths. Whilst these cracks appeared to be typical at the time of inspection, we strongly recommend you monitor these cracks and if worsening occurs contact a concreter for further advice.

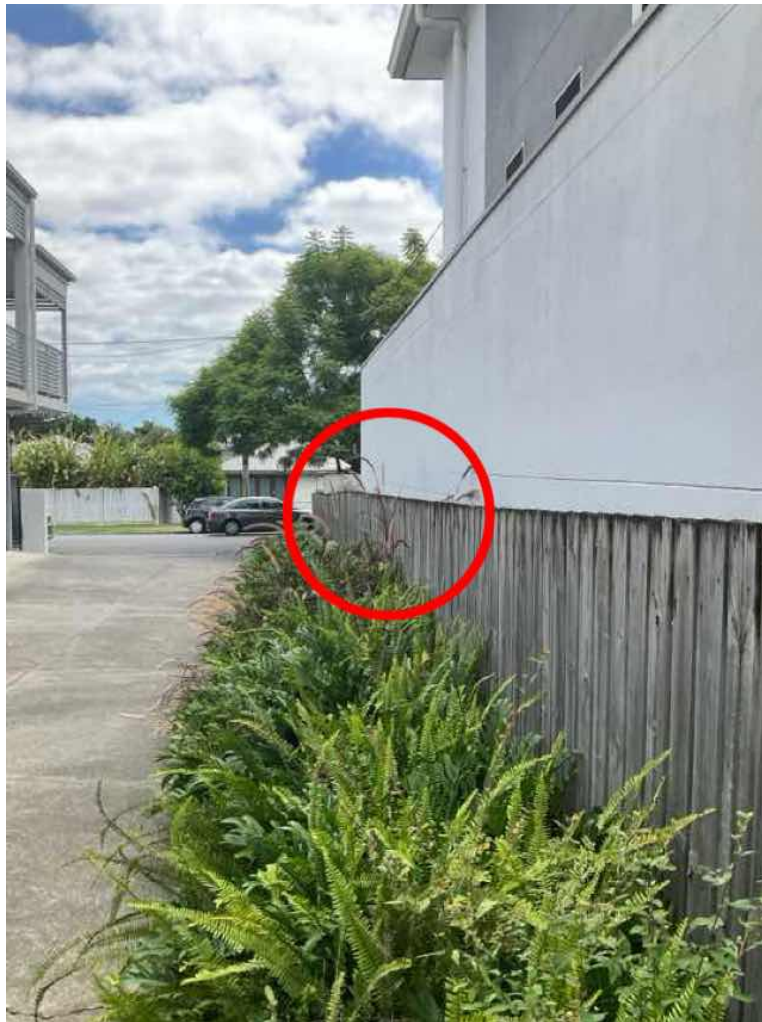
General age to fence components. General upkeep and maintenance required. A qualified fencing contractor should be engaged for repairs.

Fence rot/leaning. Repairs are required by a fencing contractor to avoid unsafe conditions.

| Section | Location | Name | Comment |
|---|---|---|--|
| SITE | Fences & Gates | Overall Condition | Fence rot/leaning. Repairs are required by a fencing contractor to avoid unsafe conditions. |

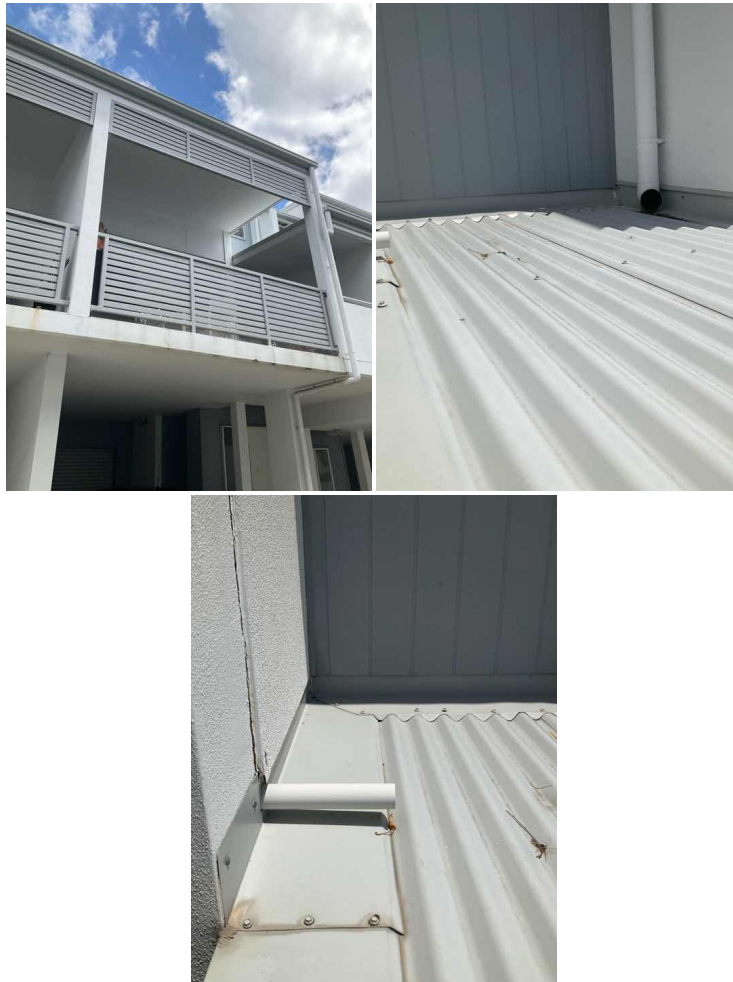
Of the visible areas, the general condition of the roof is in serviceable condition for the age.

Note: In the absence of rainfall there is no guarantee that the roof won't leak.

Not inspected as too high to reach by ladder. Viewed from a distance.

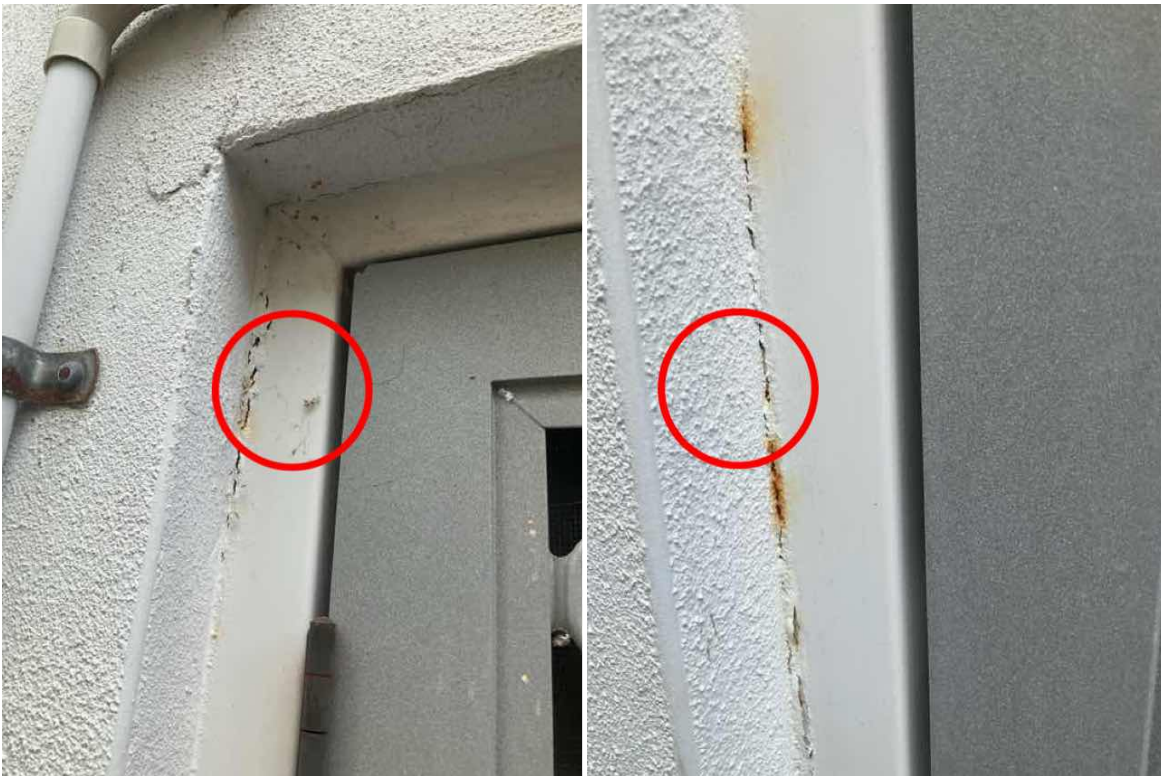
On Visual Inspection the external condition of the doors is serviceable.

General age/damage has occurred to door frame, face or components. Recommendations: A qualified carpenter should be engaged for advice and recommendations.

| Section | Location | Name | Comment |
|---|---|---|--|
| EXTERIOR | External Door Components | Door Findings | General age/damage has occurred to door frame, face or components. Recommendations: A qualified carpenter should be engaged for advice and recommendations. |

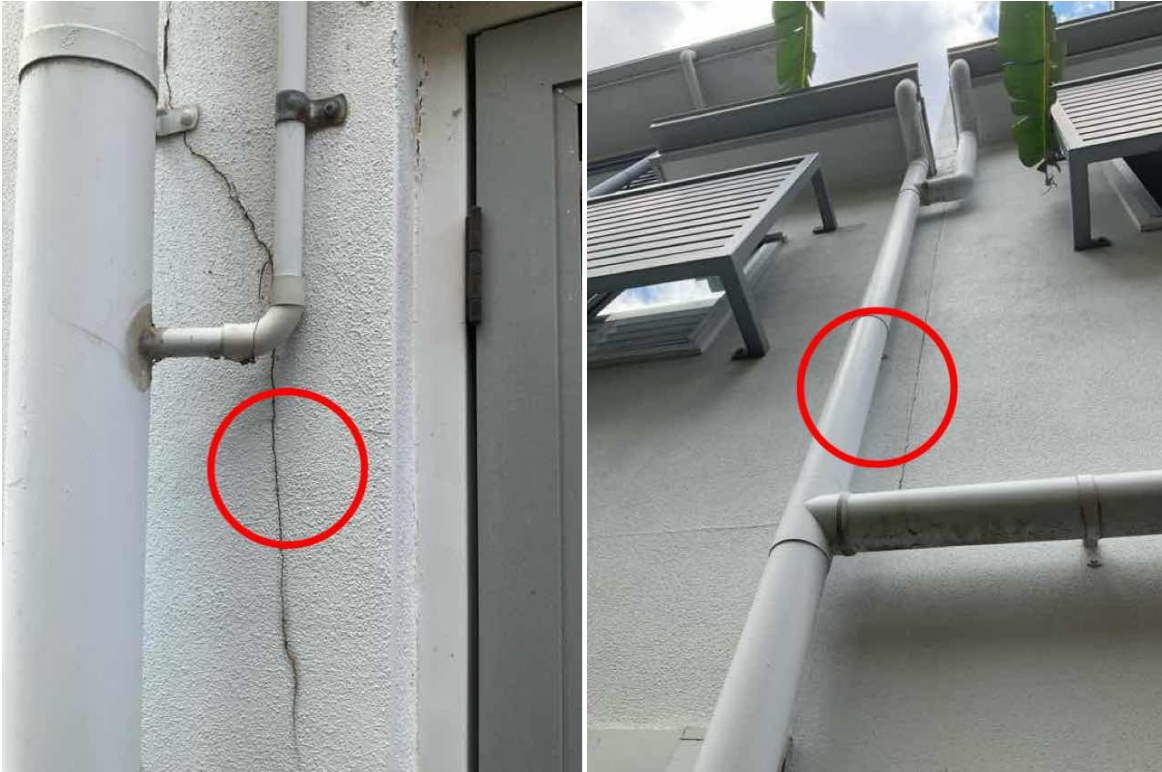
On visual inspection, the general condition of the exterior walls is serviceable for the age.

There appears to have been some settlement in the building which has caused some cracking to the walls. These cracks are categorized as 0 to 2. This can also cause some doors to bind or be out of square. In the inspectors opinion these cracks are due to settlement, usually due to ground movement and subsequent movement to building materials can be expected. Any cracks should be monitored and if cracks increase in size, further investigation should be carried out by a structural engineer.

*For clarification on the category of cracks please refer to Cracking of Building Elements in Section 2D of the Terms and Conditions contained in this report.*

We strongly advise that any cracking reported in this report should be referred to a structural engineer for further assessment and advice. Please refer to Cracking Of Building Elements in section 2G of these Terms And Condition

**IMPORTANT:** Regardless of location or size If cracks have been identified then a structural engineer is required to determine the significance of the cracking prior to a decision to purchase.

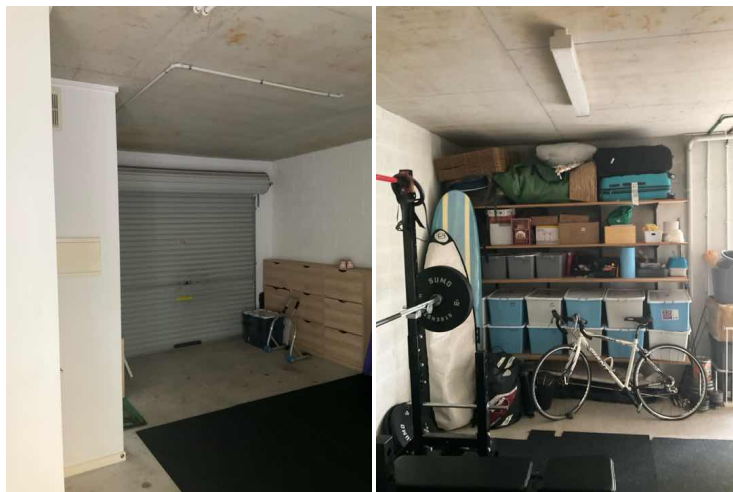
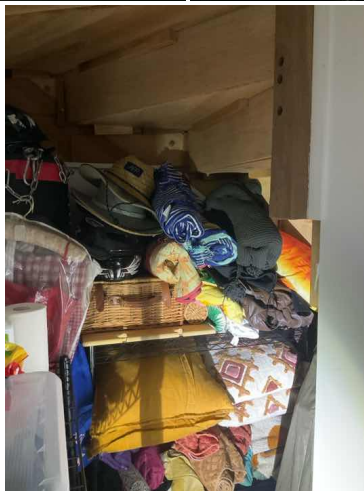
Stored items restricted a full and thorough inspection of this area. Defects may exist in the obstructed and inaccessible areas. It is strongly recommended that full access be granted to enable a thorough inspection as there may be timber pest activity, damage or defects. Note: Where vehicles and storage has restricted a full inspection it is advised that this area be cleared so a full and unobstructed inspection can be carried out.

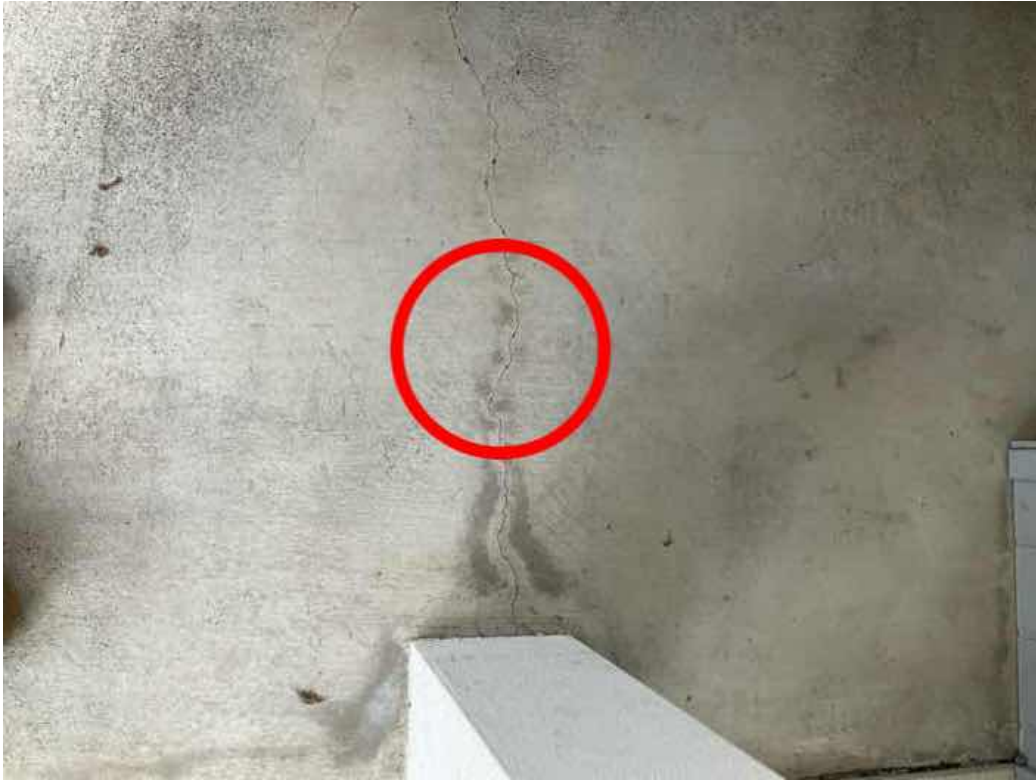
Minor hairline slab cracks - Note. Whilst these cracks appeared to be minor at the time of inspection, we strongly recommend you monitor these cracks and if worsening occurs contact a qualified concreter for further advice.

| Section | Location | Name | Comment |
|---|---|---|--|
| GARAGE - CARPORT | Garaging | Floor Findings | Minor hairline slab cracks - Note. Whilst these cracks appeared to be minor at the time of inspection, we strongly recommend you monitor these cracks and if worsening occurs contact a qualified concreter for further advice. |

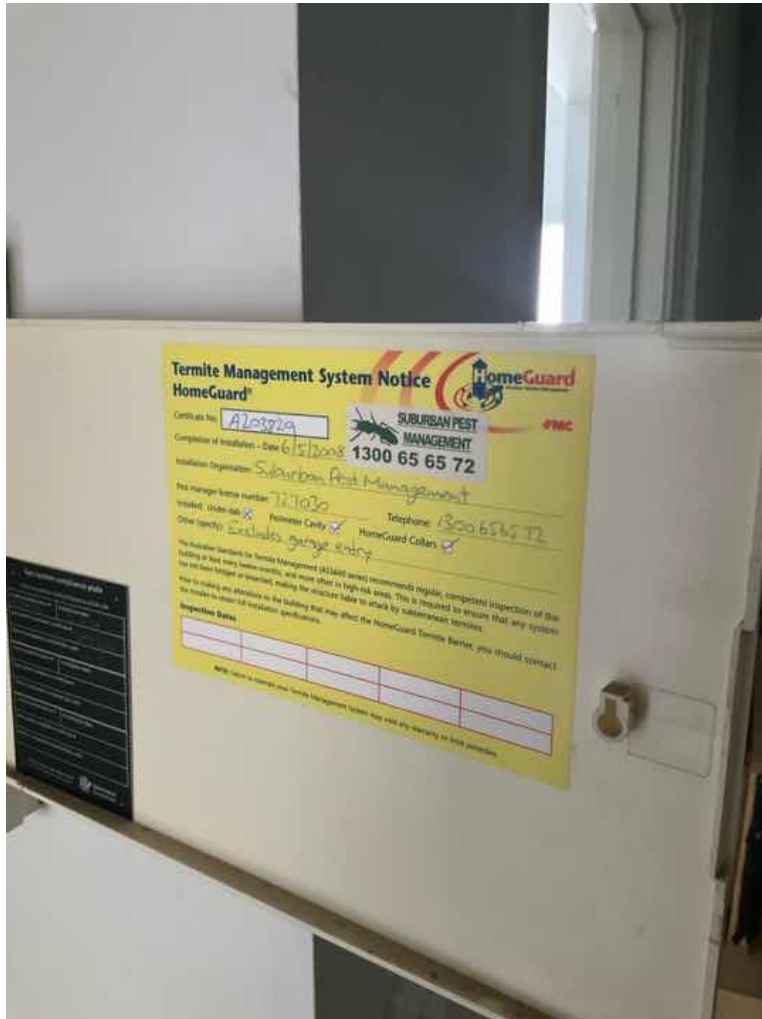
Yes, a durable notice was found in the meter-box during the inspection.
