# Inspection Report

**One Call Building and Pest Inspections**

**Unit 1/ 1 Wattle St. Cannon Hill , Brisbane , QLD**

Report/Agreement #	150324024817137
Inspection Date:	15 Mar 2024
Inspection Time:	02:48 pm

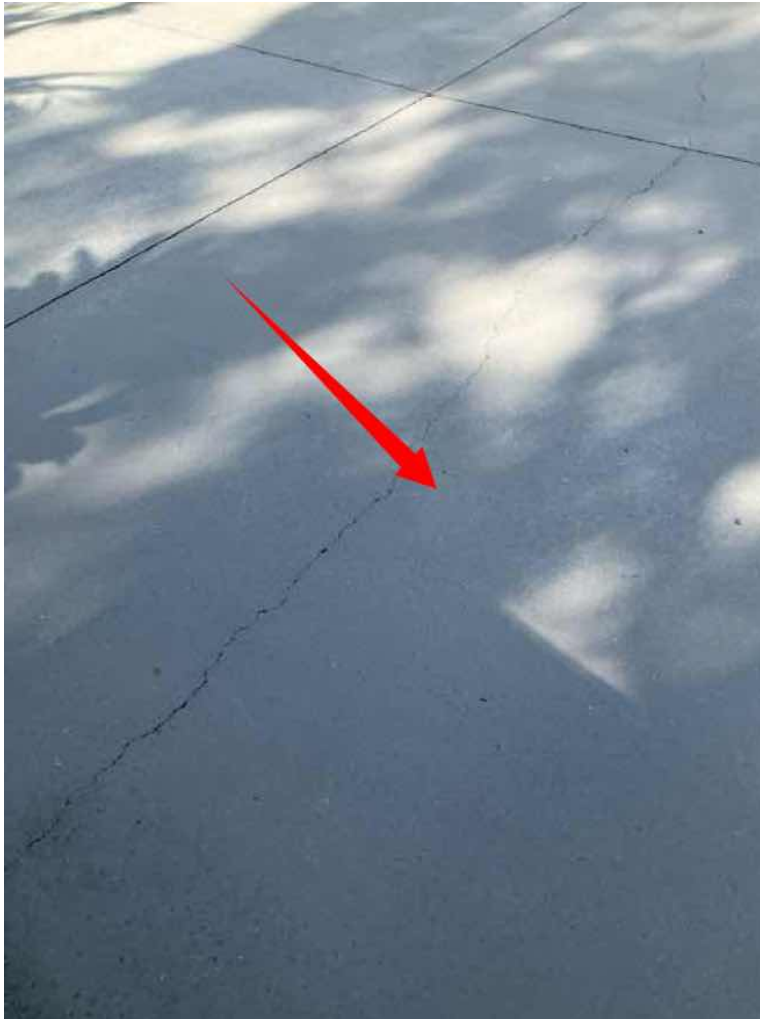
#### **Driveway Condition**

Common cracks were observed on the driveway. Whilst these cracks appeared to be typical at the time of inspection, we strongly recommend you monitor these cracks and if worsening occurs contact a concreter for further advice.

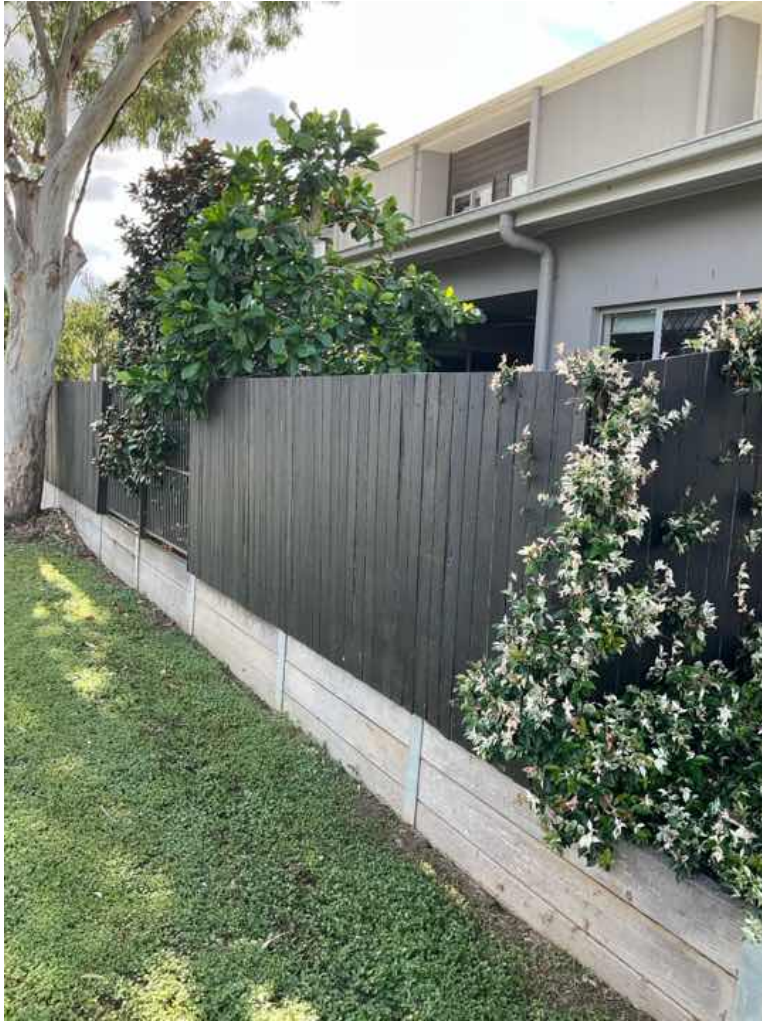
Of the visible areas, the general condition of the fences and gates is serviceable for the age of dwelling.

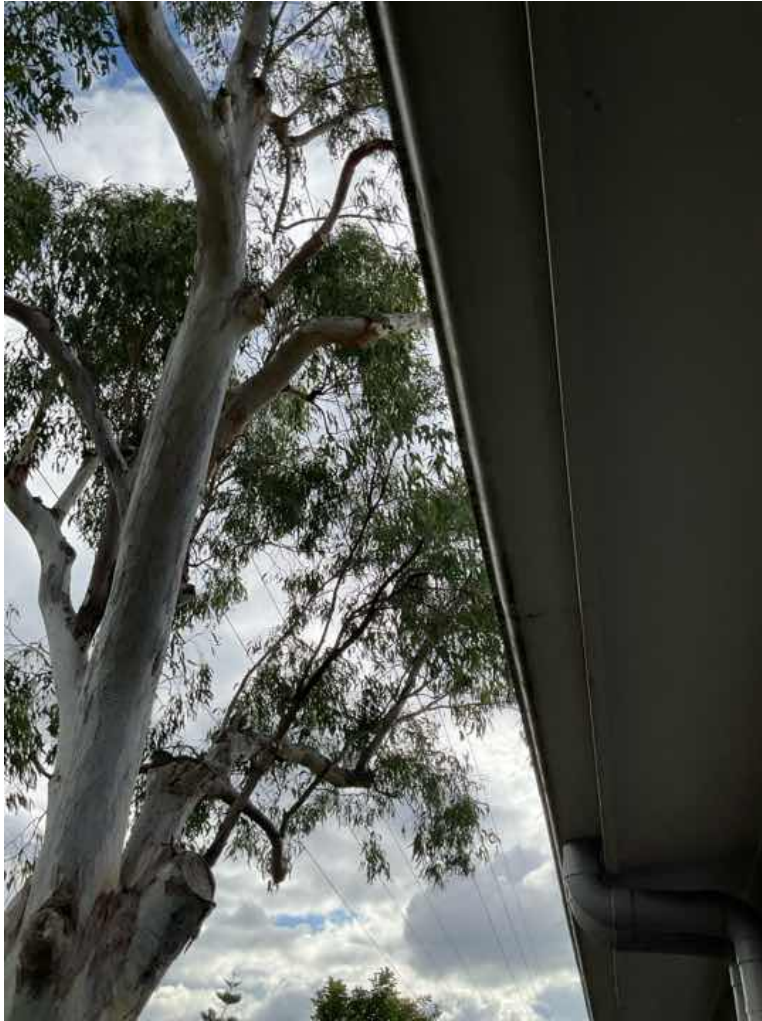
Trees are overhanging roof areas. These should be cut back away from the roof line and gutters.

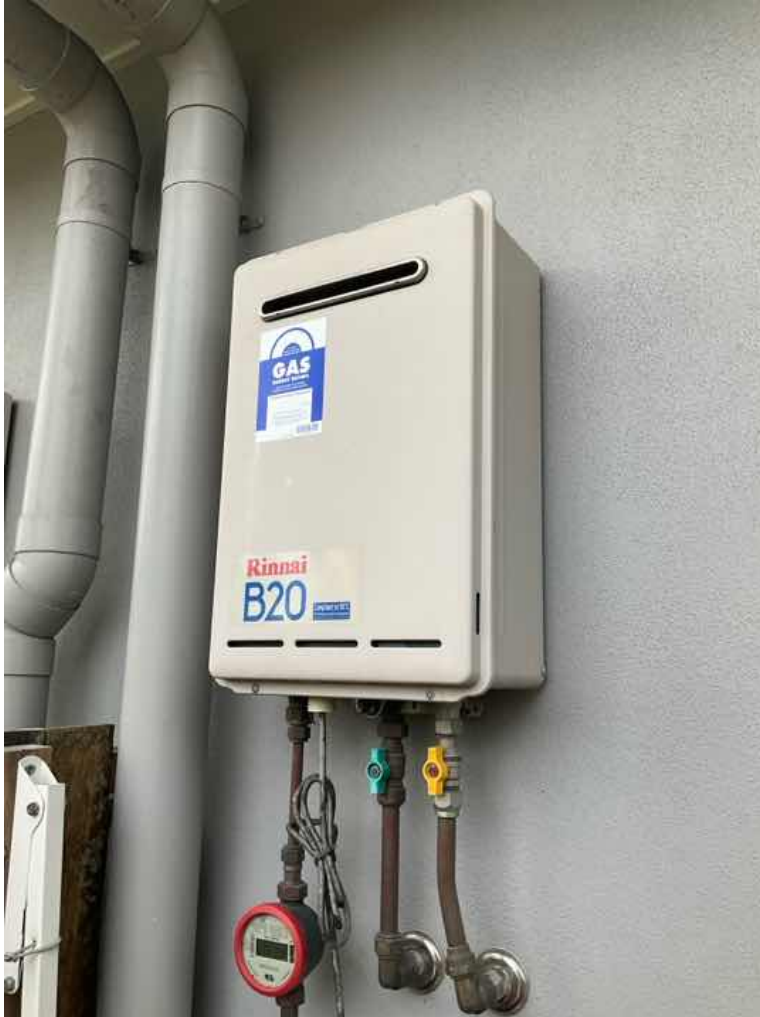
The hot water unit is a gas storage system.

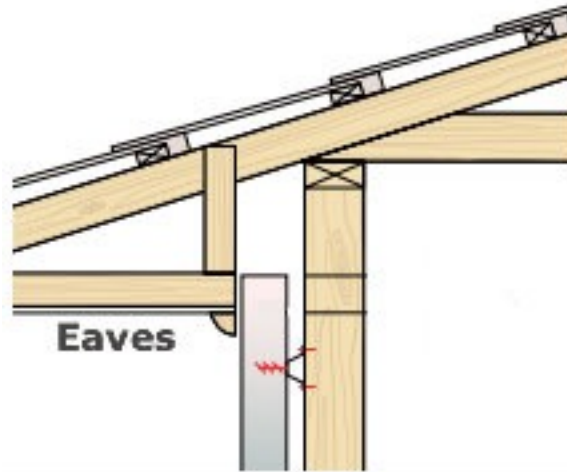
### **Eave Condition**

The soffit lining (eaves) are in a serviceable condition with no notable defects.

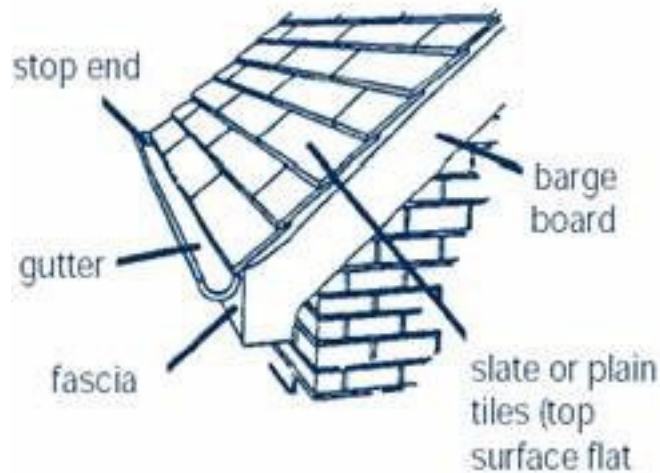
On visual inspection, the general condition of the fascia/barge boards is serviceable.

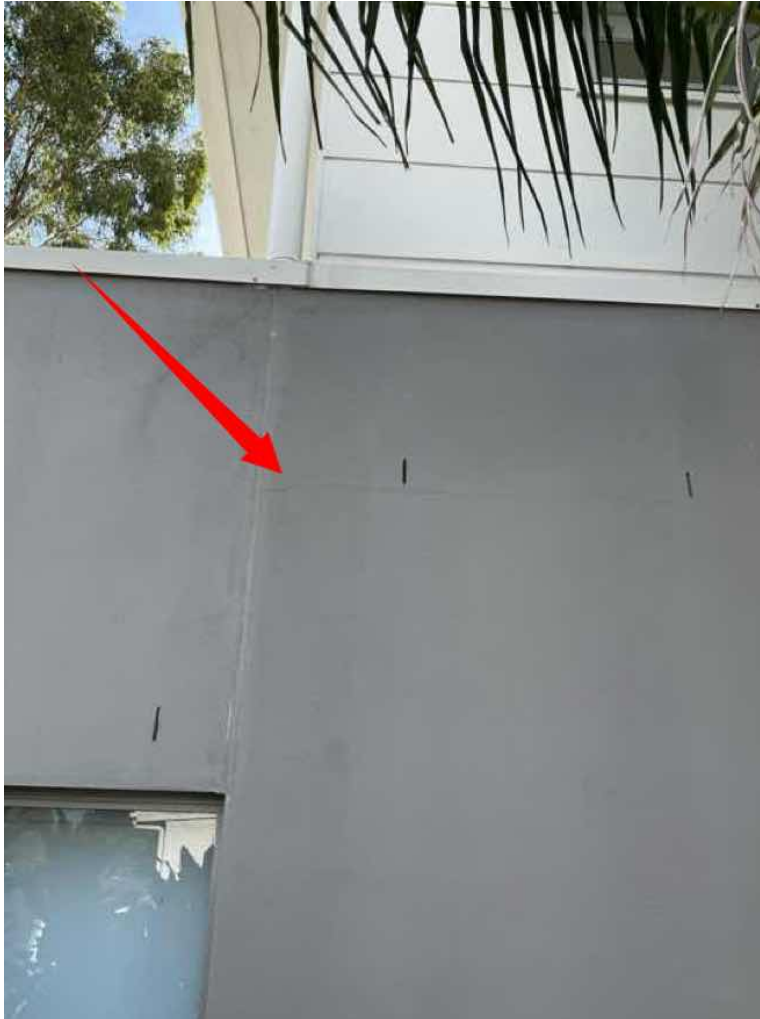
Section	Location	Name	Comment
EXTERIOR	Walls	Condition	<p>There appears to have been some settlement in the building which has caused some cracking to the walls. These crack are catergorized as 0 to 2. This can also cause some doors to bind or be out of square. In the inspectors opinion these cracks are due to settlement, usually due to ground movement and subsequent movement to building materials can be expected. Any cracks should be monitored and if cracks increase in size, further investigation should be carried out by a structural engineer.</p> <p>For clarification on the catergory of cracks please refer to Cracking of Building Elements in Section 2D of the Terms and Conditions contained in this report.</p>
GARAGE - CARPORT	Garaging	Floor Findings	Minor hairline slab cracks - Note. Whilst these cracks appeared to be minor at the time of inspection, we strongly recommend you monitor these cracks and if worsening occurs contact a qualified concreter for further advice.

On visual inspection, the general condition of the exterior walls is serviceable for the age.

There appears to have been some settlement in the building which has caused some cracking to the walls. These cracks are categorized as 0 to 2. This can also cause some doors to bind or be out of square. In the inspectors opinion these cracks are due to settlement, usually due to ground movement and subsequent movement to building materials can be expected. Any cracks should be monitored and if cracks increase in size, further investigation should be carried out by a structural engineer.

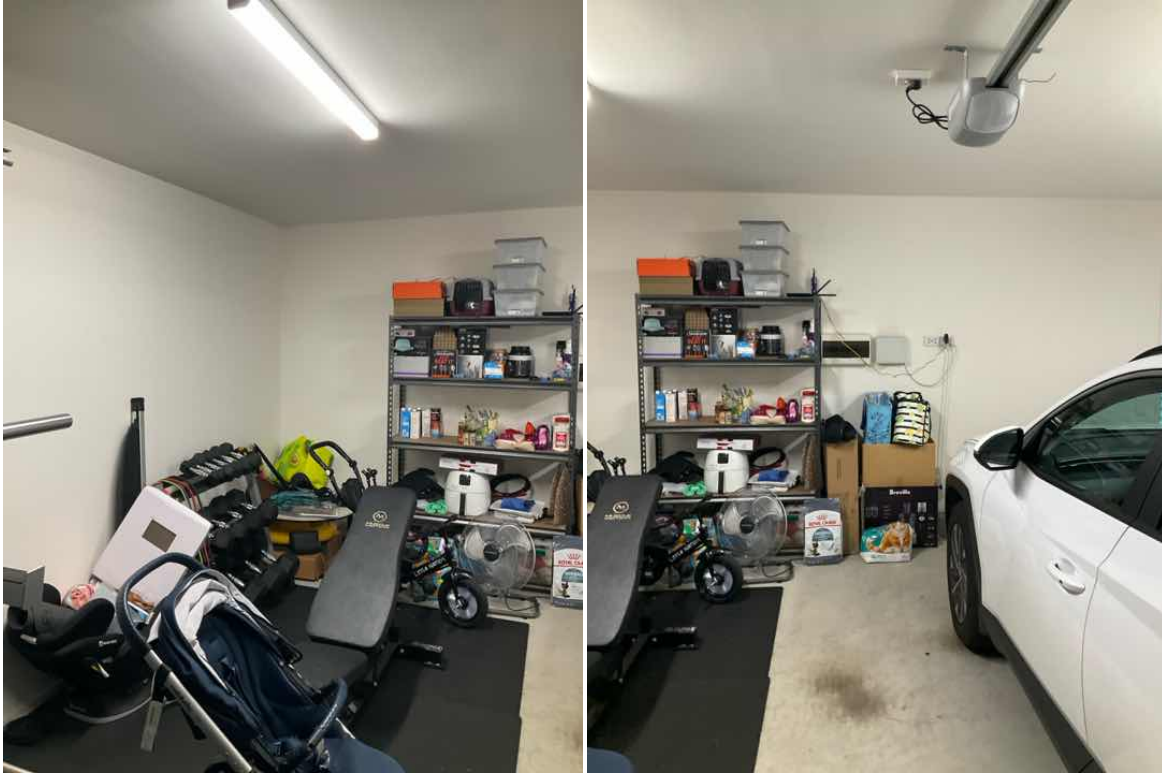
Stored items restricted a full and thorough inspection of this area. Defects may exist in the obstructed and inaccessible areas. It is strongly recommended that full access be granted to enable a thorough inspection as there may be timber pest activity, damage or defects. Note: Where vehicles and storage has restricted a full inspection it is advised that this area be cleared so a full and unobstructed inspection can be carried out.

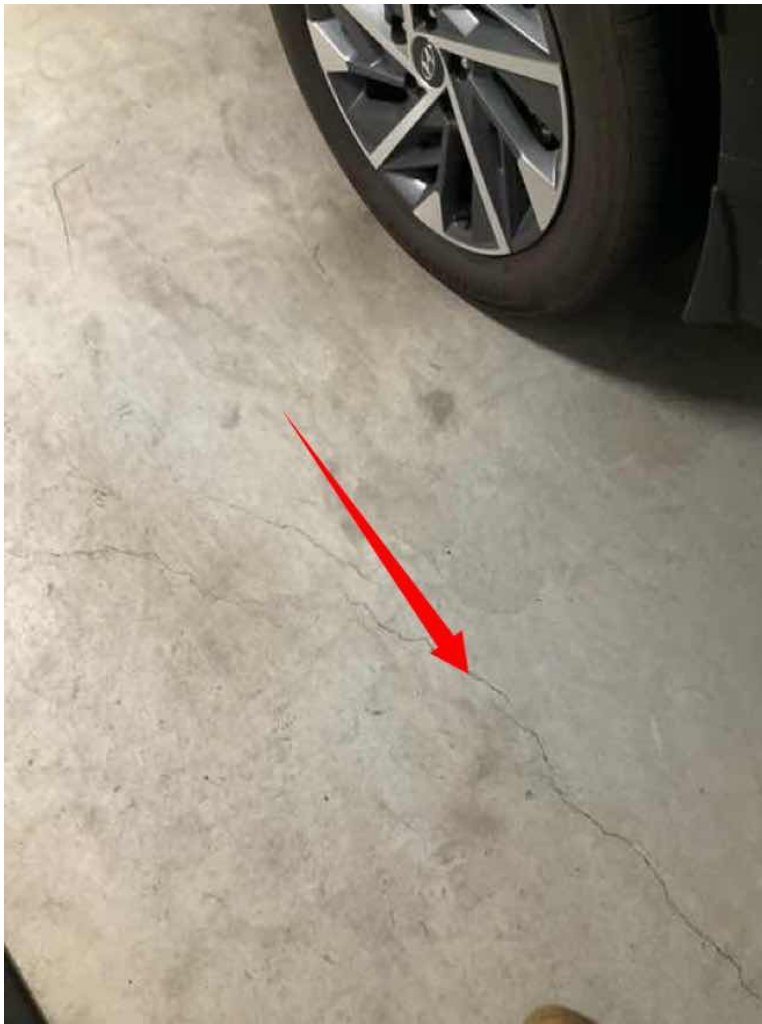
#### Floor Findings

Minor hairline slab cracks - Note. Whilst these cracks appeared to be minor at the time of inspection, we strongly recommend you monitor these cracks and if worsening occurs contact a qualified concreter for further advice.

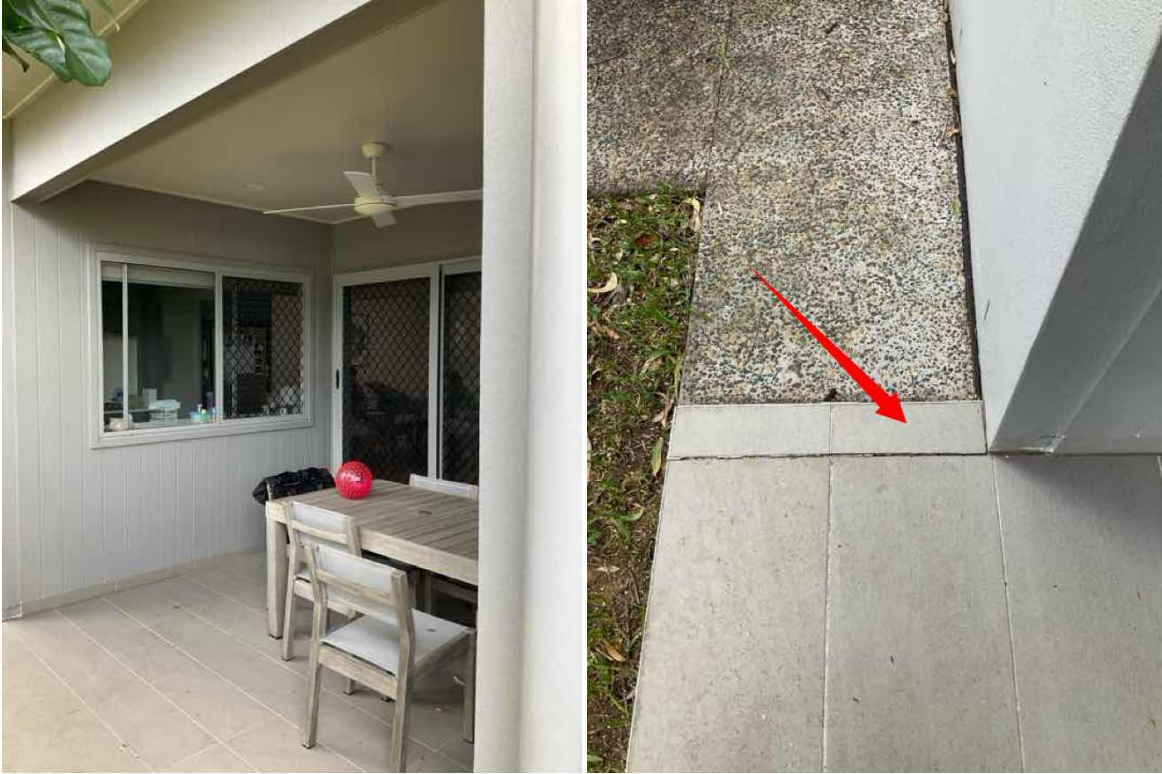
Though we are not structural engineers the balcony/s appear to be in a serviceable condition.

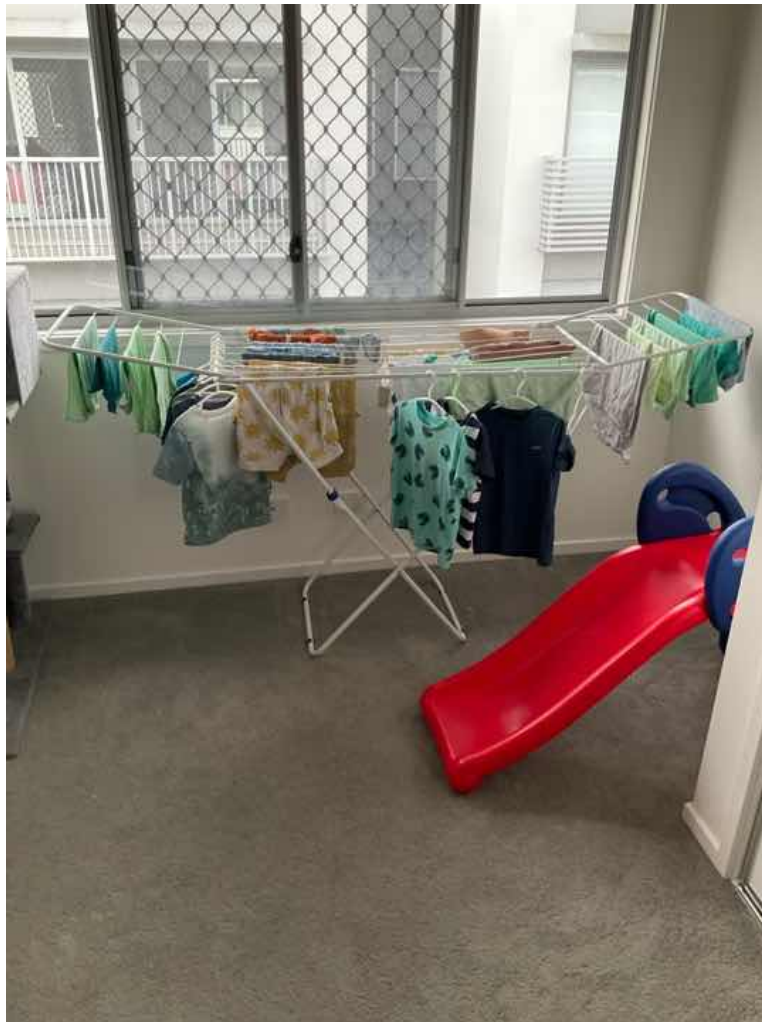
From the visible and accessible areas, this room appears to be in a serviceable condition for the age of the property with no notable structural defects sighted.

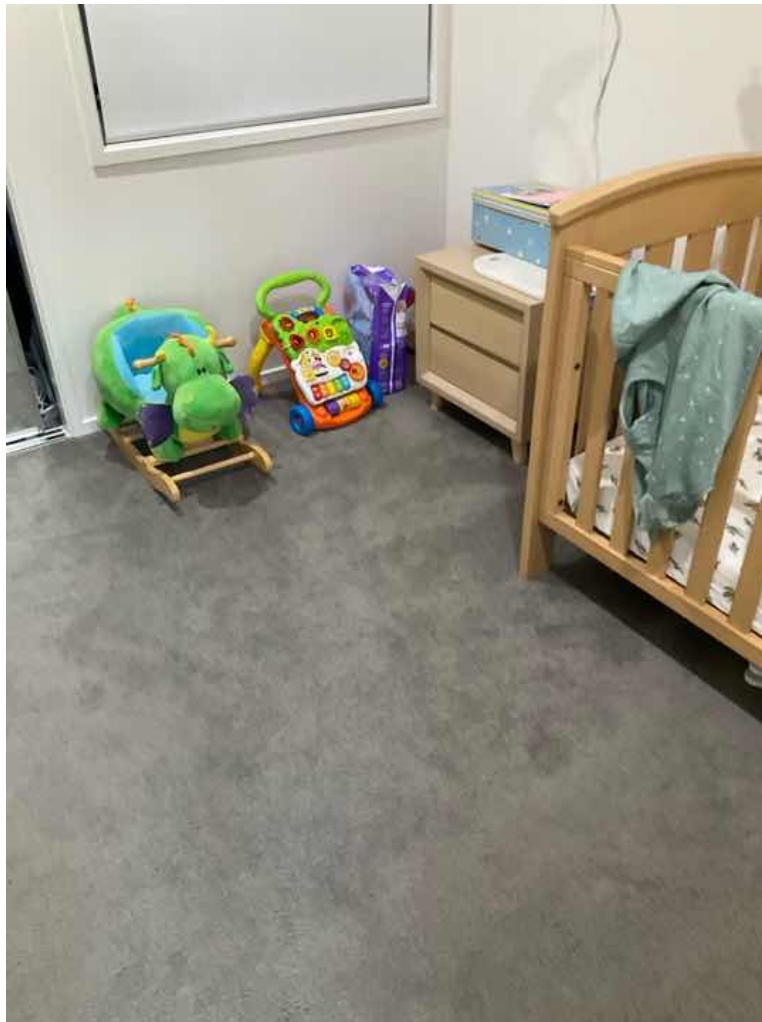
From the visible and accessible areas, this bedroom appears to be in a serviceable condition for the age of the property with no notable structural defects sighted.

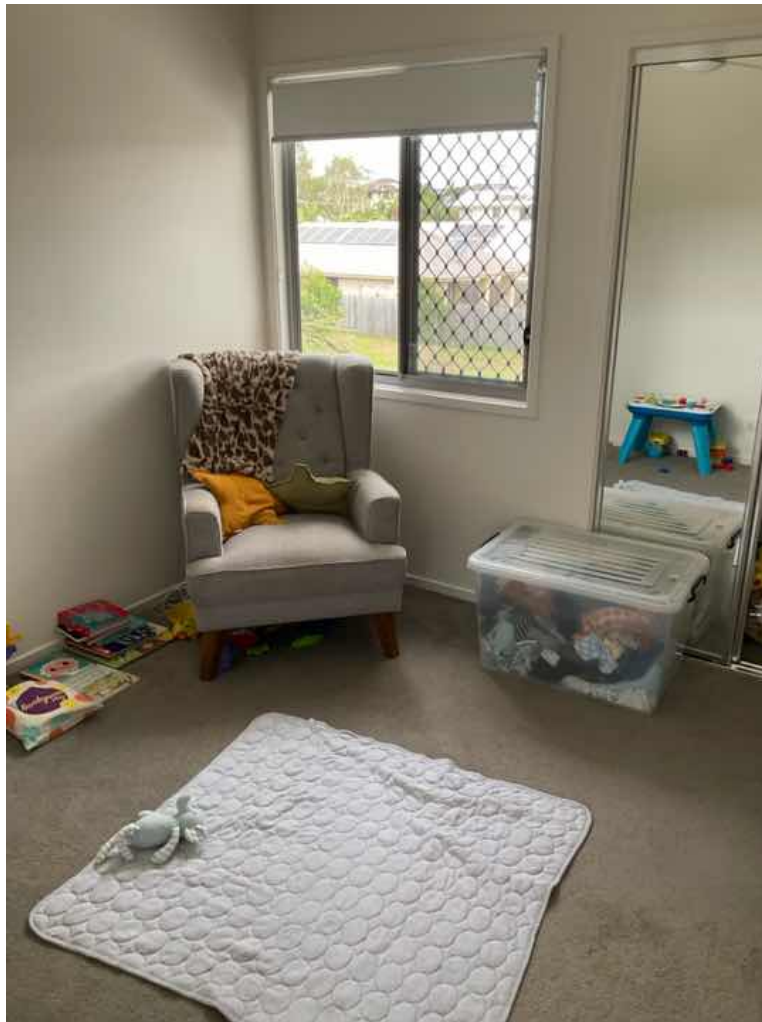
## **Bedroom 2**

From the visible and accessible areas, this bedroom appears to be in a serviceable condition for the age of the property with no notable structural defects sighted.

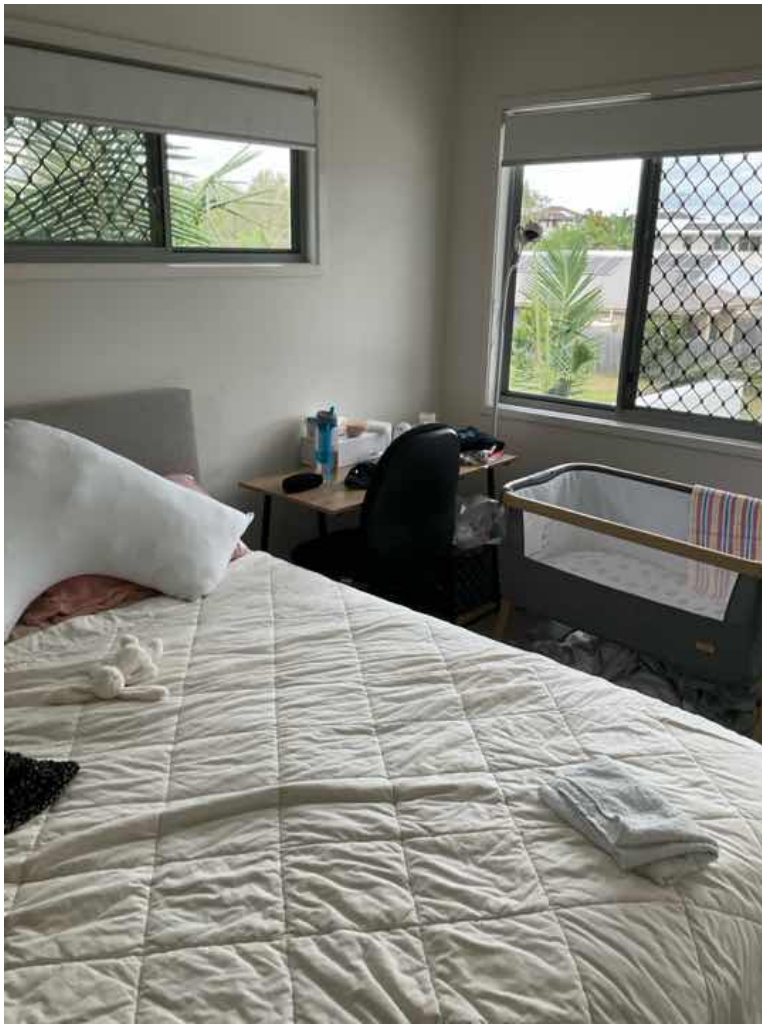
### **Bedroom 3**

From the visible and accessible areas, this bedroom appears to be in a serviceable condition for the age of the property with no notable structural defects sighted.

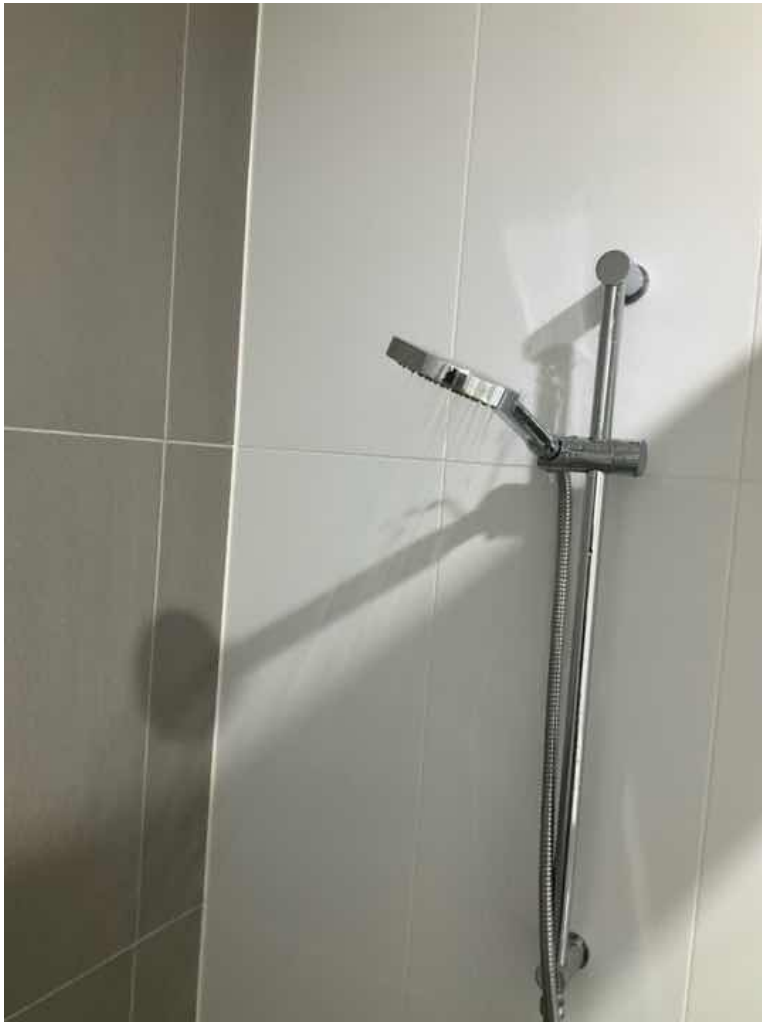
Of the visible areas, the general condition of this bathroom is serviceable or in reasonable condition for age of dwelling.

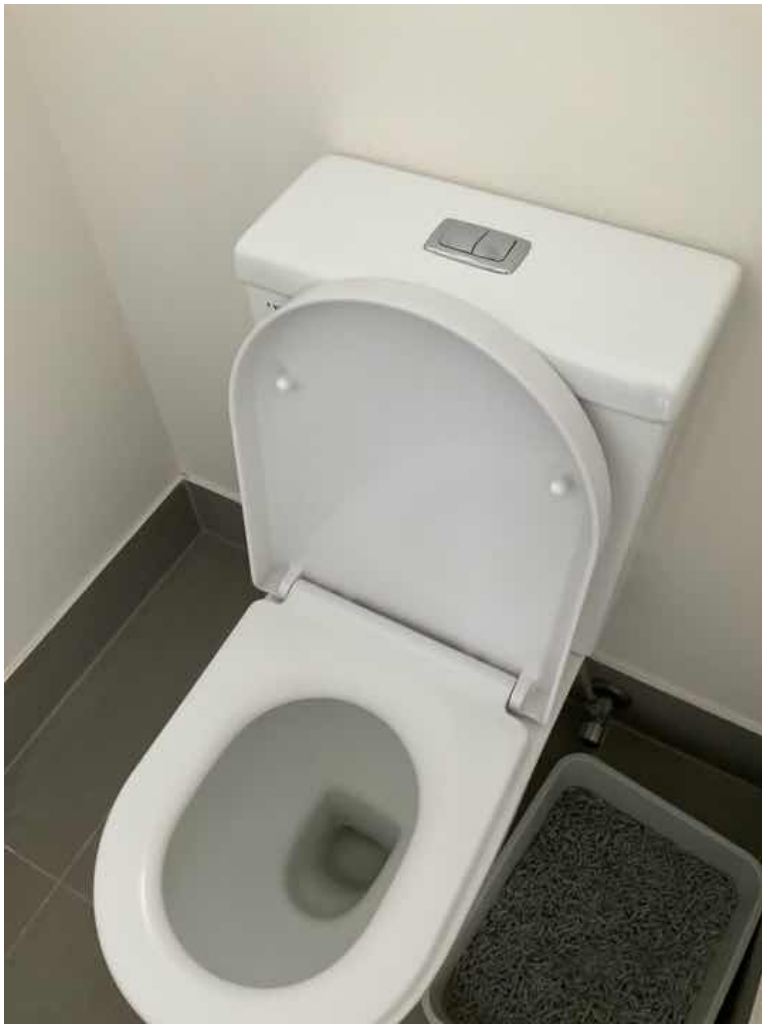
This bathroom is located in the lower level.
