Inspection Report

Dedant Building And Pest Inspections

3/8 Corrie Street, Norman Park, Qld, 4170

Inspection, Residential Pest And Building Report

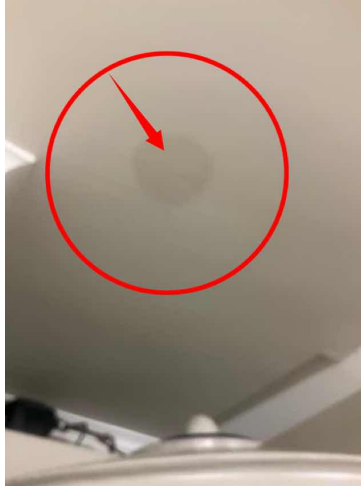
Ceiling stains - No moisture readings obtained. Recommendations: These may have been repaired, however, you will need to monitor after a prolonged period of rainfall - If leaking persists, a qualified plumber should be engaged for advice and recommendations. All water damaged plaster replaced by a qualified plasterer.

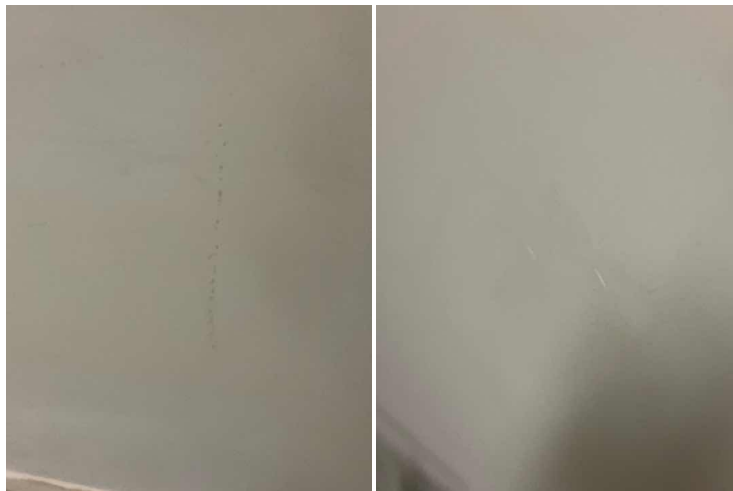
General ageing and/or denting and/or wear and/or previous wall patching and the like is evident on wall linings - Recommendations: A qualified painter should be engaged to assess and repair as required.

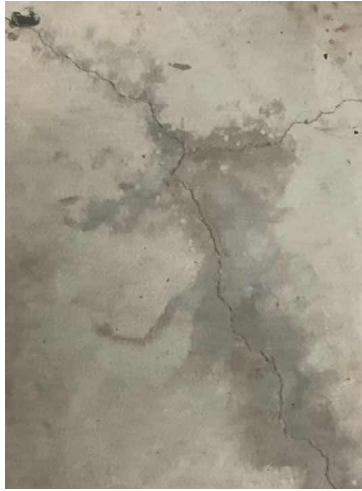
Minor slab cracks. Cracks appeared to be minor at the time of inspection, however we strongly recommend you monitor these cracks and if worsening occurs contact a qualified concreter for further advice.

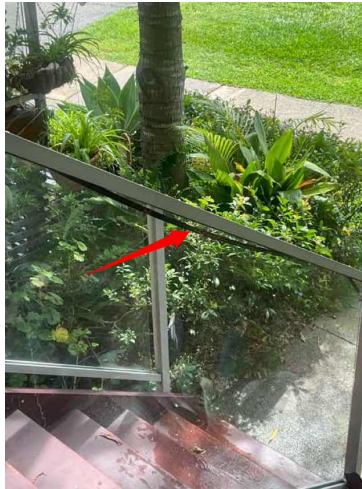
Balustrade glass rubber seal has dislodged loosening glass. A licensed glazer is recommended.

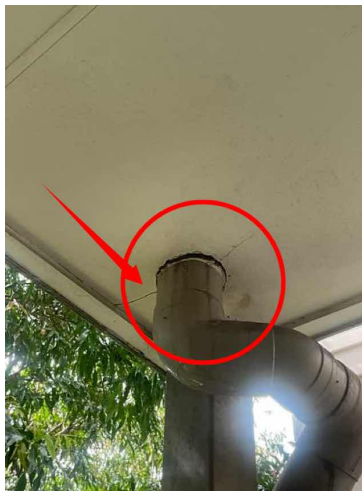
Eave lining stains observed. Normally this occurs due to overflow in blocked gutters. Recommendations. Gutters should be kept clear of debris and eave linings can then be painted or repaired as required.

Eave pipe penetration not flashed - Recommendations: A qualified plumber should be engaged for advice and recommendations to prevent potential water damage.

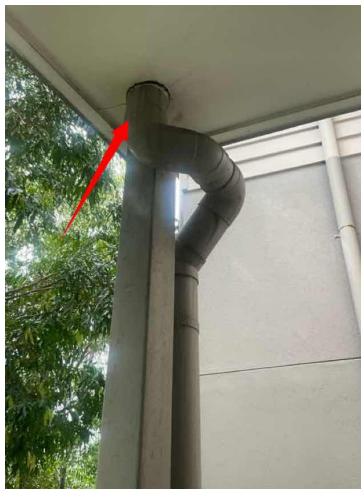
Front Elevation- Brickwork

Leaking down pipe joins visible. This can be conducive to termite infestation and cause water damage to cladding over time. Recommendations: A qualified roof plumber should be engaged to repair.

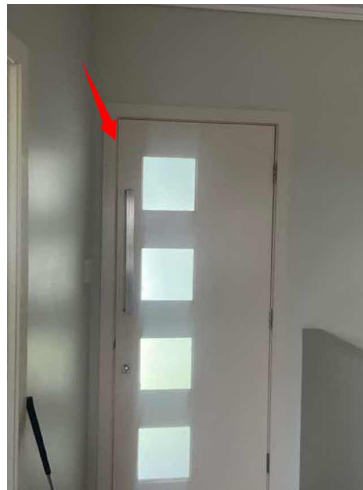
Binding door - Doors that bind on the frame can relate to some differential settlement in the footings, frame movement, age, expansion, shrinkage and the like. It can also be seasonal where it may bind for some months and then open and close sufficiently. Monitoring over time or a more invasive inspection is only method of ascertain cause. Recommendations: A qualified carpenter should be engaged for advice and recommendations.

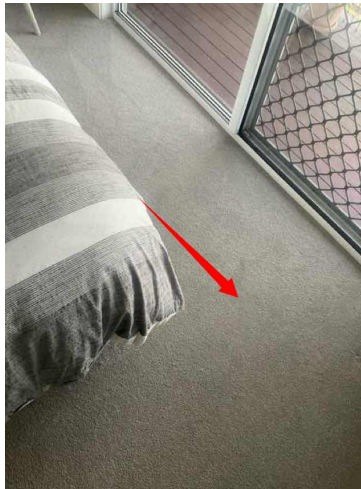
Squeaky floor boards noted. Re-fixing the floor boards may fix this issue.

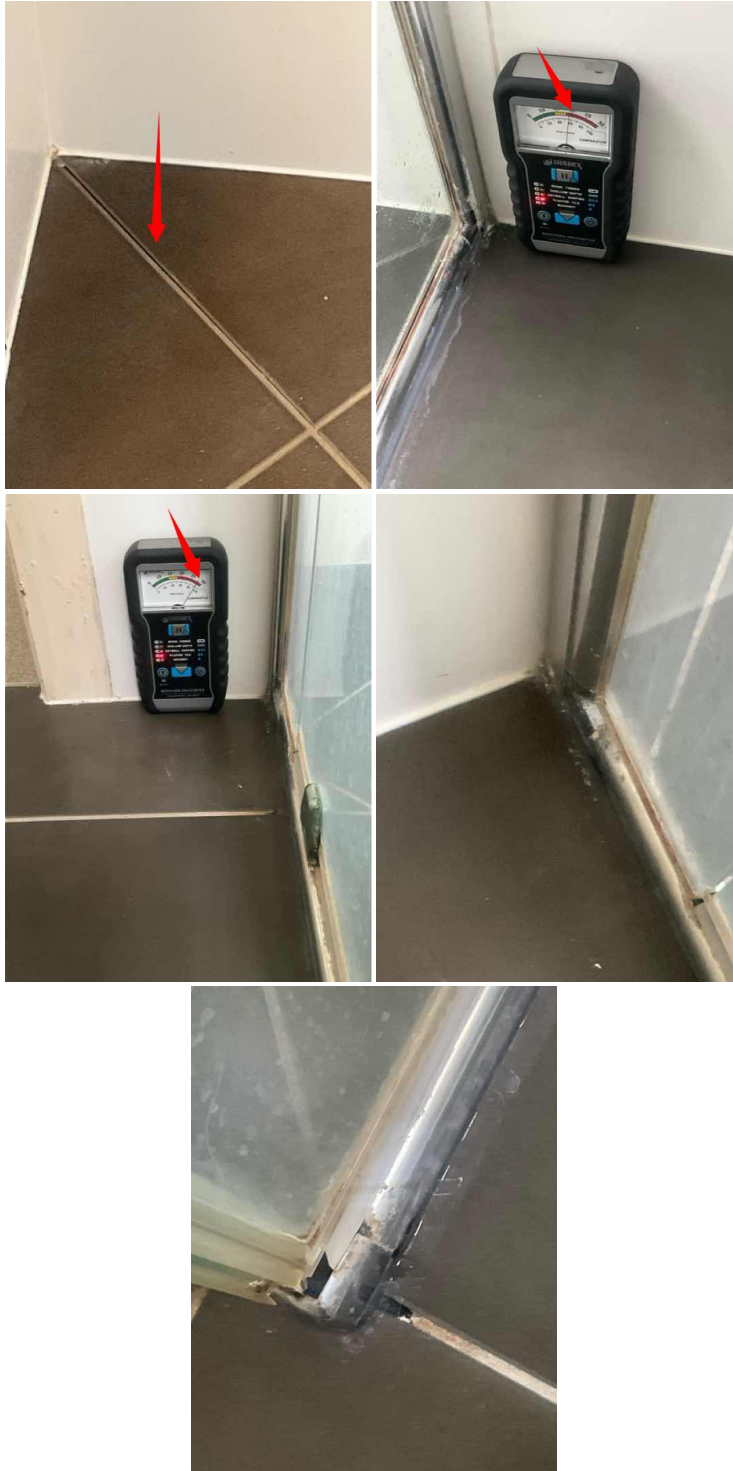
Silicone sealant has been applied to the interface of the floor and walls in the shower recess in an apparent attempt to prevent water penetration to surrounding areas. This method of repair can only be considered to be temporary. Further waterproofing may be necessary.

Tile grout deterioration. Re-grout / seal the shower tiles and screen junctions. A qualified tiler should be engaged for advice and recommendations.

Shower screen is leaking.

Excess moisture readings were obtained on the wall linings adjacent bathroom/shower. This may be related to the shower recess/plumbing in wall cavity leaking or failed waterproofing membrane to the wet area.
Recommendations: Engage a plumber and a licensed waterproofer for advice and recommendations.

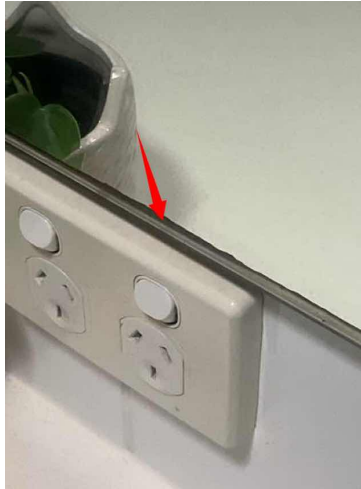
The vanity mirror is desilvering at edges. Replacement recommended.

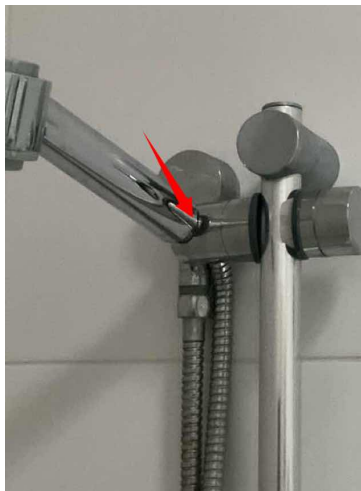
Shower head is leaking. A qualified plumber should be engaged for advice and recommendations.

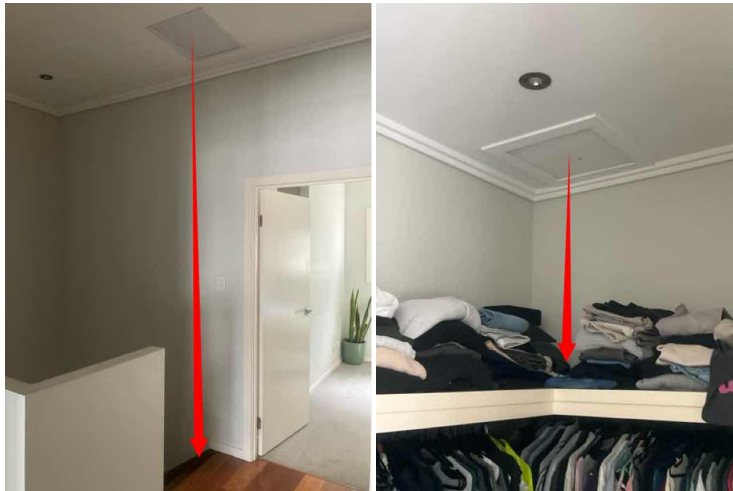
Inability to safely enter through the man hole without causing damage or injury due to clearance between access door entry and framing timbers. I would recommend relocating the access door to an area with adequate clearance to be able to safely enter without causing injury or damage.

The manhole was too small to allow full body access. The roof void was not entered. We recommend installing a 500 x 500 mm manhole at a minimum to allow further investigation of the roof void as defects may still exist
