# Visual Building Inspection Report

28 Marsh Street, Cannon Hill

30/10/2024.

9444 b

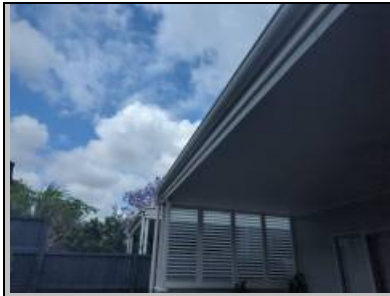
All elevations:

Appear to be in serviceable condition. Water staining was noted to sections of the gutter and fascia. Recommended to monitor when raining.

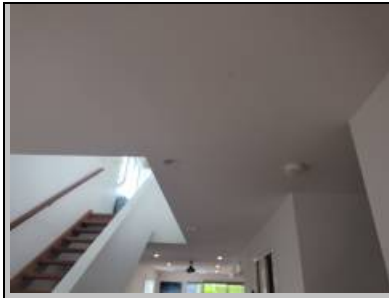
Various areas.

The condition of the ceilings is generally good. General wear and tear is noted. Minor settlement cracks were noted and these are typical of this type of material. Periodic maintenance may be required.

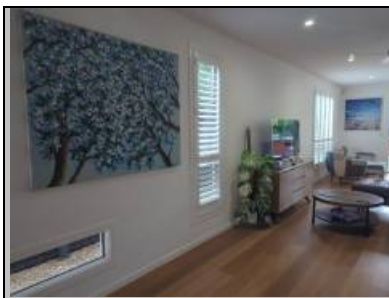
Various areas.

The condition of the walls is generally good. General wear and tear is noted. Minor cracking is evident to wall linings. Periodic maintenance may be required.

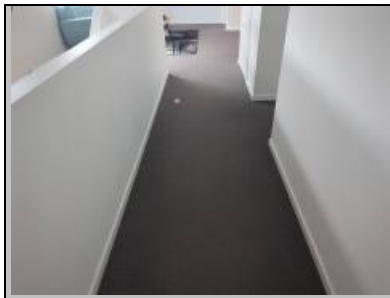
Various areas.

Floors are concealed by floor coverings, The condition of the floors is generally good. General wear and tear is noted, Squeaking flooring was noted, typical and consistent compared with buildings of similar age and construction.

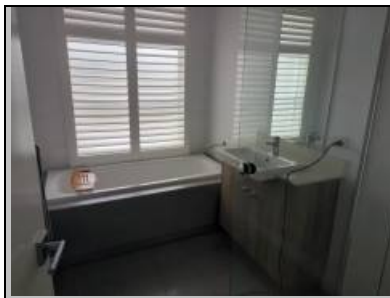
The condition of the fixtures is generally good. General wear and tear is noted.

Shower and Bath appears to be in a serviceable condition. Staining noted to grouting and silicone sealants, clean, re-grout and replace sealants as required.

Maintain all sealants and grouting to prevent moisture penetration and damage.

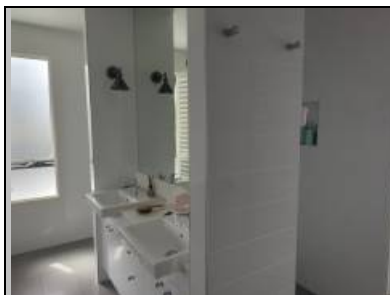
The condition of the fixtures is generally good. General wear and tear is noted.

Shower appears to be in a serviceable condition. Staining noted to grouting and silicone sealants, clean, re-grout and replace sealants as required.

Maintain all sealants and grouting to prevent moisture penetration and damage.

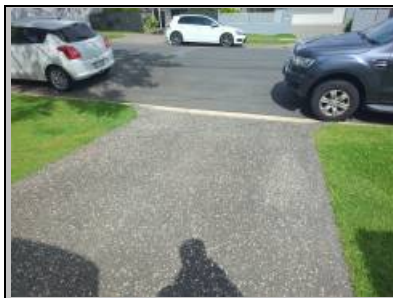
The concrete driveway stands in good condition. Minor concrete cracks are noted.

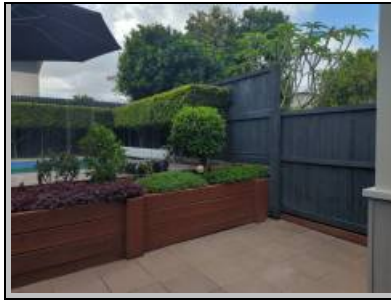
Dividing fence section:

The fences are mainly constructed from timber. The fences are generally in good condition. Minor wet rot or defects were noted to the wooden fences and minor repairs maybe needed.

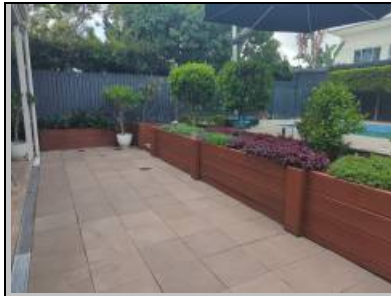
Various Elevations.

The timber retaining walls show normal deterioration and should be monitored.

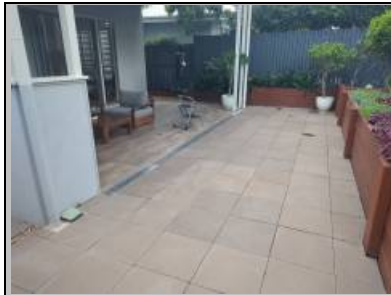
The concrete paths/paved areas are in good condition. Minor concrete cracks are noted.

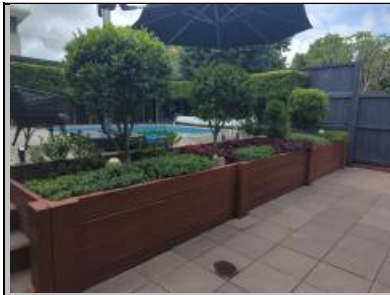
Sleepers or timber landscaping materials:

Yes - Fungal Decay (wood rot) was noted to the following timbers/areas.

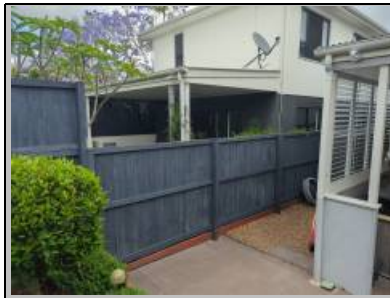
Various fencing timbers:

**Yes - Wood decay damage was noted to the following timbers/areas.**
