Visual Building Inspection Report

12 Hatherton Cres, Carindale

24/07/2024.

8878 b

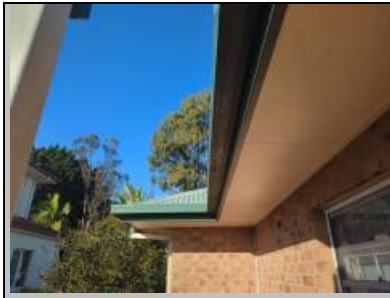
All elevations:

Appear to be in serviceable condition. Water staining was noted to sections of the gutter and fascia. Recommended to monitor when raining.

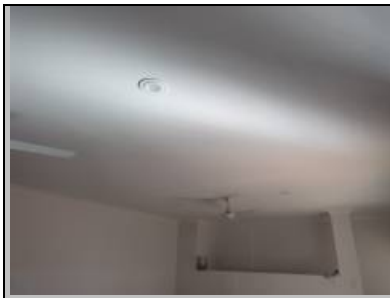
Various areas.

The condition of the ceilings is generally fair. General wear and tear is noted. Minor settlement cracks were noted and these are typical of this type of material. Periodic maintenance may be required. Evidence of past water penetration through the ceiling. No evidence of any current leaks. Patching and painting will improve overall appearance.

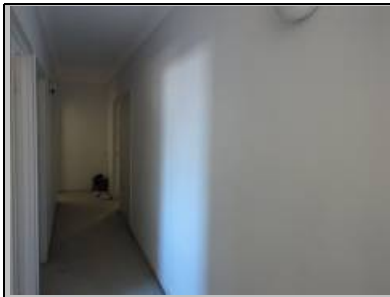
Various areas.

The condition of the walls is generally fair. General wear and tear is noted. Minor cracking is evident to wall linings. Periodic maintenance may be required. Patching and painting will improve overall appearance.

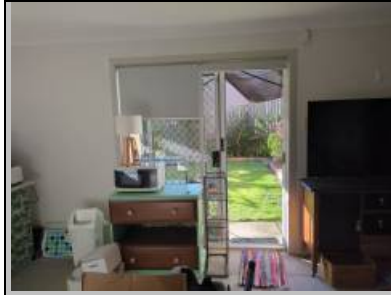
Various areas.

The condition of the windows is generally fair. General wear and tear is noted. Water damage to the lower level windows indicates the windows are leaking. Repairs are required to prevent further damage to surrounding areas.

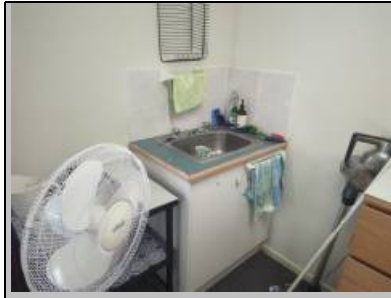
The condition of the fixtures is generally fair. General wear and tear is noted.

The condition of the tiles is generally fair. Staining noted to grouting and silicone sealants, clean, regrout and replace sealants as required.

Maintain all sealants and grouting to prevent moisture penetration and damage.

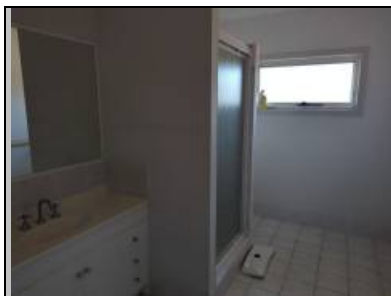
The condition of the fixtures is generally fair. General wear and tear is noted.

Shower appears to be in a serviceable condition. Staining noted to grouting and silicone sealants, clean, re-grout and replace sealants as required. Some cracked tiles were noted to walls in areas.

Maintain all sealants and grouting to prevent moisture penetration and damage.

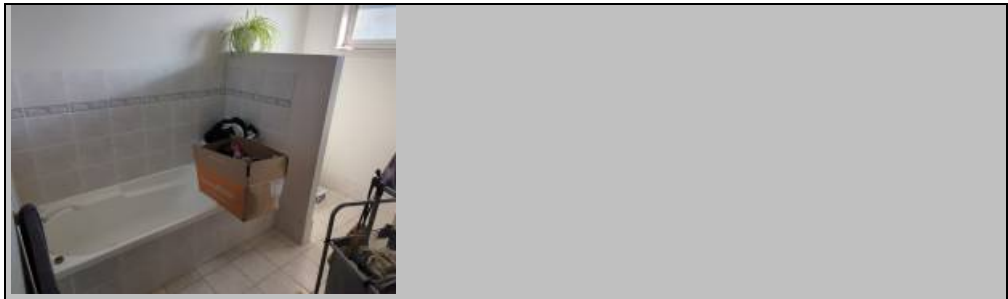
The condition of the fixtures is generally fair. General wear and tear is noted.

The shower is located over the bathtub. The area will need to be kept well sealed to prevent water penetration to surrounding areas. Staining noted to grouting and silicone sealants, clean, re-grout and replace sealants as required. Some cracked tiles were noted to walls in areas.

Maintain all sealants and grouting to prevent moisture penetration and damage.

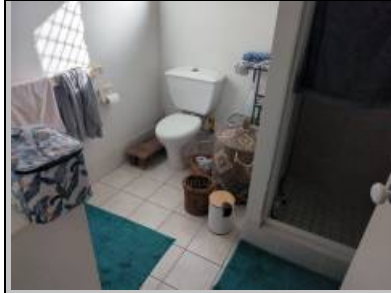
The condition of the fixtures is generally fair. General wear and tear is noted.

Shower appears to be in a serviceable condition. Staining noted to grouting and silicone sealants, clean, re-grout and replace sealants as required. Some cracked tiles were noted to walls in areas.

Maintain all sealants and grouting to prevent moisture penetration and damage.

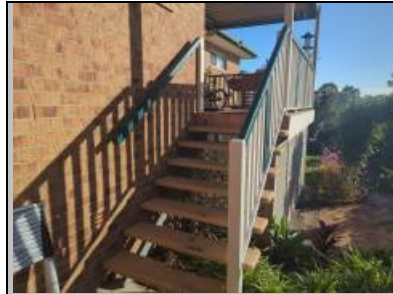
The stairs are constructed primarily from timber and steel. The overall condition of the stairs is good. Minor wood decay is noted.

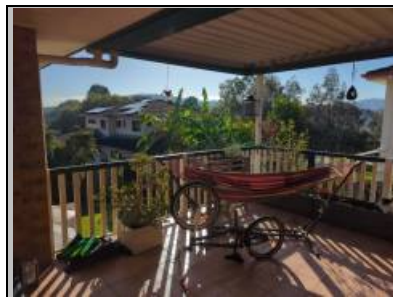
Rear elevation:

Constructed from timber and metal with masonry flooring. The general condition of this structure is fair.

Sealants will have to be kept fresh to this floor to guard against seepage going through floor into areas below. Minor wood decay is present to the structure.

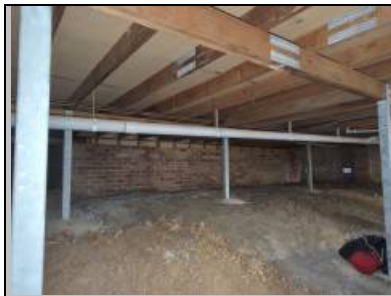
The floor framing and subfloor area appears to be generally sound, typical and consistent compared with buildings of similar age and construction. The building is constructed on a combination of strip footings and concrete slab footings. The building is constructed on metal posts. The building is constructed on Combination Brick Base and Piers. The footings appear to be generally sound. Efflorescence is noted to the face of masonry wall. This is when a white powdery deposit forms on the surface of bricks, masonry or concrete. This is caused by crystallisation and subsequent dehydration of soluble salts contained in the mortar or wall materials. Recommend the area be cleaned to remove efflorescence.

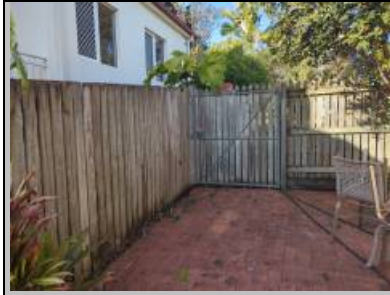
Dividing fence section:

The fences are mainly constructed from timber and metal. The fences are generally in fair condition but some repairs or maintenance is required. Minor wet rot or defects were noted to the wooden fences and minor repairs maybe needed.

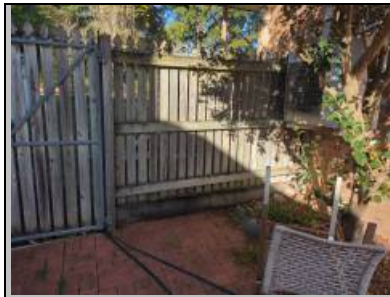
Yes - Fungal Decay (wood rot) was noted to the following timbers/areas.

Decking timbers: Steps/stair timbers: Sleepers or timber landscaping materials:
