# Visual Building Inspection Report

71 Camelia St, Cannon Hill

4/11/2024.

9447 bi

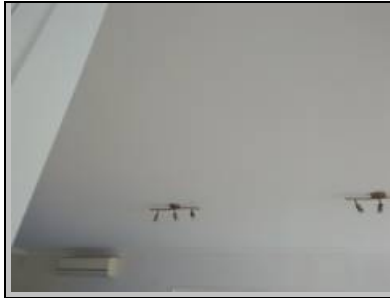
Various areas.

The condition of the ceilings is generally good. General wear and tear is noted. Minor settlement cracks were noted and these are typical of this type of material. Periodic maintenance may be required.

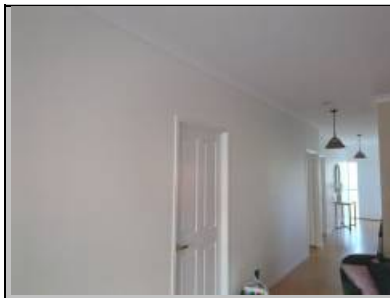
Various areas.

The condition of the walls is generally good. General wear and tear is noted. Minor cracking is evident to wall linings. Periodic maintenance may be required.

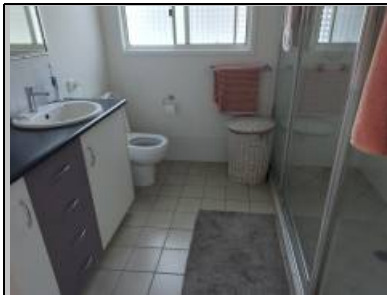
Shower appears to be in a serviceable condition. Staining noted to grouting and silicone sealants, clean, re-grout and replace sealants as required.

Maintain all sealants and grouting to prevent moisture penetration and damage.

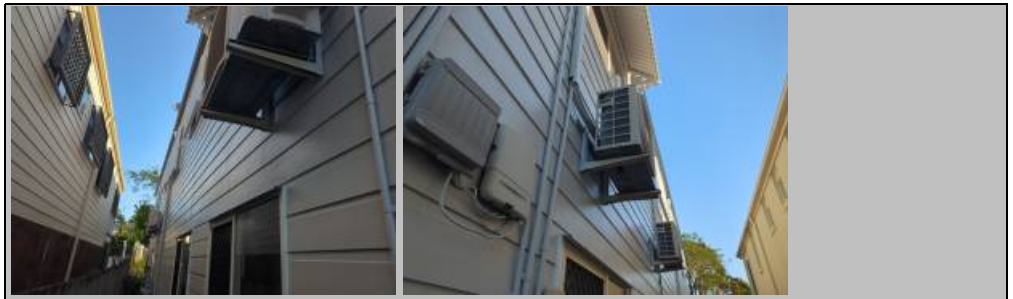
All elevations:

The condition of the walls is generally good. General wear and tear is noted. Minor bulging was noted to some sections of the cladding. This is consistent with settlement of timbers/ age and type of building.

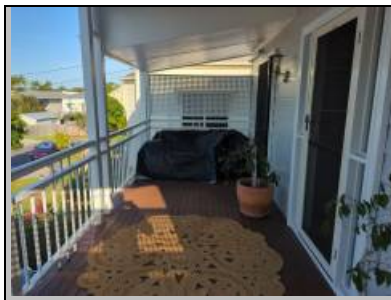
Front elevation:

Minor wood decay is present to the structure.

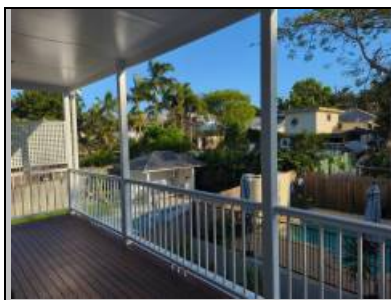
Rear elevation:

Minor wood decay is present to the structure.

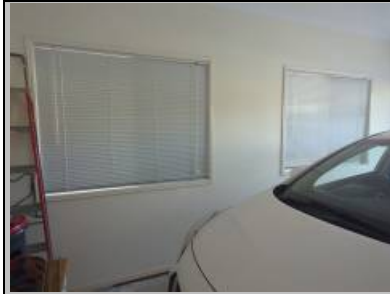
Stored items restricted inspection to the interior. Stored items should be removed to enable a more complete report to be submitted.

The concrete floor is generally in good condition. minor concrete cracks are noted. Efflorescence is noted to the face edge of the slab. This is when a white powdery deposit forms on the surface of bricks, masonry or concrete. This is caused by crystallisation and subsequent dehydration of soluble salts contained in the mortar or wall materials. Recommend the area be cleaned to remove efflorescence.

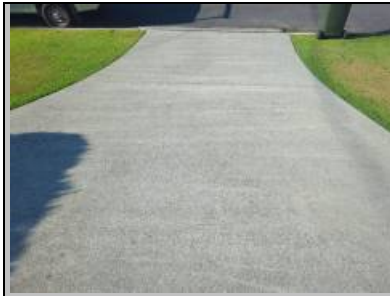
The concrete driveway stands in good condition. Minor concrete cracks are noted.

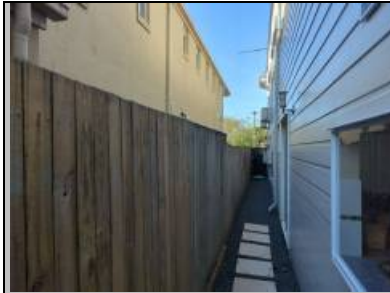
Dividing fence section:

The fences are mainly constructed from timber and metal. The fences are generally in fair condition but some repairs or maintenance is required. Minor wet rot or defects were noted to the wooden fences and minor repairs maybe needed. The fences are leaning and repairs maybe required.

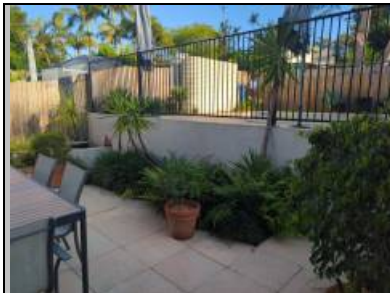
Various Elevations.

The timber retaining walls show normal deterioration and should be monitored. The masonry retaining walls show normal deterioration, cracks etc, and should be monitored for any movement.

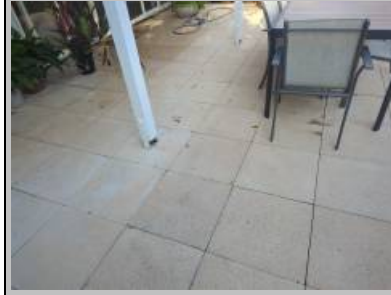
The concrete paths/paved areas are in good condition. Minor concrete cracks are noted.

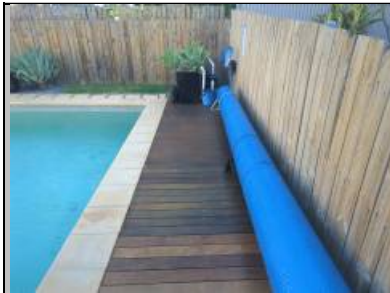
**Yes - Fungal Decay (wood rot) was noted to the following timbers/areas.**

Decking timbers: Sleepers or timber landscaping materials:

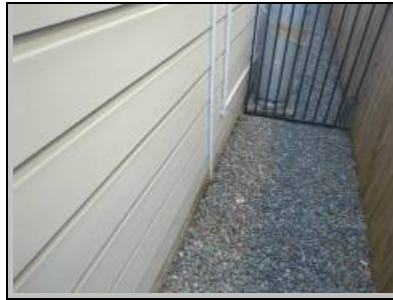
The air-conditioning condenser discharges adjacent to the external walls. We recommend modification so that water is discharged over a drain. Air conditioning units which release water alongside or near to building walls should be piped to a drain (if not possible then several meters away from the building) as the resulting wet area is highly conducive to termites.

Some external timbers and cladding are in contact with soil. These should be modified so that timber to soil contact does not occur.

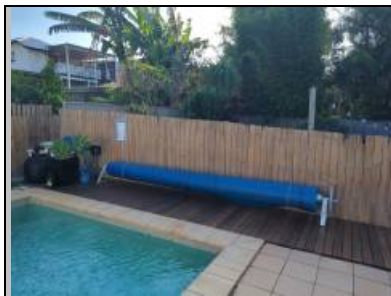
**Yes - Wood decay damage was noted to the following timbers/areas.**

Various fencing timbers:
