Inspection Report

One Call Building and Pest Inspections

113 Beelarong St Morningside , Brisbane , QLD

Pest And Building Inspection

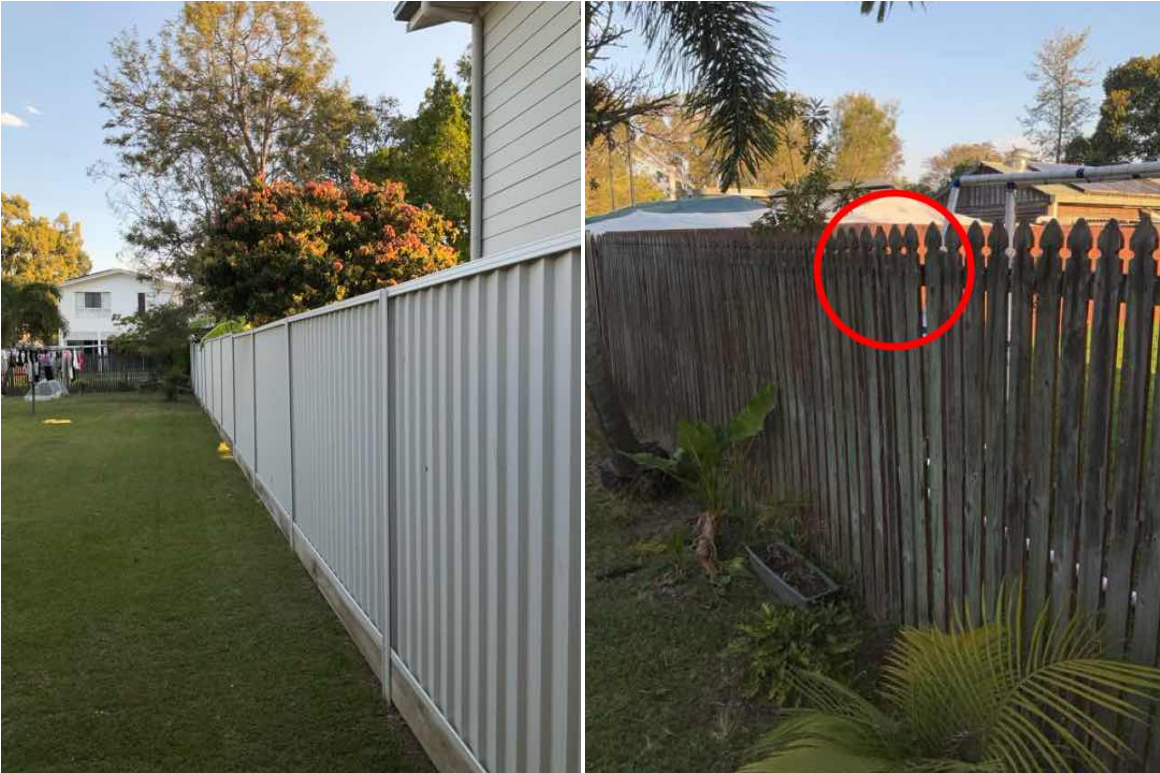
General age to fence components. General upkeep and maintenance required. A qualified fencing contractor should be engaged for repairs.

Fence rot/leaning. Repairs are required by a fencing contractor to avoid unsafe conditions.

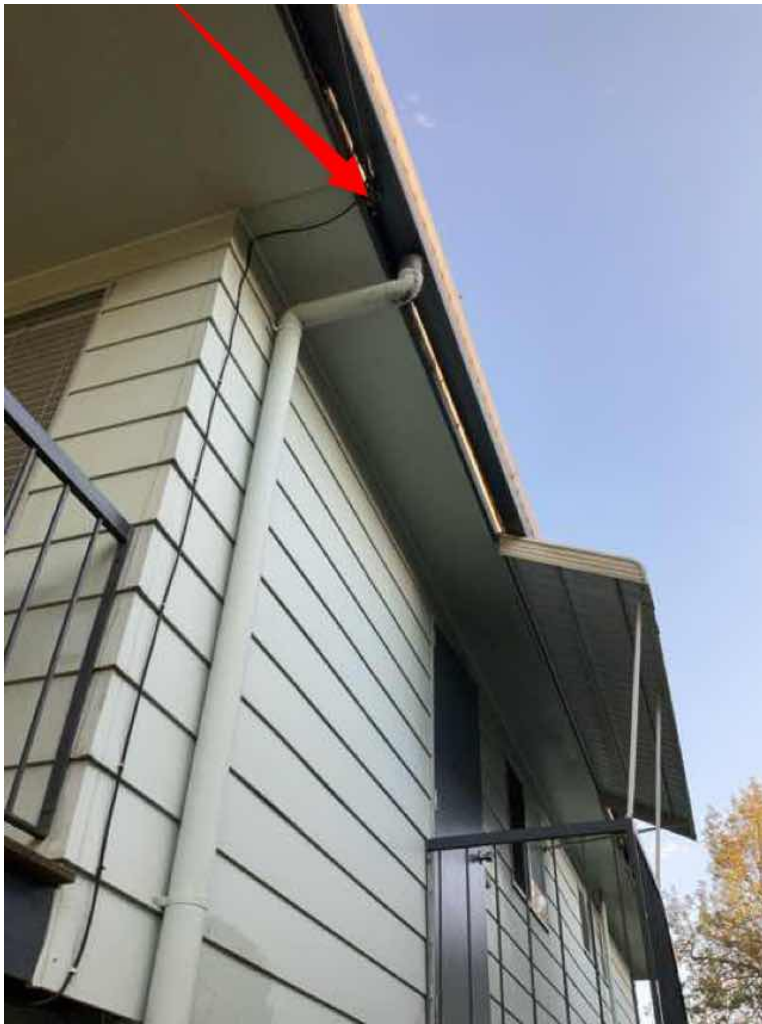
The gutter clips have detached in areas. Recommendations: This can be rectified by maintenance contractors.

Debris in guttering areas- this requires cleaning out to prevent blocking of downpipes and leaking into eaves and fascia. Have gutters cleaned and assessed by a plumber for adequate fall. Regularly clean to prevent ponding. Ponding water will contribute to rust.

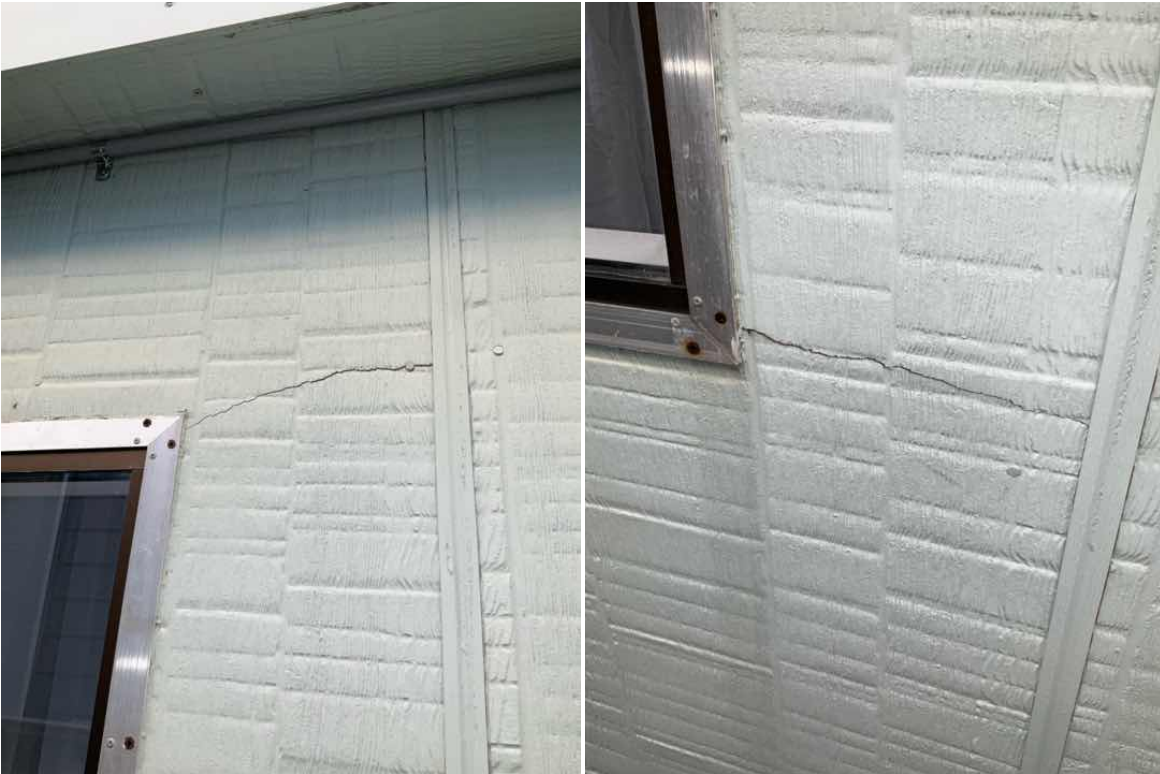
Paneling/cladding damaged. Have a suitably qualified tradesman assess and repair.

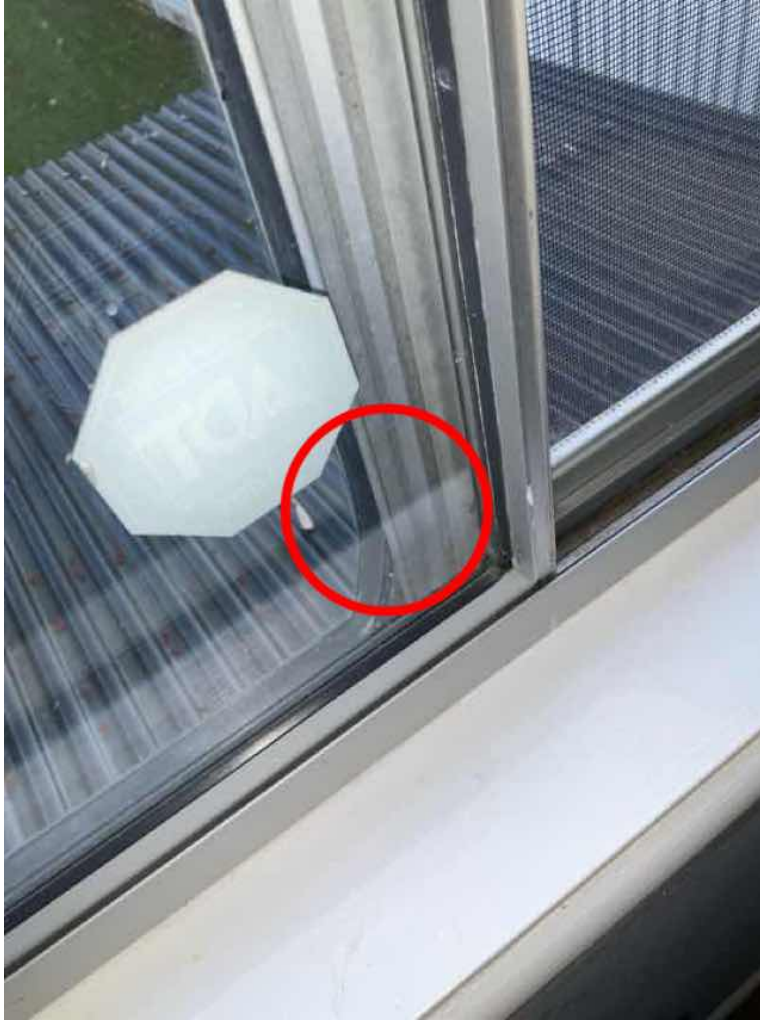
Deterioration of sections of window rubber seals was observed. A qualified glazier should be engaged for advice and recommendations.

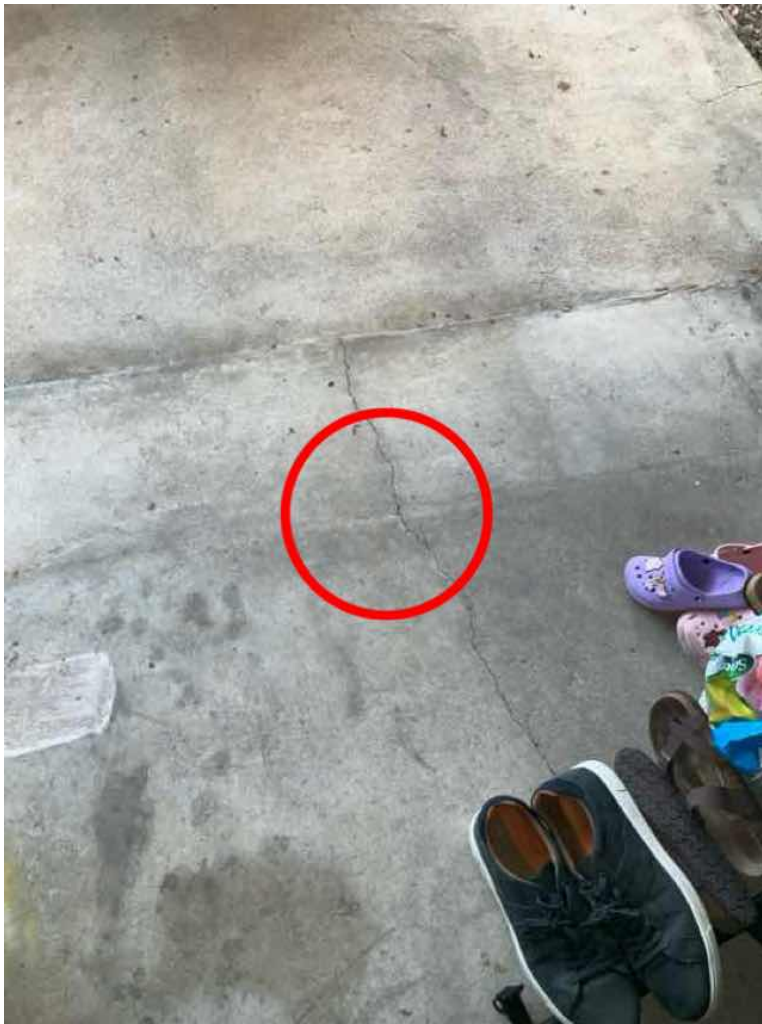
Minor hairline slab cracks - Note. Whilst these cracks appeared to be minor at the time of inspection, we strongly recommend you monitor these cracks and if worsening occurs contact a qualified concreter for further advice.

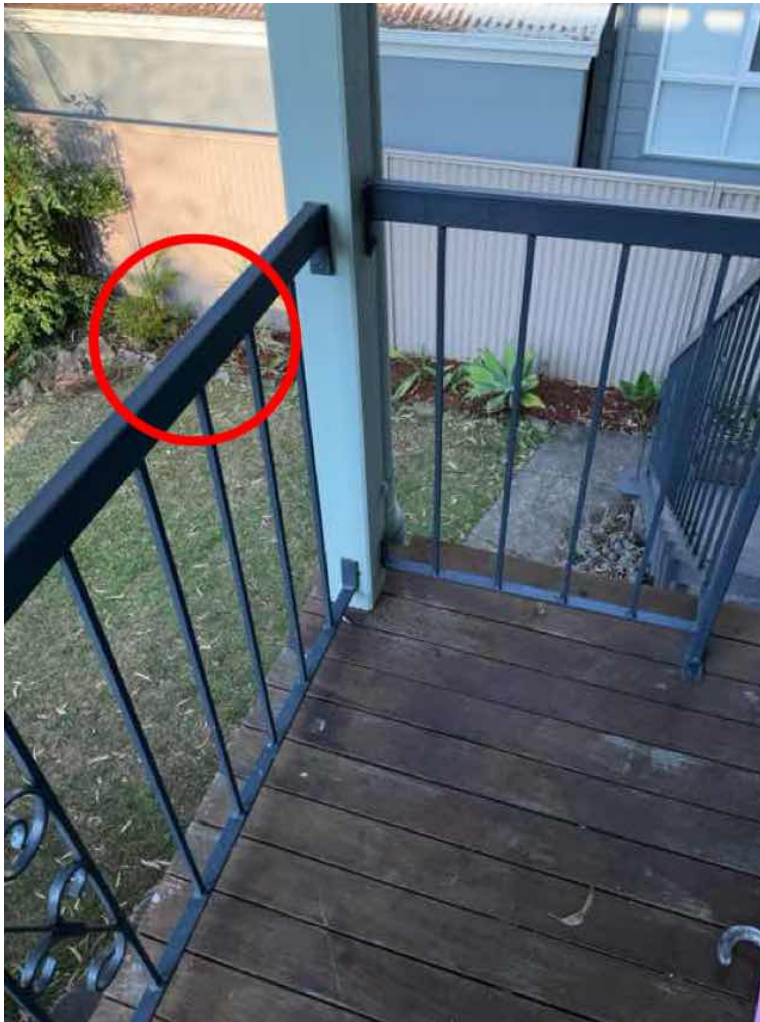
Balustrade rail height- should be 1 m in height from deck/balcony/patio floor. In some circumstances this regulation was non-existent dependent on the age of the dwelling and technically there is no requirement to rectify. Recommendations: We strongly advise you rectify to comply for safety concerns.

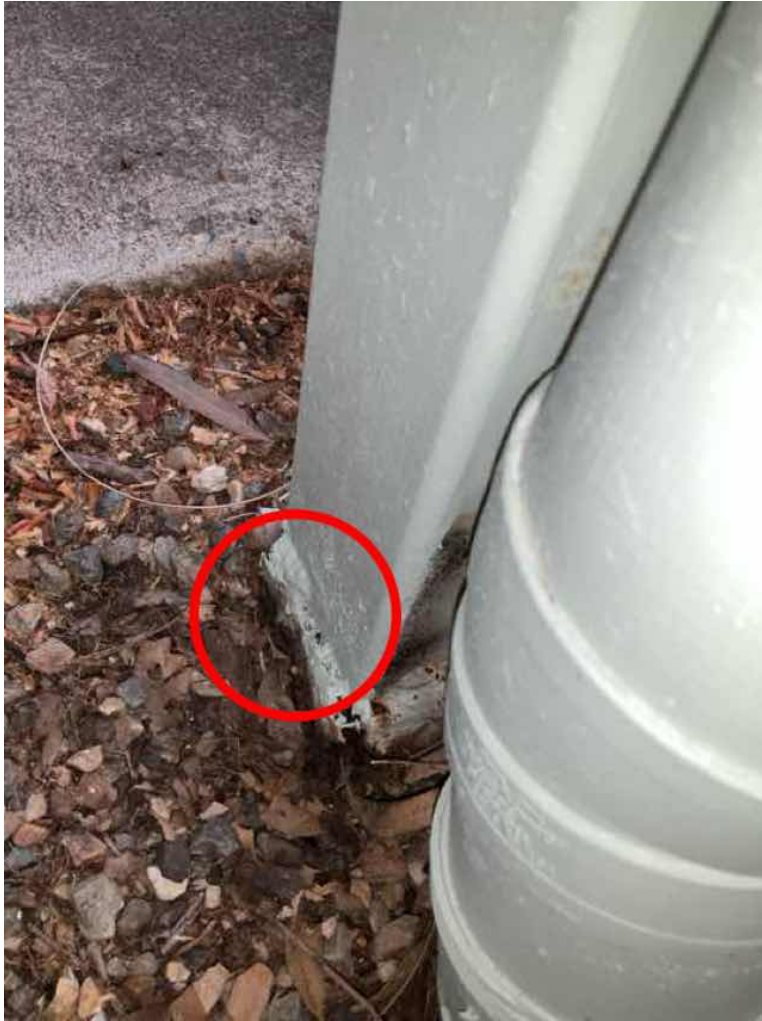
Rust evident in area/s. Recommendations: Have assessed by contractor with view of restricting/repairing and sealing affected areas.

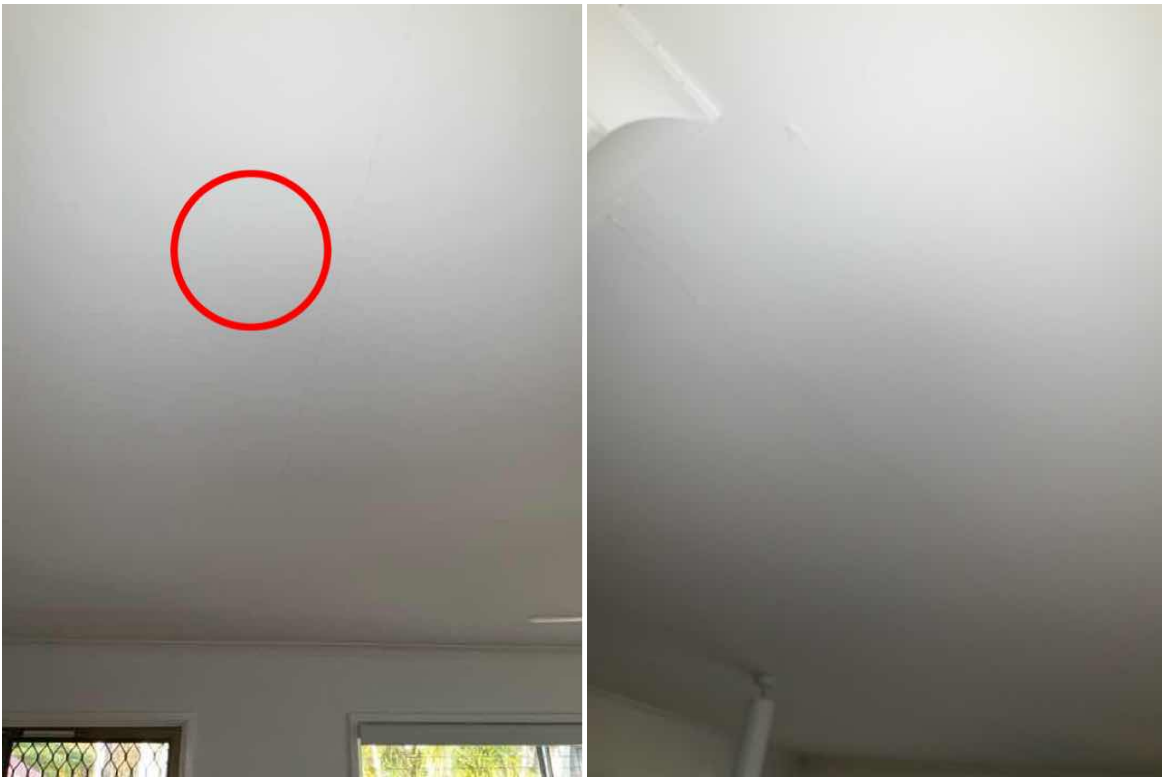
Settlement Cracks Noted. These are typical and generally patch and paint will suffice, however monitoring these cracks is advised for 12 months and if they become worse, further investigation by a suitably qualified professional is advised.

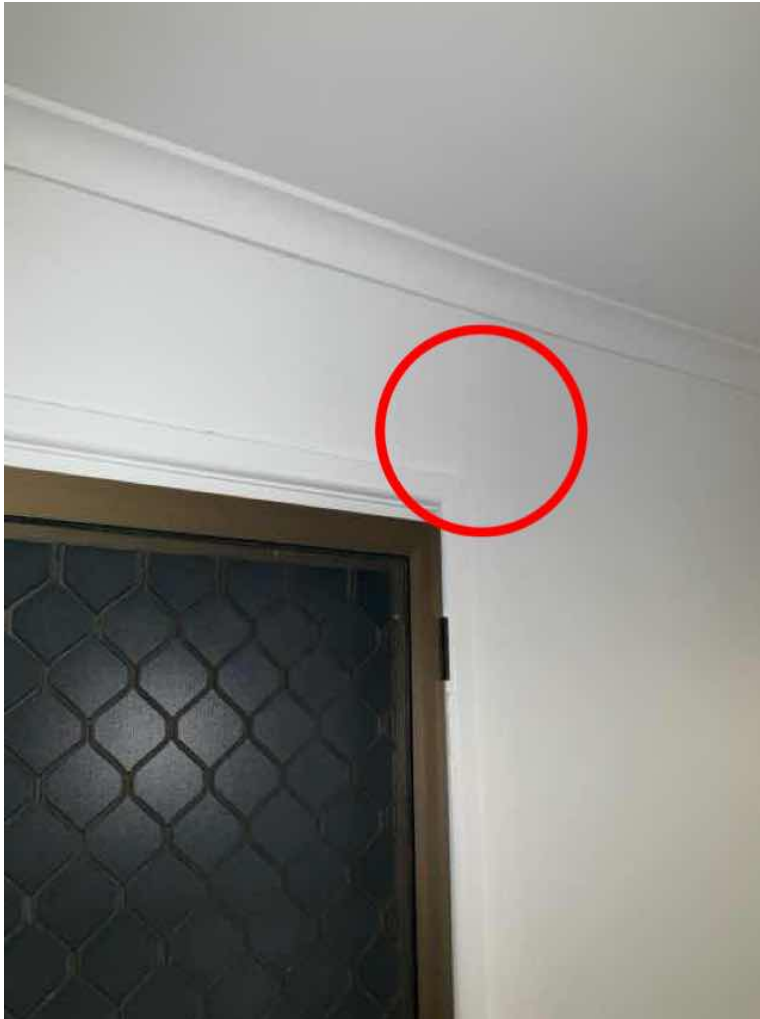
Settlement Cracks Noted . These are typical and generally patch and paint will suffice, however Monitoring these cracks advised for 12 months and if become wider or longer, you will need to contact a structural engineers to assess.

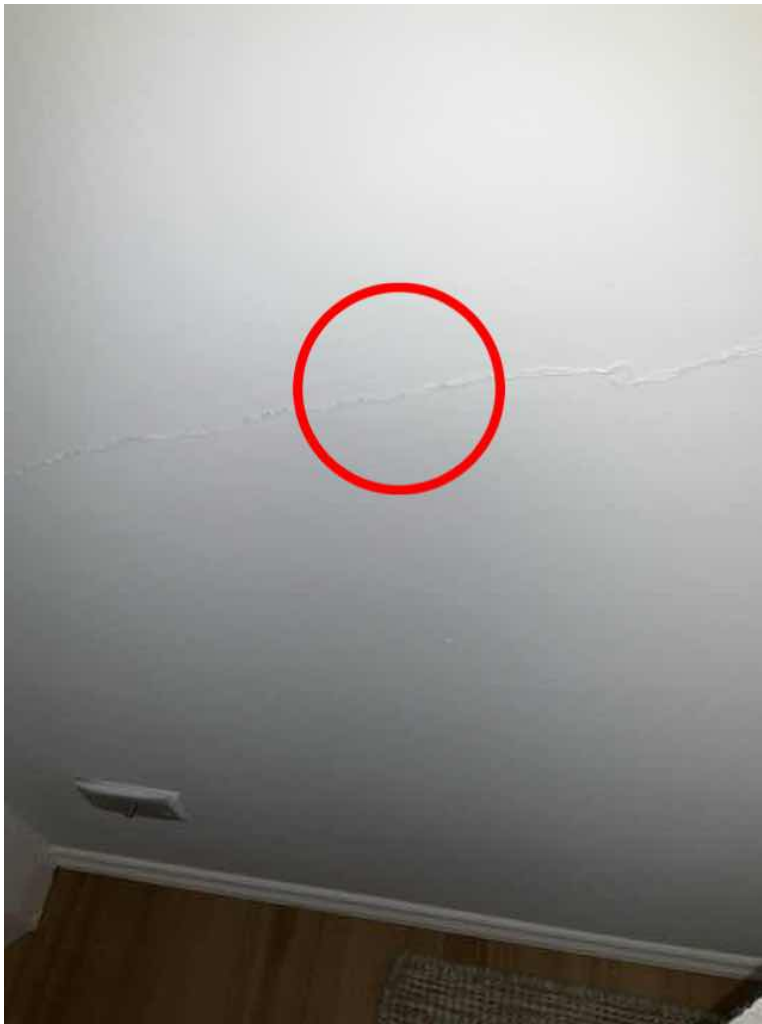
Settlement Cracks Noted . These are typical and generally patch and paint will suffice, however Monitoring these cracks advised for 12 months and if become wider or longer, you will need to contact a structural engineers to assess.

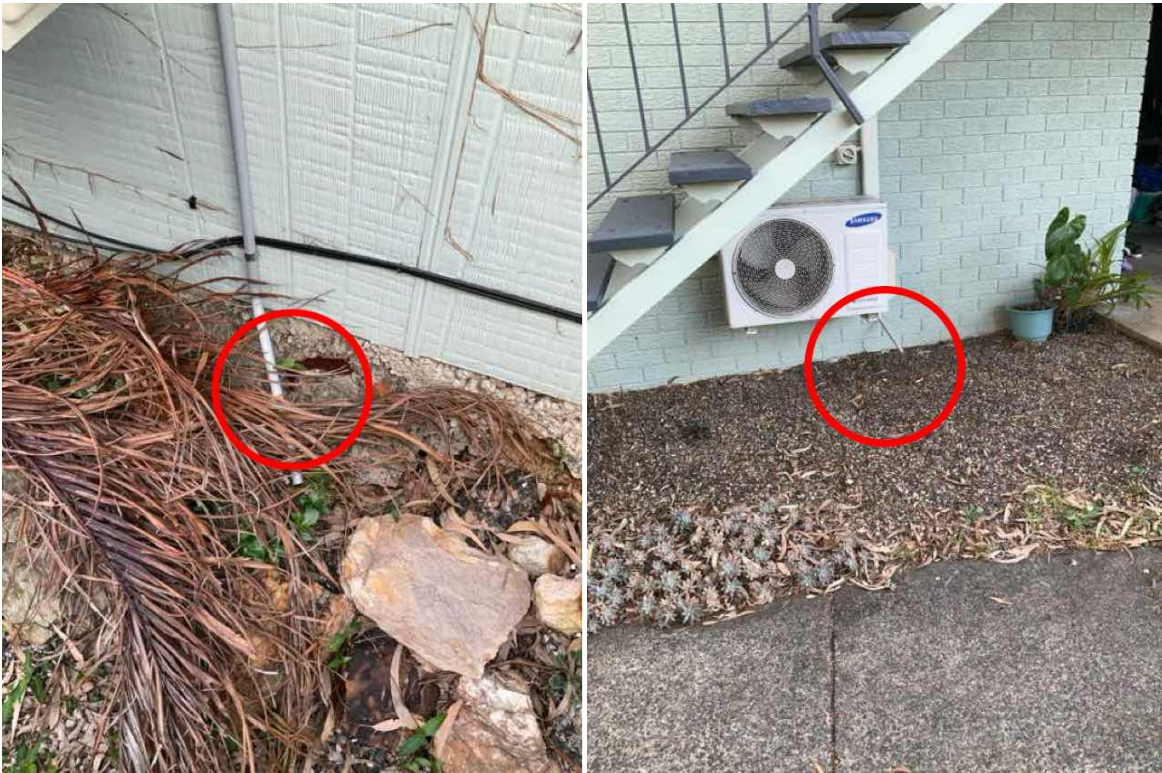
Was the Air Conditioner Sufficiently Drained

No - Divert A/C overflow away from the building perimeter.

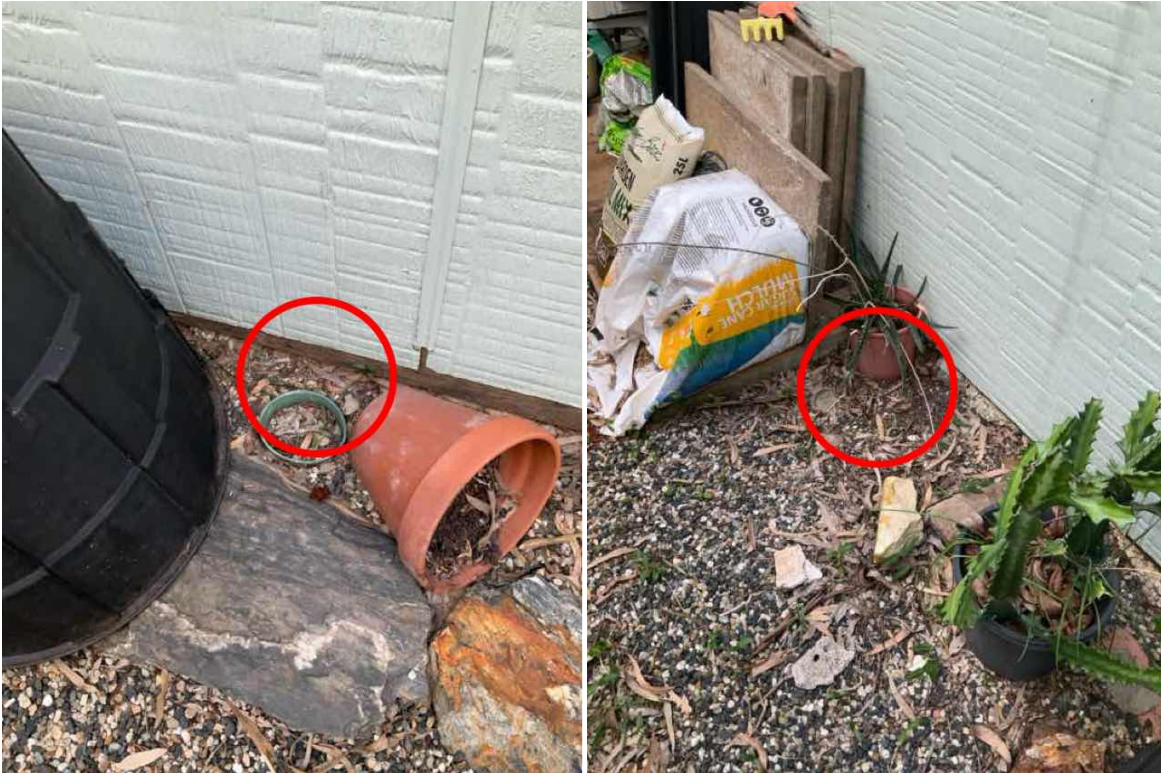
Is the Slab Edge adequately Exposed

No. Slab edge should be exposed a minimum of 75mm.
