# Visual Building Inspection Report

16 Gatling Rd, Cannon Hill

8/11/2024.

9493 b

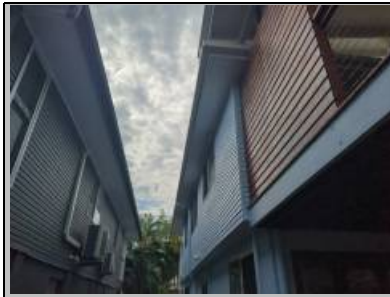
Appear to be in serviceable condition.

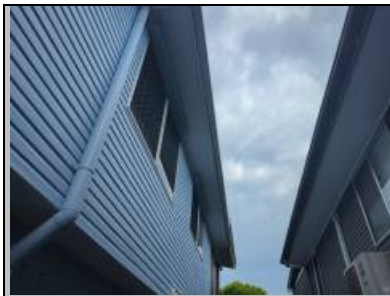
The eaves are lined with asbestos cement sheeting. The overall condition of the eaves lining is good.

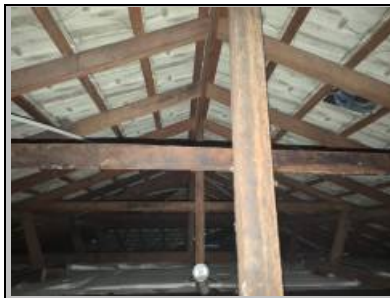
The cut and pitched roof timbers appear to provide adequate support. Timber deflection noted to some roof timbers. This is consistent with to settlement of timbers/ age and type of building.

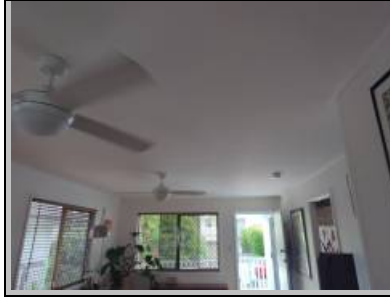
The condition of the ceilings is generally good. General wear and tear is noted.

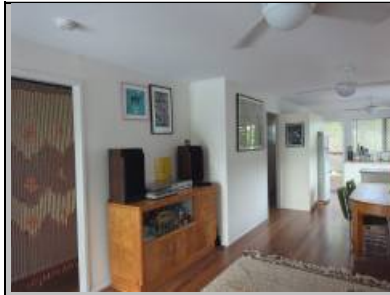
The condition of the walls is generally good. General wear and tear is noted.

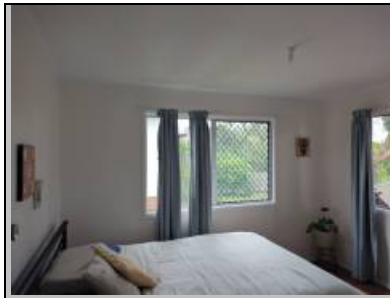
The condition of the windows is generally good. General wear and tear is noted.

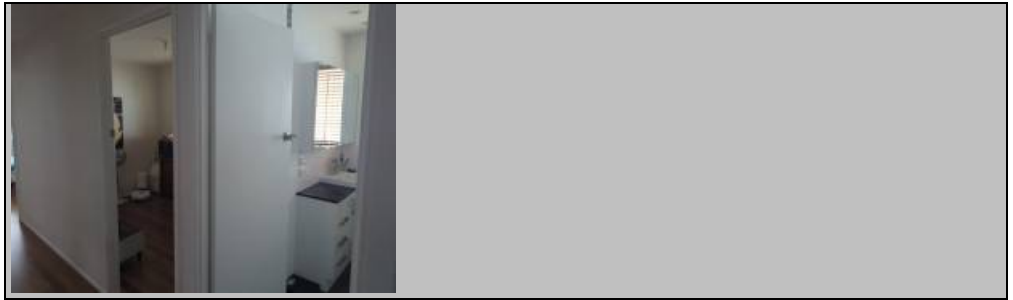
The condition of the doors is generally good. General wear and tear is noted.

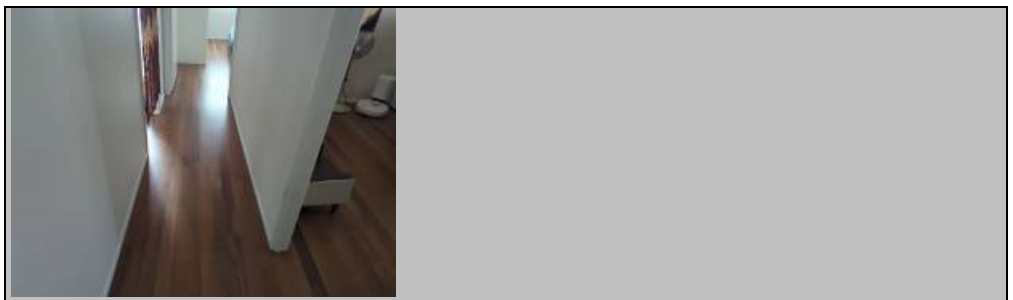
Floors are concealed by floor coverings, The condition of the floors is generally good. General wear and tear is noted, Timber deflection noted to some flooring timbers. This is consistent with to settlement of timbers/ age and type of building. minor concrete cracks are noted.

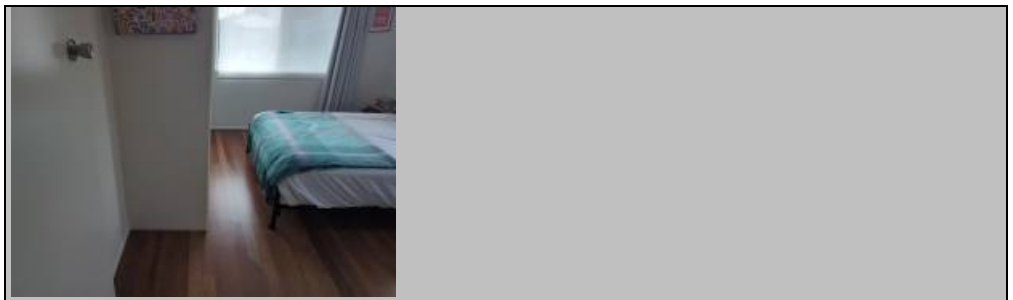
The condition of the woodwork is generally good. General wear and tear is noted.

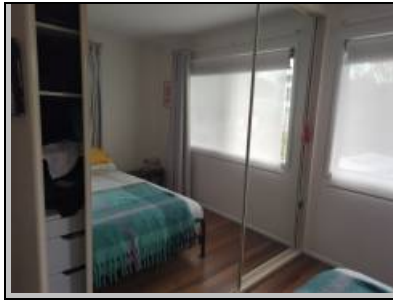
The condition of the built-in wardrobes is generally good. General wear and tear is noted.

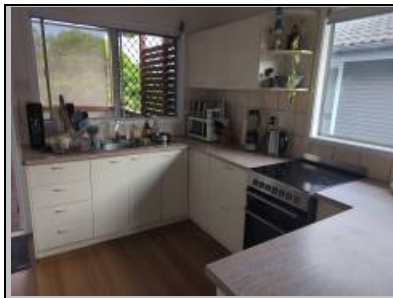
The condition of the fixtures is generally fair. General wear and tear is noted. The laminate is lifting and/or damaged in some areas. Adjustment is required to some door and drawers to ensure smooth operation.

Maintain all sealants and grouting to prevent moisture penetration and damage.

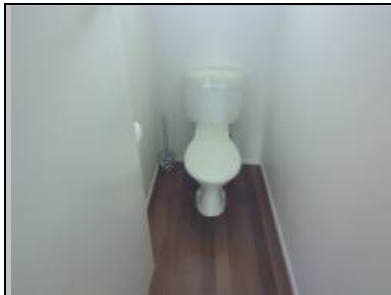
The toilet appears to be in working order. Dual flush. The toilet cistern is noted as having surface deterioration from a cosmetic point of view only. Replace cistern when necessary.

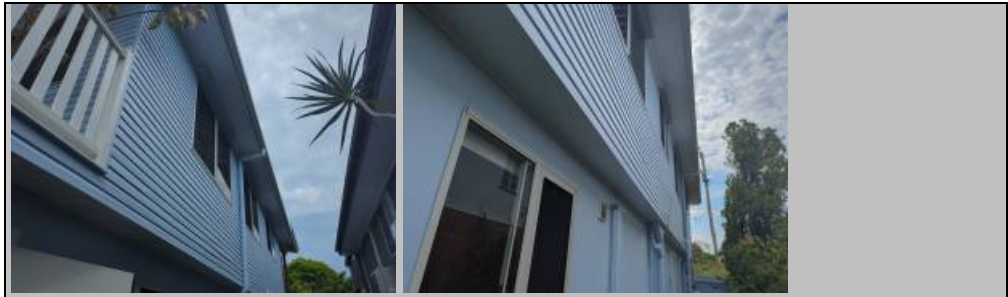
The condition of the walls is generally good. General wear and tear is noted.

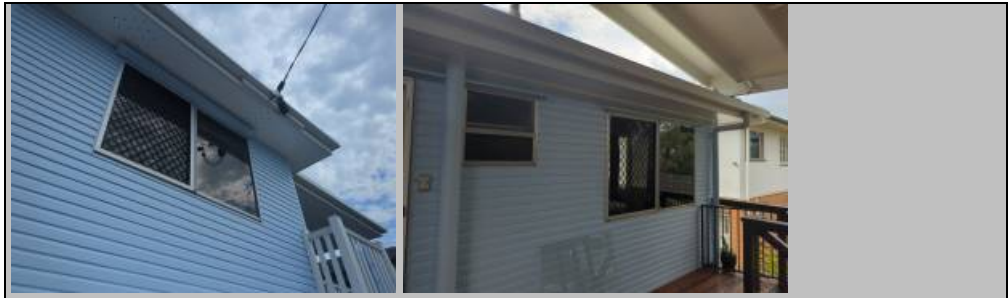
The condition of the exterior of the windows is generally fair. General wear and tear is noted.

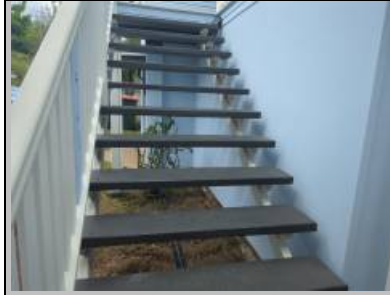
The stairs are constructed primarily from timber and steel. The overall condition of the stairs is fair. Minor Wood decay is noted.

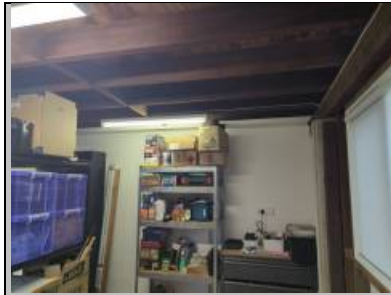
The floor framing and subfloor area appears to be generally sound, typical and consistent compared with buildings of similar age and construction. The building is constructed on a concrete slab. The building is constructed on concrete stumps. Timber deflection noted to some flooring timbers. This is consistent with to settlement of timbers/ age and type of building, Packers have been used under bearers, these packers have possibly been installed due to subsidence in stumps or in relation to leveling, if these packers come loose they may cause floor to 'drop'.

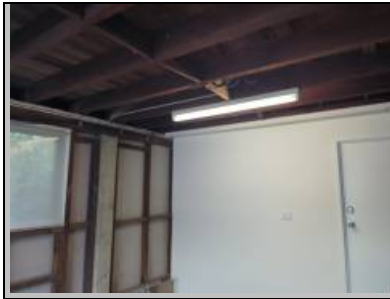
Stored items restricted inspection to the interior. Stored items should be removed to enable a more complete report to be submitted.

The overall condition of the garage is fair.

The main garage door is a tilt style door and is in fair condition.

The concrete floor is generally in fair condition. minor concrete cracks are noted.

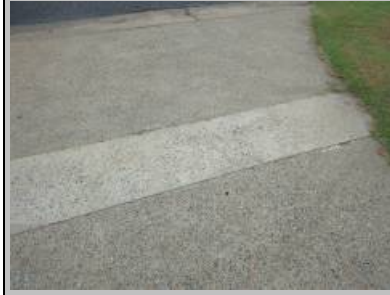
The concrete driveway stands in fair condition. Minor concrete cracks are noted.

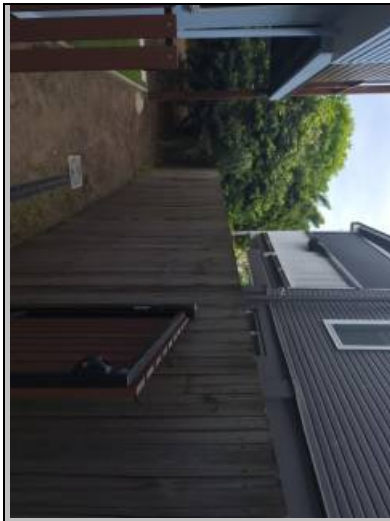
Dividing fence section:

The fences are mainly constructed from timber and metal. The fences are generally in fair condition but some repairs or maintenance is required. Minor wet rot or defects were noted to the wooden fences and minor repairs maybe needed.

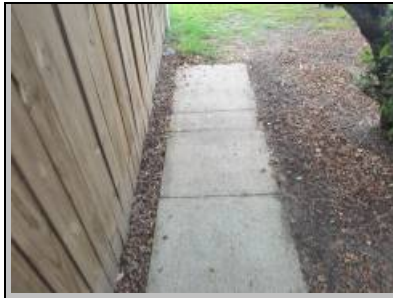
The concrete paths/paved areas are in fair condition. Minor concrete cracks are noted.

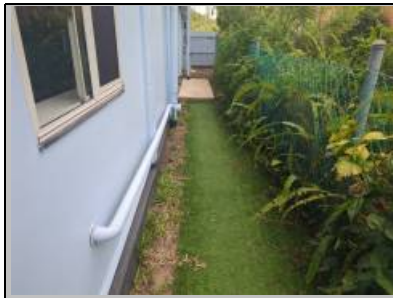
Site drainage appears to be acceptable. However, the site should be monitored during heavy rain. All surface water should divert away from house footings/ foundations.
