Visual Building Inspection Report

67 Camelia St, Cannon Hill

30/10/2024.

VISUAL TIMBER PEST INSPECTION REPORT as per AS4349.3-2010

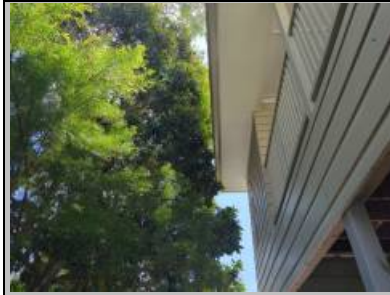
All elevations:

Appear to be in serviceable condition. Water staining was noted to sections of the gutter and fascia. Recommended to monitor when raining. Leaves and debris are present in gutters. These should be cleared.

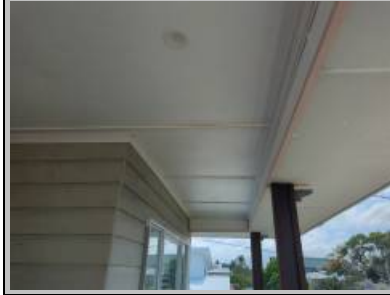
Front elevation:

The eaves are lined with fibre cement sheeting. The overall condition of the eaves lining is fair. Sections of the front eaves require painting.

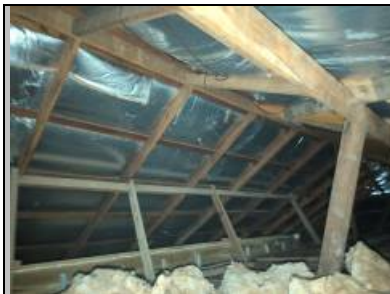
The cut and pitched roof timbers appear to provide adequate support. Timber deflection noted to some roof timbers. This is consistent with to settlement of timbers/ age and type of building.

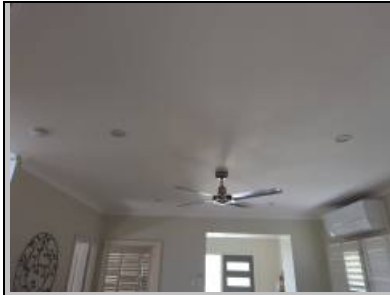
Various areas.

The condition of the ceilings is generally fair. General wear and tear is noted. Minor settlement cracks were noted and these are typical of this type of material. Periodic maintenance may be required. Patching and painting will improve overall appearance.

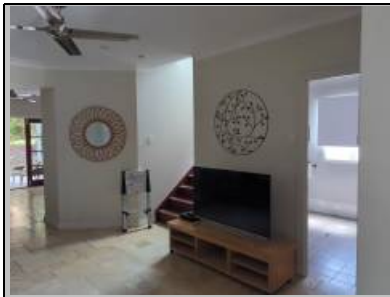
Various areas.

The condition of the walls is generally fair. General wear and tear is noted. Minor cracking is evident to wall linings. Periodic maintenance may be required. Patching and painting will improve overall appearance.

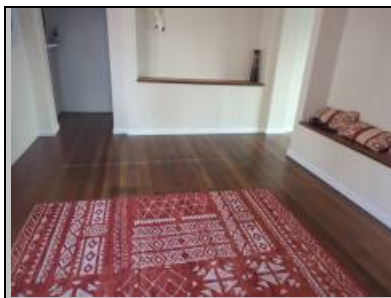
Throughout.

Floors are concealed by floor coverings, The condition of the floors is generally fair. General wear and tear is noted, Timber deflection noted to some flooring timbers. This is consistent with to settlement of timbers/ age and type of building.

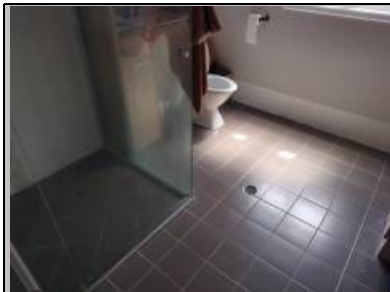
The condition of the fixtures is generally fair. General wear and tear is noted.

Shower appears to be in a serviceable condition. Staining noted to grouting and silicone sealants, clean, re-grout and replace sealants as required.

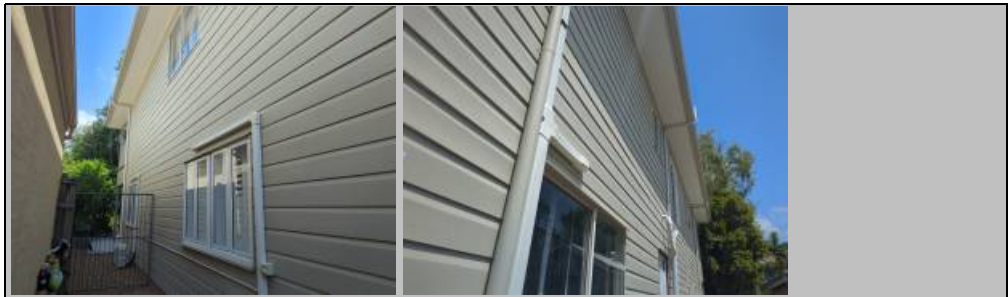
Various Elevations.

The condition of the walls is generally fair. General wear and tear is noted. Patching and painting will improve overall appearance.

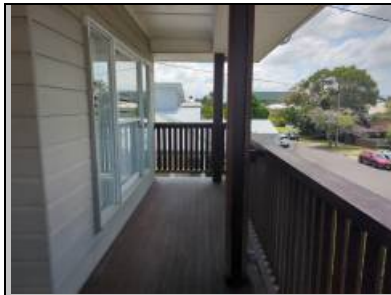
Front elevation:

Constructed from timber and metal. The general condition of this structure is good.

Minor wood decay is present to the structure. Bottom rails of handrails installed incorrectly. Vertical timbers may easily be pushed out when deteriorated. Consideration to improve fixing of vertical timbers should be given. Minor rust/corrosion to sections of metal. Rust treatment/maintenance recommended.

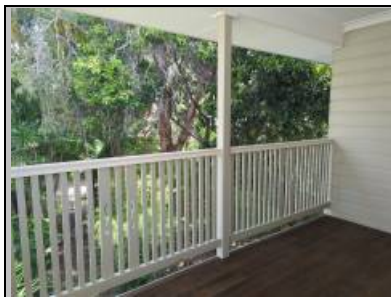
Rear elevation:

Constructed from timber. The general condition of this structure is good.

Minor wood decay is present to the structure. Bottom rails of handrails installed incorrectly. Vertical timbers may easily be pushed out when deteriorated. Consideration to improve fixing of vertical timbers should be given.

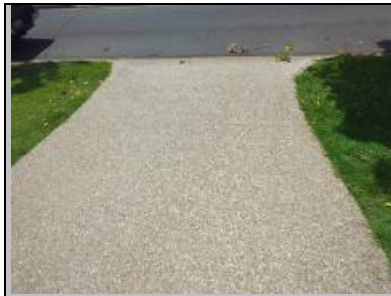
The concrete driveway stands in good condition. Minor concrete cracks are noted.

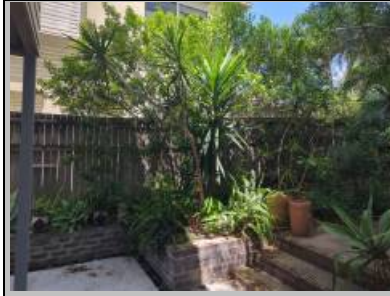
Dividing fence section:

The fences are constructed from a combination of timber, brick and metal. The fences are generally in fair condition but some repairs or maintenance is required. Minor wet rot or defects were noted to the wooden fences and minor repairs maybe needed.

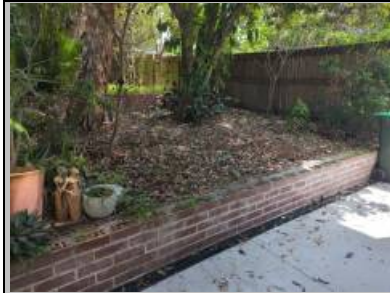
Various Elevations.

The timber retaining walls show normal deterioration and should be monitored. The masonry retaining walls show normal deterioration, cracks etc, and should be monitored for any movement.

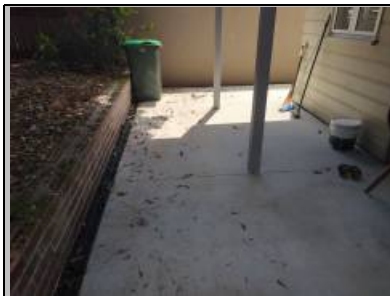
The concrete paths/paved areas are in good condition. Minor concrete cracks are noted.

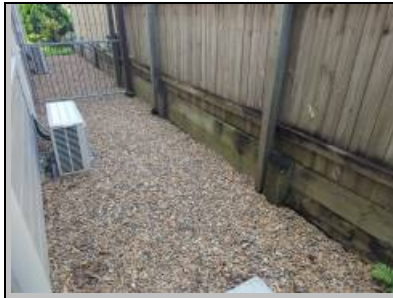
Yes - Fungal Decay (wood rot) was noted to the following timbers/areas.

Decking timbers: Sleepers or timber landscaping materials:

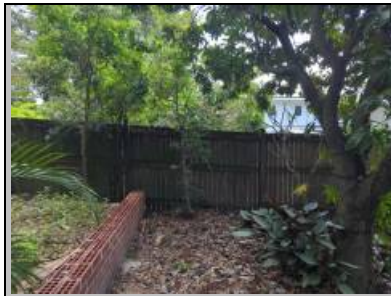
Yes - Wood decay damage was noted to the following timbers/areas.

Various fencing timbers:
