Visual Building Inspection Report

9 Glenheaton Ct, Carindale

4/10/2024.

VISUAL BUILDING INSPECTION REPORT

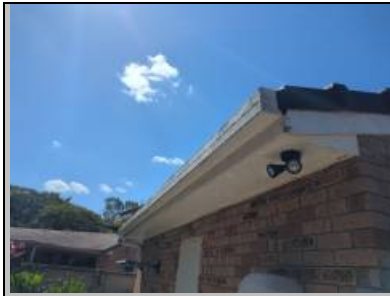
All elevations:

Appear to be in serviceable condition. Water staining was noted to sections of the gutter and fascia. Recommended to monitor when raining.

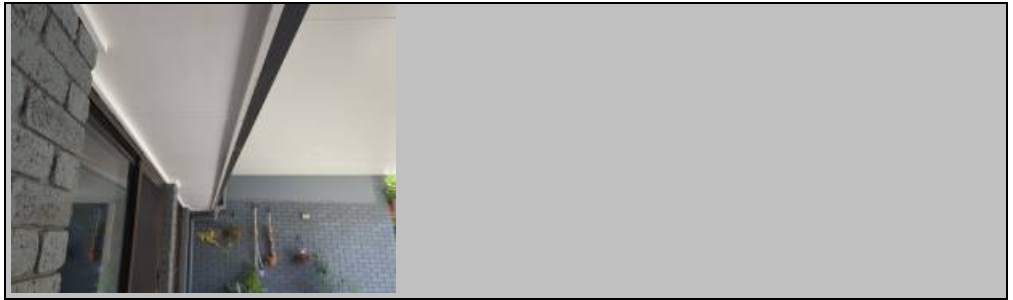
Northern elevation:

The overall condition of the eaves lining is fair. The paint work to the eaves is deteriorating and maintenance is required.

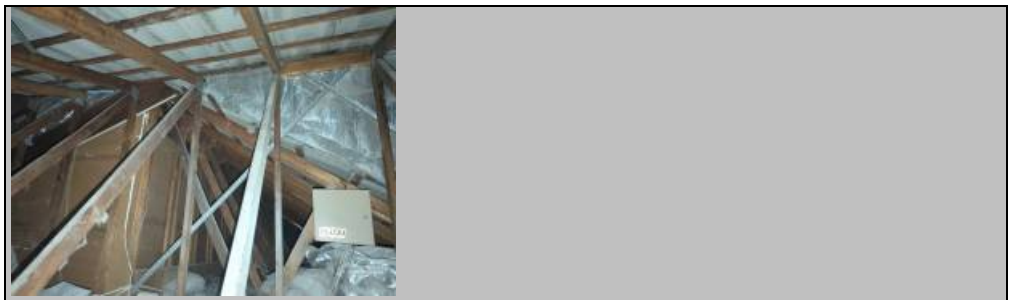
The truss and cut and pitched roof timbers appear to provide adequate support. Timber deflection noted to some roof timbers. This is consistent with to settlement of timbers/ age and type of building.

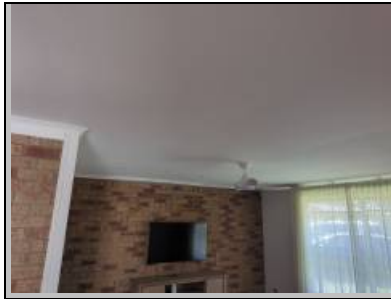
Throughout.

The condition of the ceilings is generally fair. General wear and tear is noted. Minor settlement cracks were noted and these are typical of this type of material. Periodic maintenance may be required. Moderate undulations were noted to the ceiling lining. This is to be expected in a house of this age. Periodic maintenance will be required.

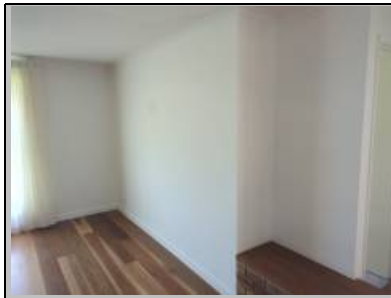
Throughout.

The condition of the walls is generally good. General wear and tear is noted. Minor cracking is evident to wall linings. Periodic maintenance may be required.

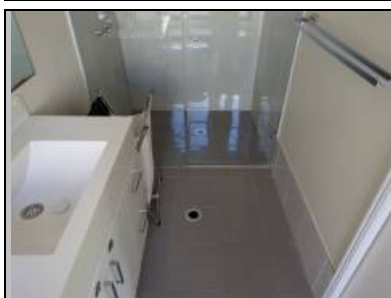
Shower appears to be in a serviceable condition. Staining noted to grouting and silicone sealants, clean, re-grout and replace sealants as required.

Maintain all sealants and grouting to prevent moisture penetration and damage.

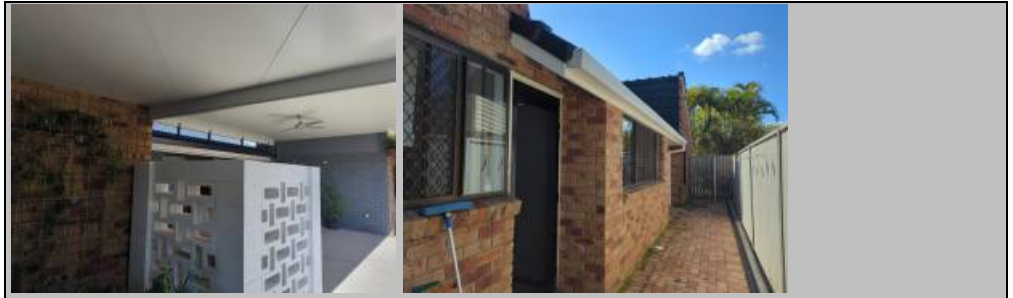
All elevations:

The condition of the walls is generally good. General wear and tear is noted.

Minor appearance cracks were noted and these are typical of this type of material. This is considered to be an appearance defect. Periodic maintenance may be required.

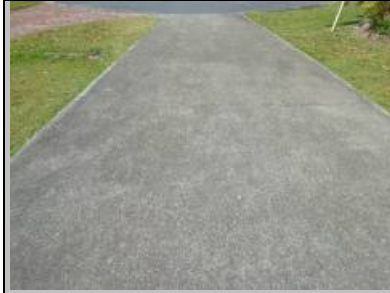
The concrete driveway stands in fair condition. Minor concrete cracks are noted.

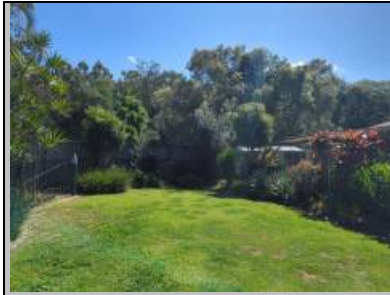
Dividing fence section:

The fences are constructed from a combination of timber, brick and metal. The fences are generally in fair condition but some repairs or maintenance is required. Minor wet rot or defects were noted to the wooden fences and minor repairs maybe needed.

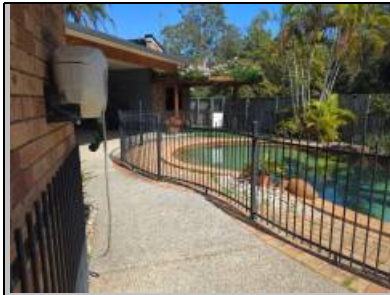
The concrete paths/paved areas are in fair condition. Minor concrete cracks are noted.

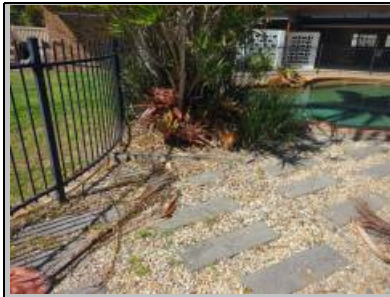
Sleepers or timber landscaping materials:

Yes - Fungal Decay (wood rot) was noted to the following timbers/areas.

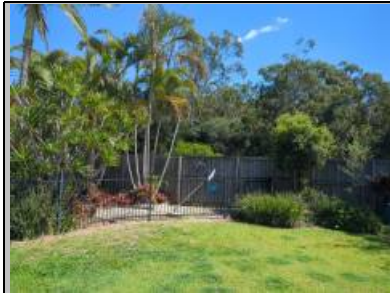
Various fencing timbers:

Yes - Wood decay damage was noted to the following timbers/areas.
