Visual Building Inspection Report

73 Nordenfeldt Rd, Cannon Hill

VISUAL BUILDING INSPECTION REPORT

VISUAL TIMBER PEST INSPECTION REPORT as per AS4349.3-2010

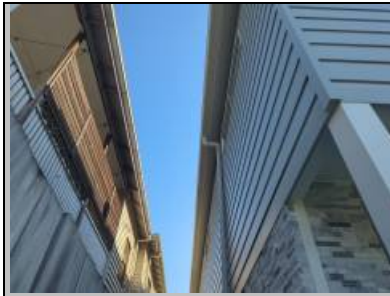
All elevations:

Appear to be in serviceable condition.

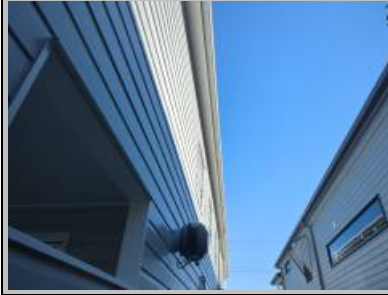
All elevations:

The eaves are lined with fibre cement sheeting. The overall condition of the eaves lining is good.

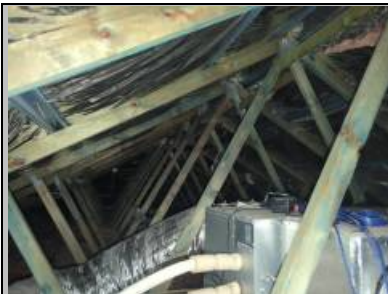
The timber truss roof system is adequate for the roof covering.

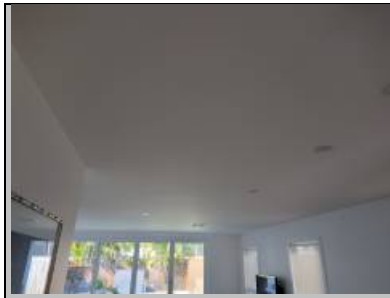
Throughout.

The condition of the ceilings is generally good. General wear and tear is noted.

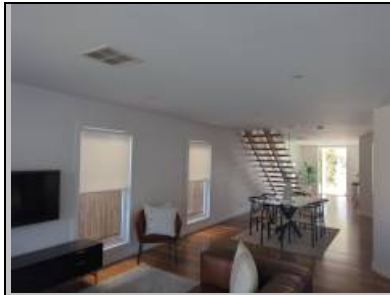
Throughout.

The condition of the walls is generally good. General wear and tear is noted.

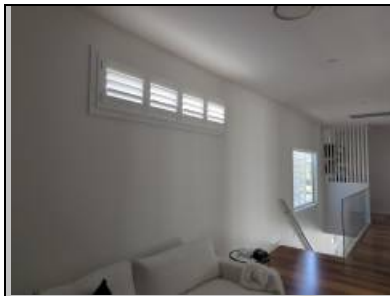
Throughout.

The condition of the windows is generally good. General wear and tear is noted.

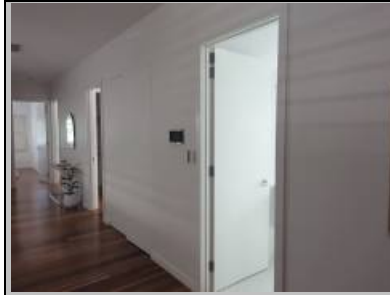
Throughout.

The condition of the doors is generally good. General wear and tear is noted.

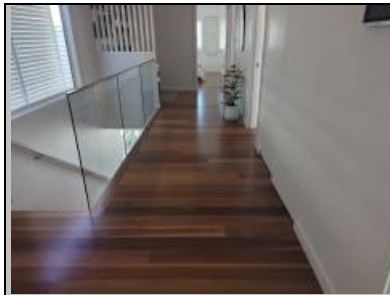
Throughout.

Floors are concealed by floor coverings, The condition of the floors is generally good. General wear and tear is noted.

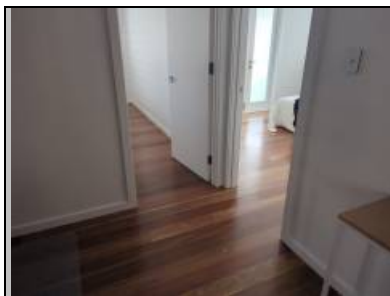
Throughout.

The condition of the woodwork is generally good. General wear and tear is noted.

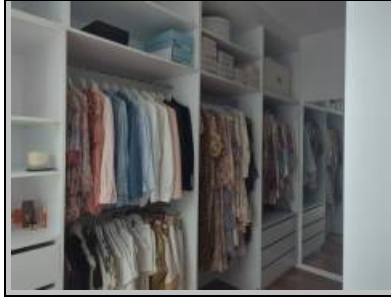
Throughout.

The condition of the built-in wardrobes is generally good. General wear and tear is noted.

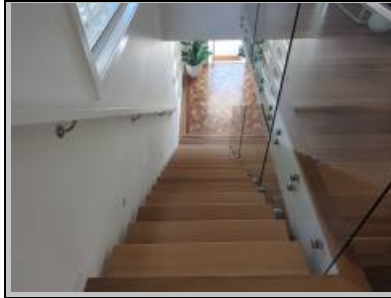
The stairs are constructed primarily from timber. The overall condition of the stairs is good.

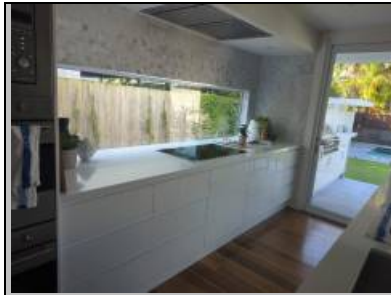
The condition of the fixtures is generally good. General wear and tear is noted.

Maintain all sealants and grouting to prevent moisture penetration and damage.

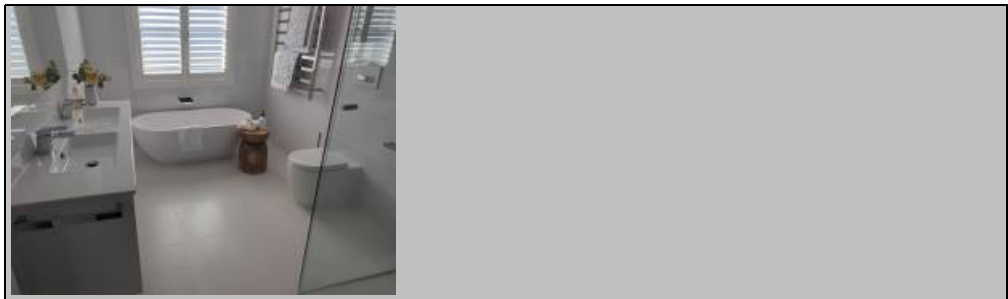
The condition of the fixtures is generally good. General wear and tear is noted.

Maintain all sealants and grouting to prevent moisture penetration and damage.

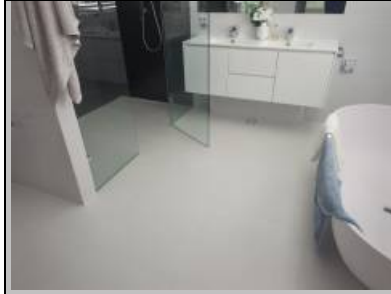
The condition of the fixtures is generally good. General wear and tear is noted.

Maintain all sealants and grouting to prevent moisture penetration and damage.

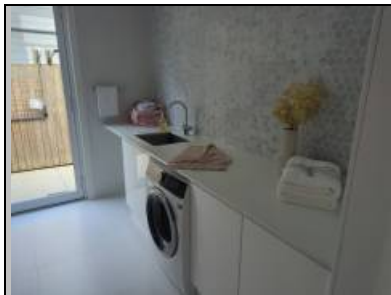
This area is generally in good condition. General wear and tear is noted.

Maintain all sealants and grouting to prevent moisture penetration and damage.

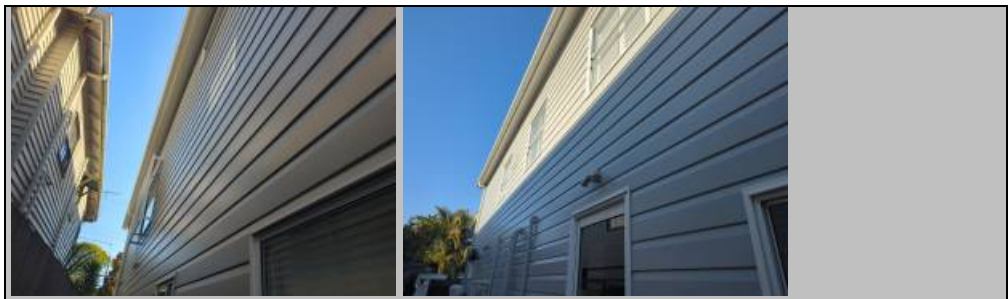
All elevations:

The condition of the walls is generally good. General wear and tear is noted.

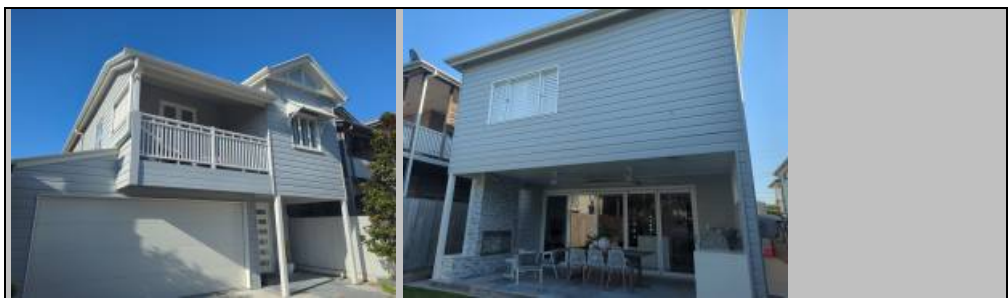
All elevations:

The condition of the exterior windows is generally good. General wear and tear is noted.

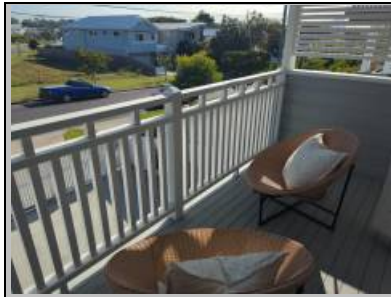
Front elevation:

Constructed from timber. The general condition of this structure is good.

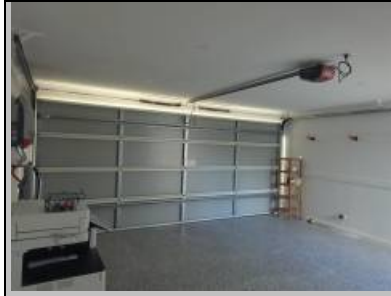
Part of the main building.

The overall condition of the garage is good.

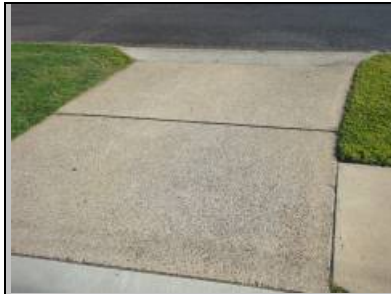
The concrete driveway stands in good condition. Minor concrete cracks are noted.

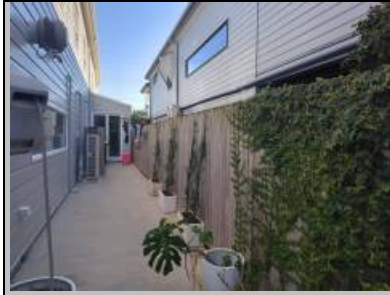
Dividing fence section:

The fences are mainly constructed from timber. The fences are generally in good condition. Minor wet rot or defects were noted to the wooden fences and minor repairs maybe needed.

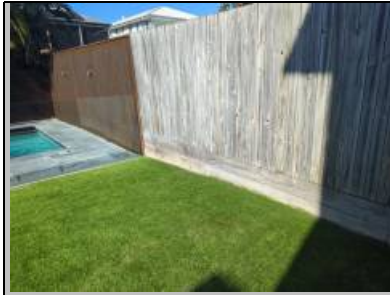
Various Elevations.

The timber retaining walls show normal deterioration and should be monitored.

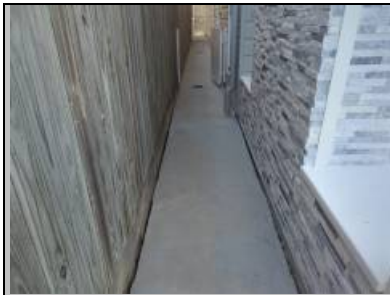
The concrete paths/paved areas are in good condition. Minor concrete cracks are noted.

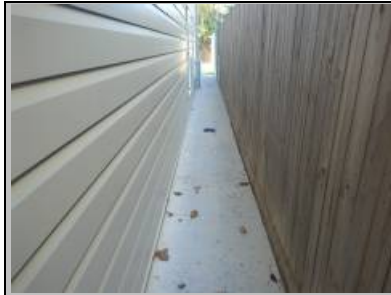
Pit or Grate drains to site appear to be acceptable. However, these pit or grate drains should be maintained and monitored during heavy rain to determine whether the existing drains can cope. If they cannot cope, then additional drains may be required.

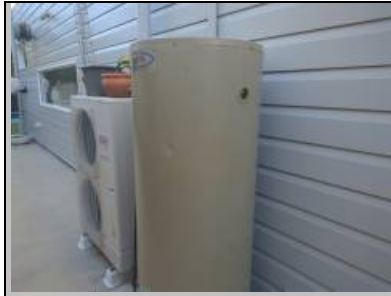
Mains electric hot water system: Located externally: The hot water system appears to be in working condition. No specific tests other than running the hot water from a tap was carried out. No determination has been made as to the suitability or adequacy of the hot water system in relation to capacity or otherwise.

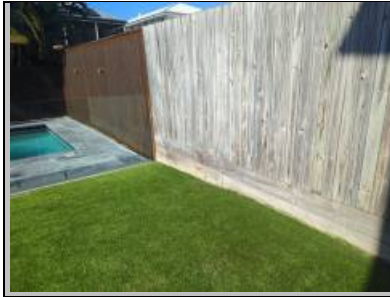
Sleepers or timber landscaping materials:

Yes - Fungal Decay (wood rot) was noted to the following timbers/areas.

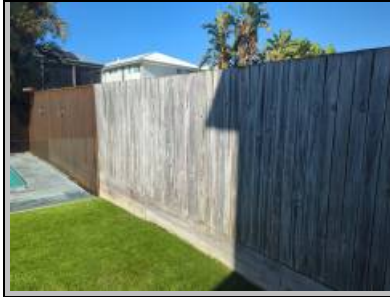
Various fencing timbers:

Yes - Wood decay damage was noted to the following timbers/areas.
