Visual Building Inspection Report

15 Grenade Street, Cannon Hill

18/10/2024.

9377 b

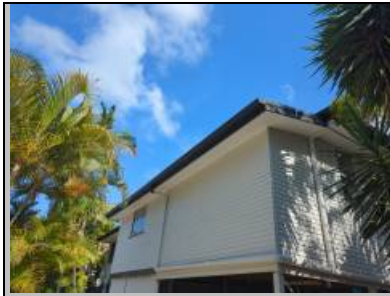
All elevations:

Appear to be in serviceable condition. Water staining was noted to sections of the gutter and fascia. Recommended to monitor when raining.

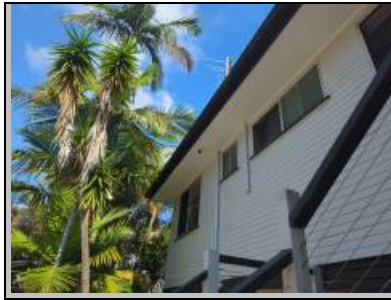
All elevations:

The eaves are lined with asbestos cement and/or fibre cement sheeting. The overall condition of the eaves lining is good.

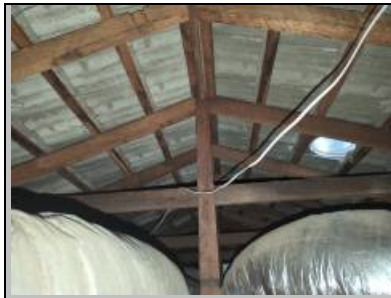
The cut and pitched roof timbers appear to provide adequate support. Timber deflection noted to some roof timbers. This is consistent with to settlement of timbers/ age and type of building.

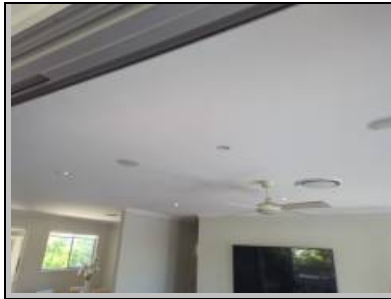
Throughout.

The condition of the ceilings is generally fair. General wear and tear is noted. Minor settlement cracks were noted and these are typical of this type of material. Periodic maintenance may be required. Minor undulations were noted to the ceiling lining. This is to be expected in a house of this age. Periodic maintenance may be required.

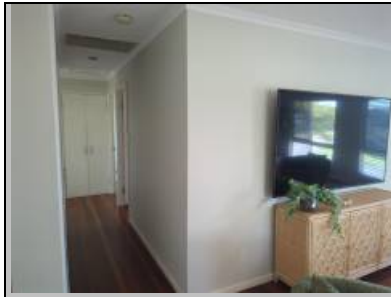
Throughout.

The condition of the walls is generally fair. General wear and tear is noted. Minor cracking is evident to wall linings. Periodic maintenance may be required. Patched/ repaired sections was noted to some wall surfaces.

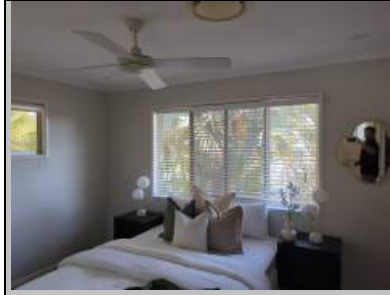
Throughout.

The condition of the windows is generally fair. General wear and tear is noted.

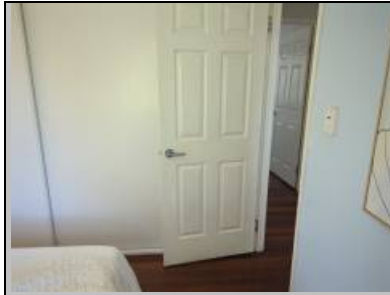
Various areas.

The condition of the doors is generally fair. General wear and tear is noted. The door binds and minor adjustments are required to ensure correct operation. The door handle and latch needs adjusting and/or repair.

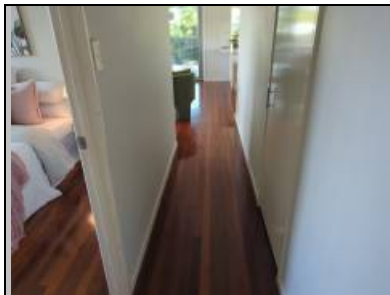
Throughout.

Floors are concealed by floor coverings, The condition of the floors is generally fair. General wear and tear is noted, Timber deflection noted to some flooring timbers. This is consistent with to settlement of timbers/ age and type of building.

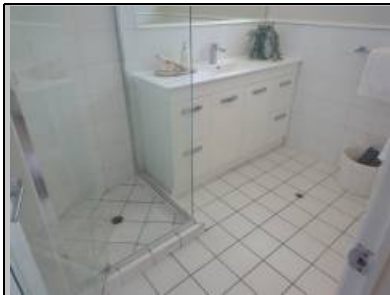
The condition of the fixtures is generally fair. General wear and tear is noted.

Shower appears to be in a serviceable condition. Staining noted to grouting and silicone sealants, clean, re-grout and replace sealants as required.

Maintain all sealants and grouting to prevent moisture penetration and damage.

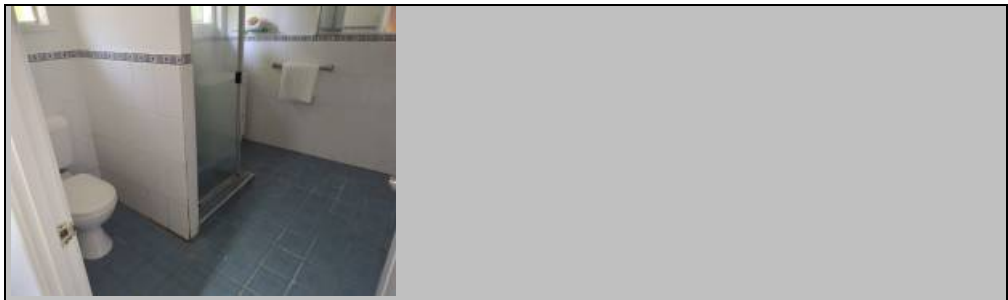
There is moisture to walls and floor backing onto shower. Further investigation will be required to this area. Recommend seeking advice from a waterproofing contractor.

The condition of the tiles is generally fair. Staining noted to grouting and silicone sealants, clean, re-grout and replace sealants as required.

Maintain all sealants and grouting to prevent moisture penetration and damage.

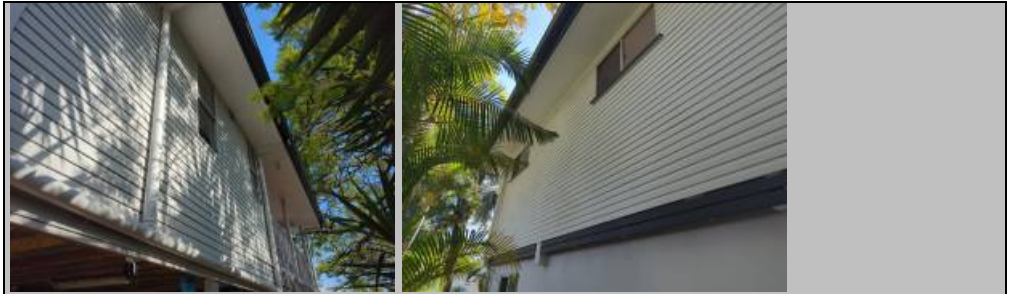
All elevations:

The condition of the walls is generally good. General wear and tear is noted.

Minor appearance cracks were noted and these are typical of this type of material. This is considered to be an appearance defect. Periodic maintenance may be required.

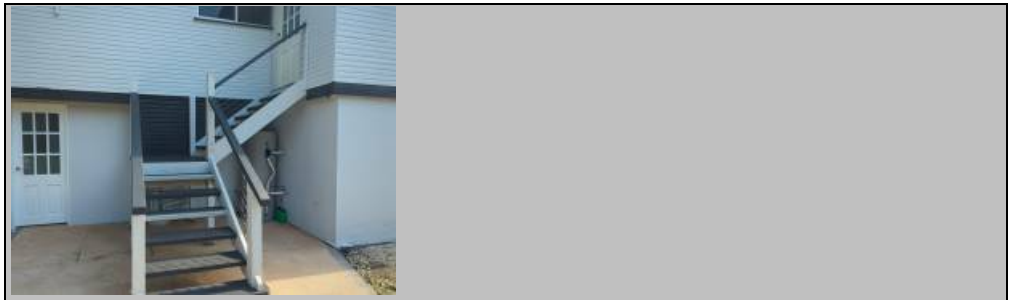
The stairs are constructed primarily from timber. The overall condition of the stairs is fair.

Minor wood decay damage was noted. Maintenance and repair is required.

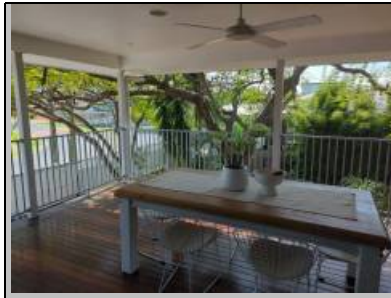
Front elevation:

Constructed from timber and metal. The general condition of this structure is good.

Deck floors are weathered. Timber treatment is recommended to prevent deterioration. Minor rust/corrosion to sections of metal. Rust treatment/maintenance recommended.

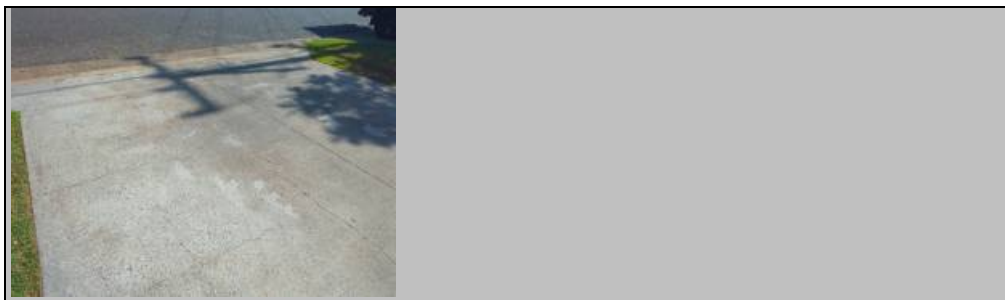
The concrete driveway stands in good condition. Minor concrete cracks are noted.

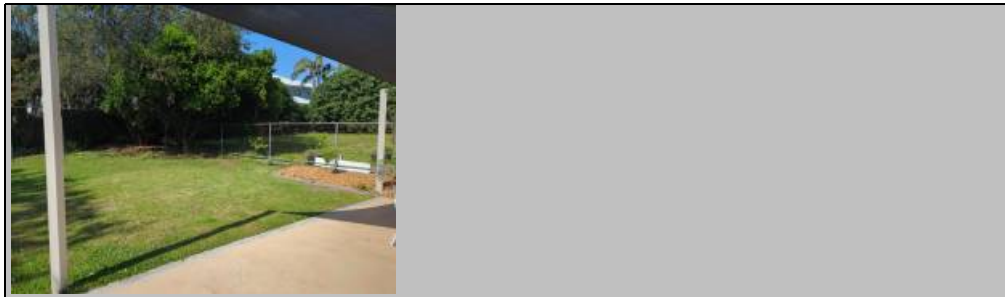
Dividing fence section:

The fences are constructed from a combination of timber, brick and PVC. The fences are generally in good condition. Minor wet rot or defects were noted to the wooden fences and minor repairs maybe needed.

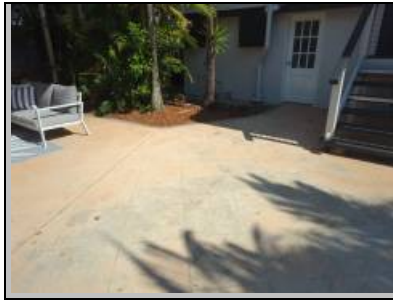
The concrete paths/paved areas are in good condition. Minor concrete cracks are noted.

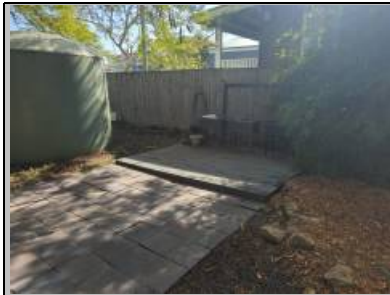
Yes - Fungal Decay (wood rot) was noted to the following timbers/areas.

Decking timbers: Steps/stair timbers: Sleepers or timber landscaping materials:

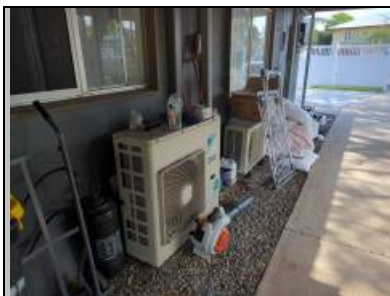
The air-conditioning condenser discharges adjacent to the external walls. We recommend modification so that water is discharged over a drain. Air conditioning units which release water alongside or near to building walls should be piped to a drain (if not possible then several meters away from the building) as the resulting wet area is highly conducive to termites.

Some external timbers and cladding are in contact with soil. These should be modified so that timber to soil contact does not occur.

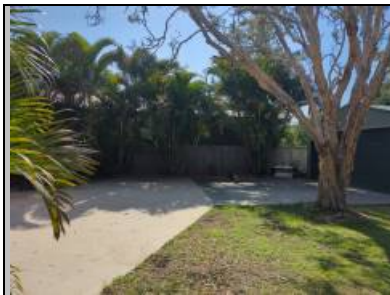
Yes - Wood decay damage was noted to the following timbers/areas.

Various fencing timbers:
