Visual Building Inspection Report

Enyi Pty Ltd

19 Meyrick St, Cannon Hill

3/04/2024.

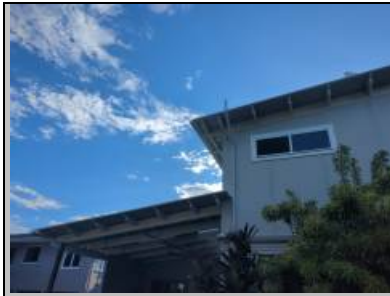
All elevations:

Appear to be in serviceable condition. Water staining was noted to sections of the gutter and fascia. Recommended to monitor when raining.

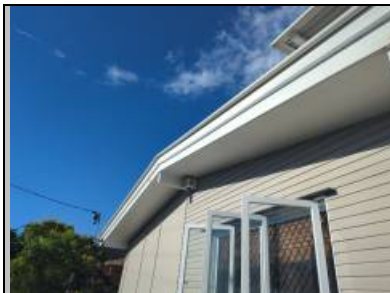
Various Elevations.

The overall condition of the eaves lining is fair.

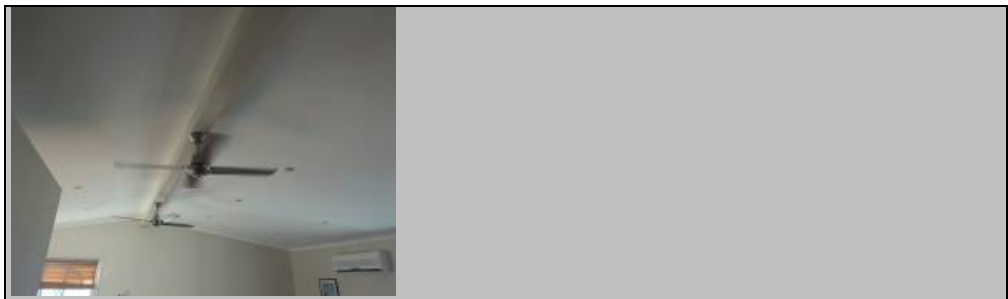
Throughout.

The condition of the ceilings is generally fair. General wear and tear is noted.

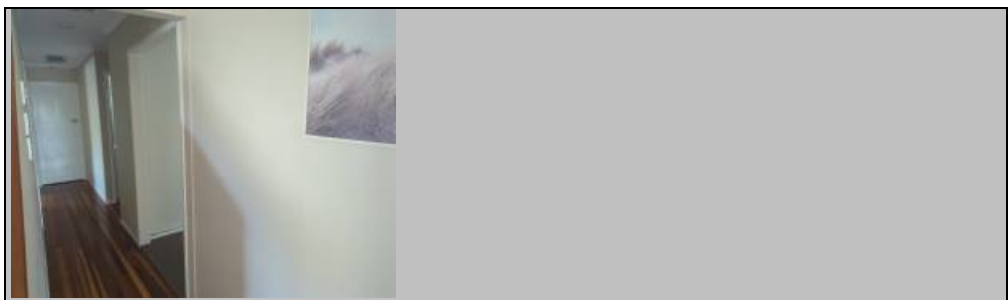
Throughout.

The condition of the walls is generally fair. General wear and tear is noted.

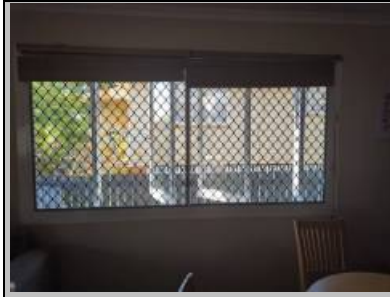
Throughout.

The condition of the windows is generally fair. General wear and tear is noted.

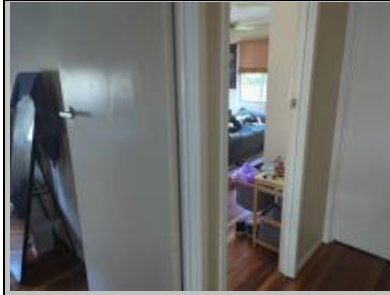
Throughout.

The condition of the doors is generally fair. General wear and tear is noted.

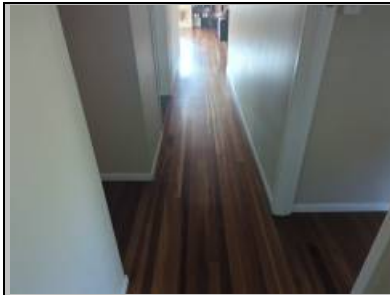
Throughout.

Floors are concealed by floor coverings, The condition of the floors is generally fair. General wear and tear is noted, Timber deflection noted to some flooring timbers. This is consistent with to settlement of timbers/ age and type of building.

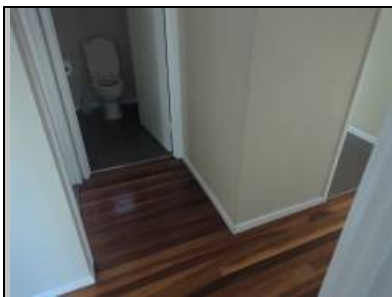
Throughout.

The condition of the woodwork is generally fair. General wear and tear is noted.

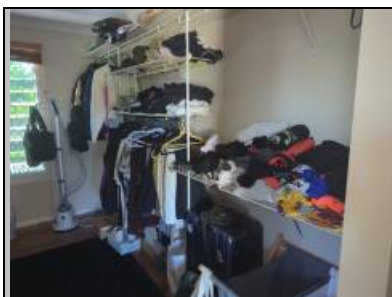
Throughout.

The condition of the built-in wardrobes is generally fair. General wear and tear is noted.

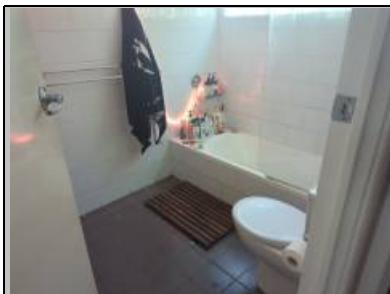
The condition of the fixtures is generally fair. General wear and tear is noted.

The shower is located over the bathtub. The area will need to be kept well sealed to prevent water penetration to surrounding areas. Staining noted to grouting and silicone sealants, clean, re-grout and replace sealants as required. Tap faulty due grit build up. Repairs/ maintenance are needed.

Maintain all sealants and grouting to prevent moisture penetration and damage.

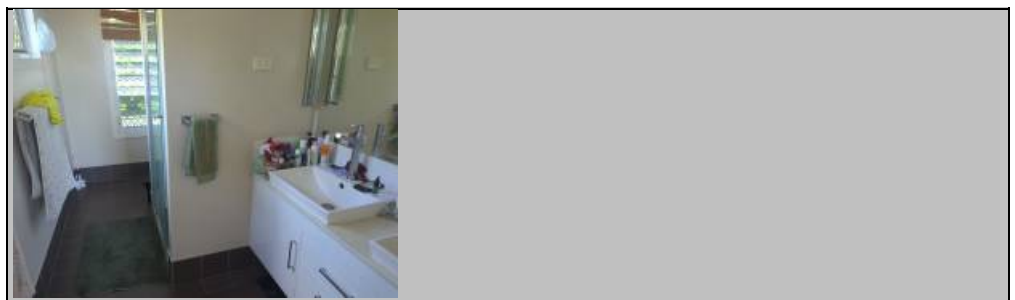
The condition of the fixtures is generally fair. General wear and tear is noted.

Shower appears to be in a serviceable condition. Staining noted to grouting and silicone sealants, clean, re-grout and replace sealants as required.

Maintain all sealants and grouting to prevent moisture penetration and damage.

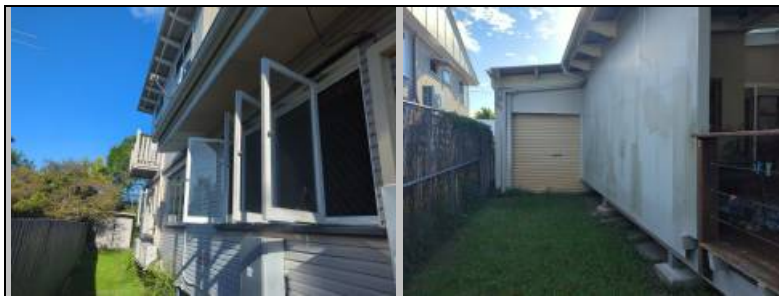
All elevations:

The condition of the walls is generally fair. General wear and tear is noted. Patching and painting will improve overall appearance.

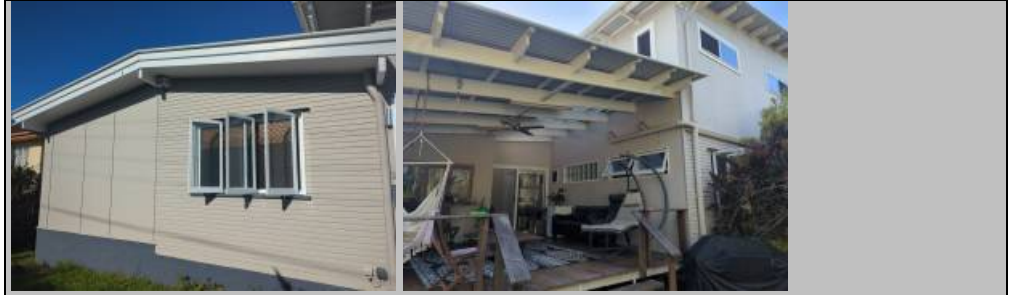
All elevations:

The condition of the exterior of the windows is generally fair. General wear and tear is noted.

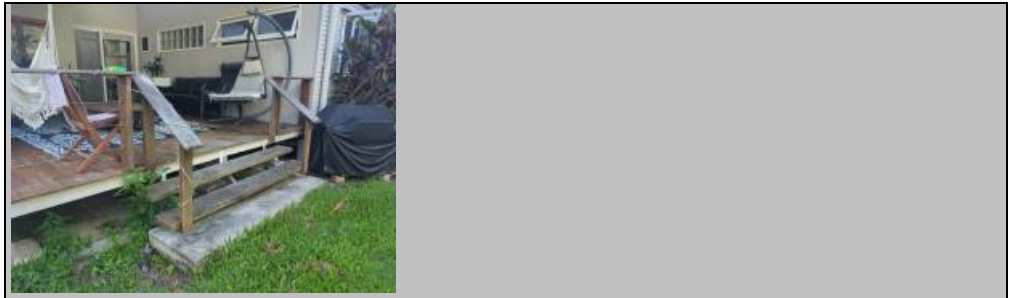
The stairs are constructed primarily from timber and steel. The overall condition of the stairs is fair. Rust scale to stair supports/stringers and balustrade, maintenance required.

Minor wood decay damage was noted. Maintenance and repair is required.

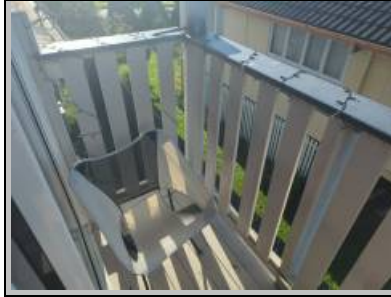
Rear elevation:

Constructed from timber. The general condition of this structure is fair.

Minor wood decay is present to the structure.

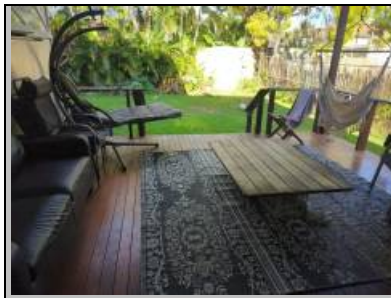
Rear elevation:

Constructed from timber and metal. The general condition of this structure is fair.

Minor wood decay is present to the structure. Minor rust/corrosion to sections of metal. Rust treatment/maintenance recommended.

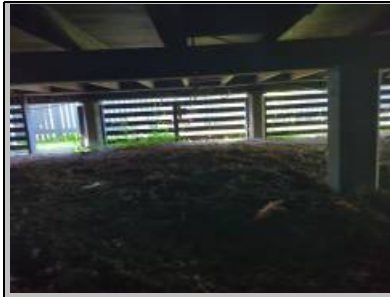
The floor framing and subfloor area appears to be generally sound, typical and consistent compared with buildings of similar age and construction. The building is constructed on a concrete slab. The building is constructed on concrete stumps. The building is constructed on Combination Brick Base and Piers. Timber deflection noted to some flooring timbers. This is consistent with to settlement of timbers/ age and type of building, The footings appear to be generally sound. Efflorescence is noted to the face of masonry wall. This is when a white powdery deposit forms on the surface of bricks, masonry or concrete. This is caused by crystallisation and subsequent dehydration of soluble salts contained in the mortar or wall materials. Recommend the area be cleaned to remove efflorescence.

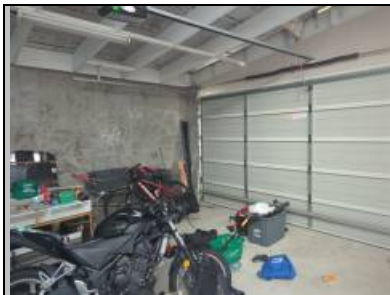
Part of the main building.

The overall condition of the garage is fair.

The condition of the walls is generally fair. Minor cracking is evident to wall linings. Periodic maintenance may be required.

The concrete floor is generally in good condition. minor concrete cracks are noted.

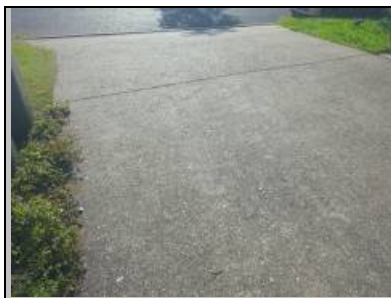
The concrete driveway stands in good condition. Minor concrete cracks are noted.

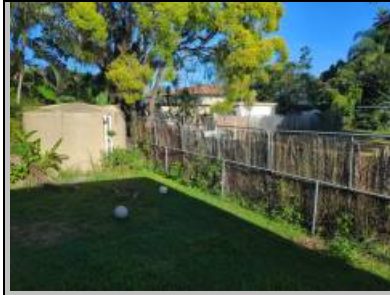
Dividing fence section:

The fences are mainly constructed from timber and metal. The fences are generally in fair condition but some repairs or maintenance is required. Minor wet rot or defects were noted to the wooden fences and minor repairs maybe needed.

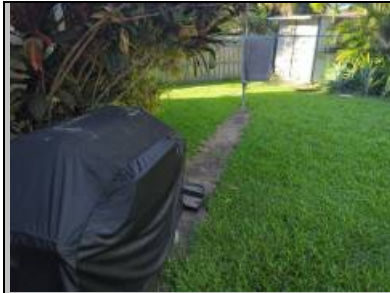
The concrete paths/paved areas are in fair condition. Minor concrete cracks are noted.

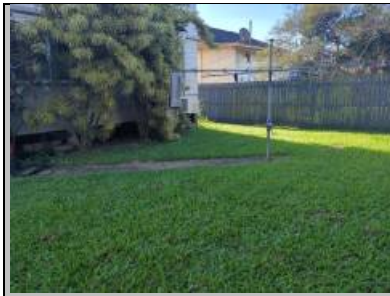
Site drainage appears to be acceptable. However, the site should be monitored during heavy rain. All surface water should divert away from house footings/ foundations.

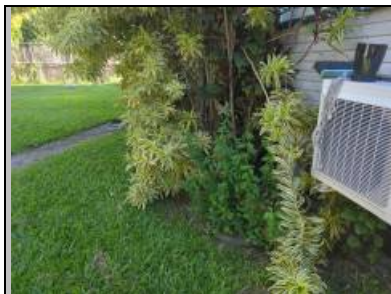
Garden beds have been built up against the external walls. These should be removed as they can allow concealed termite entry.

Some external timbers and cladding are in contact with soil. These should be modified so that timber to soil contact does not occur.
