# Inspection Report

**One Call Building and Pest Inspections**

**Unit 4/31 Burrai St Morningside , Brisbane , QLD**

### Pest And Building Inspection

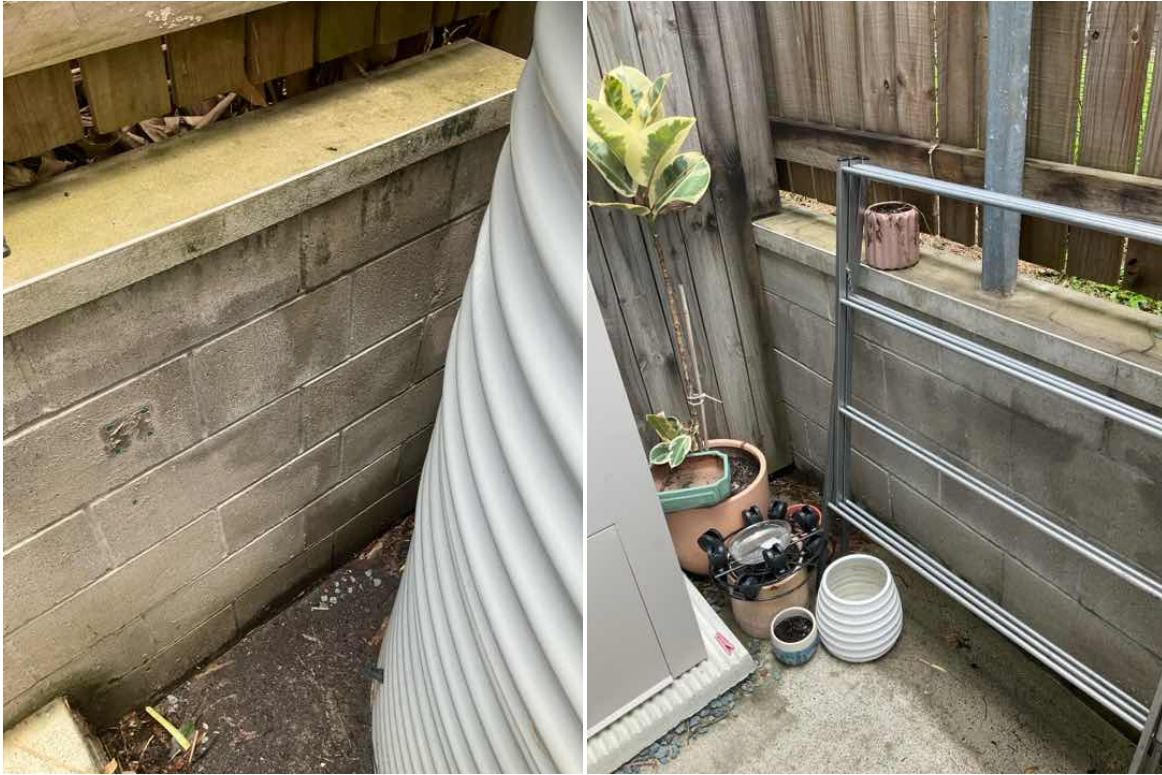
The retaining all is a concrete block construction.

Of the visible areas, the general condition is serviceable or in reasonable condition for age of dwelling.

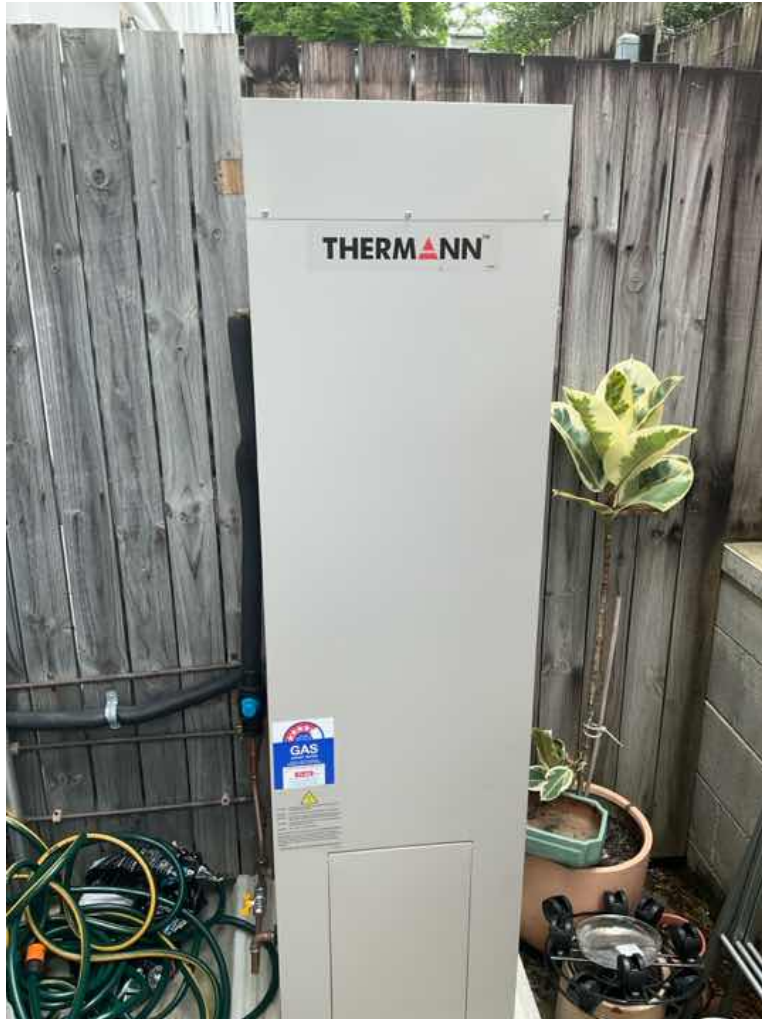
The hot water unit is a gas storage system.

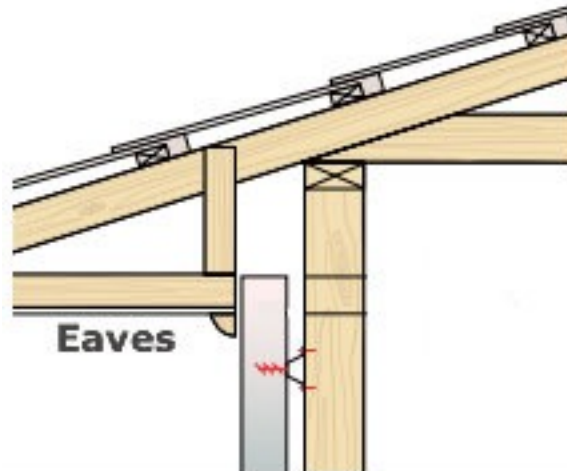
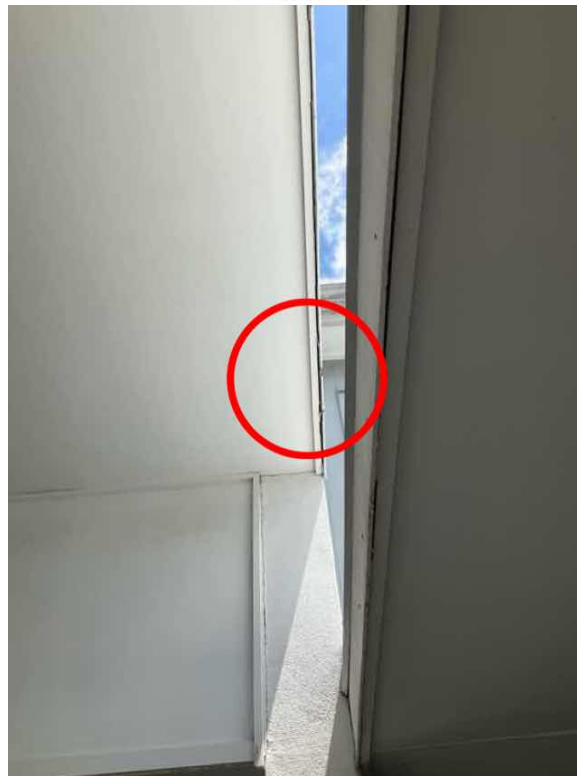
The soffit lining (eaves) are in a serviceable condition with no notable defects.

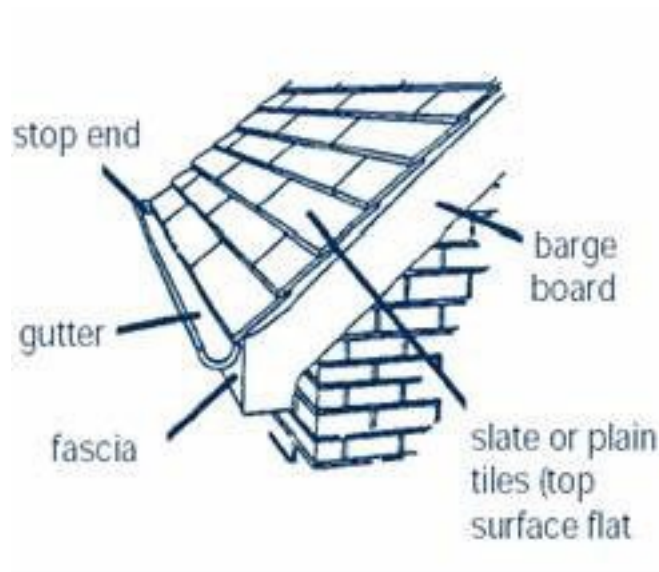
On visual inspection, the general condition of the fascia/barge boards is serviceable.

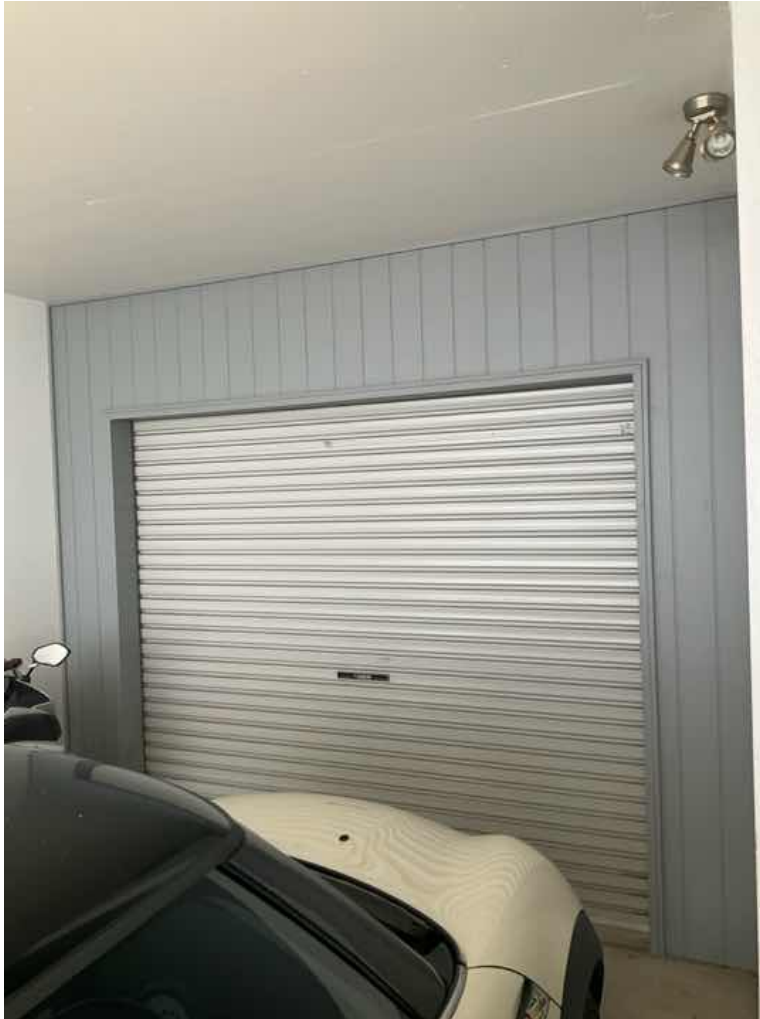
Attached garage.

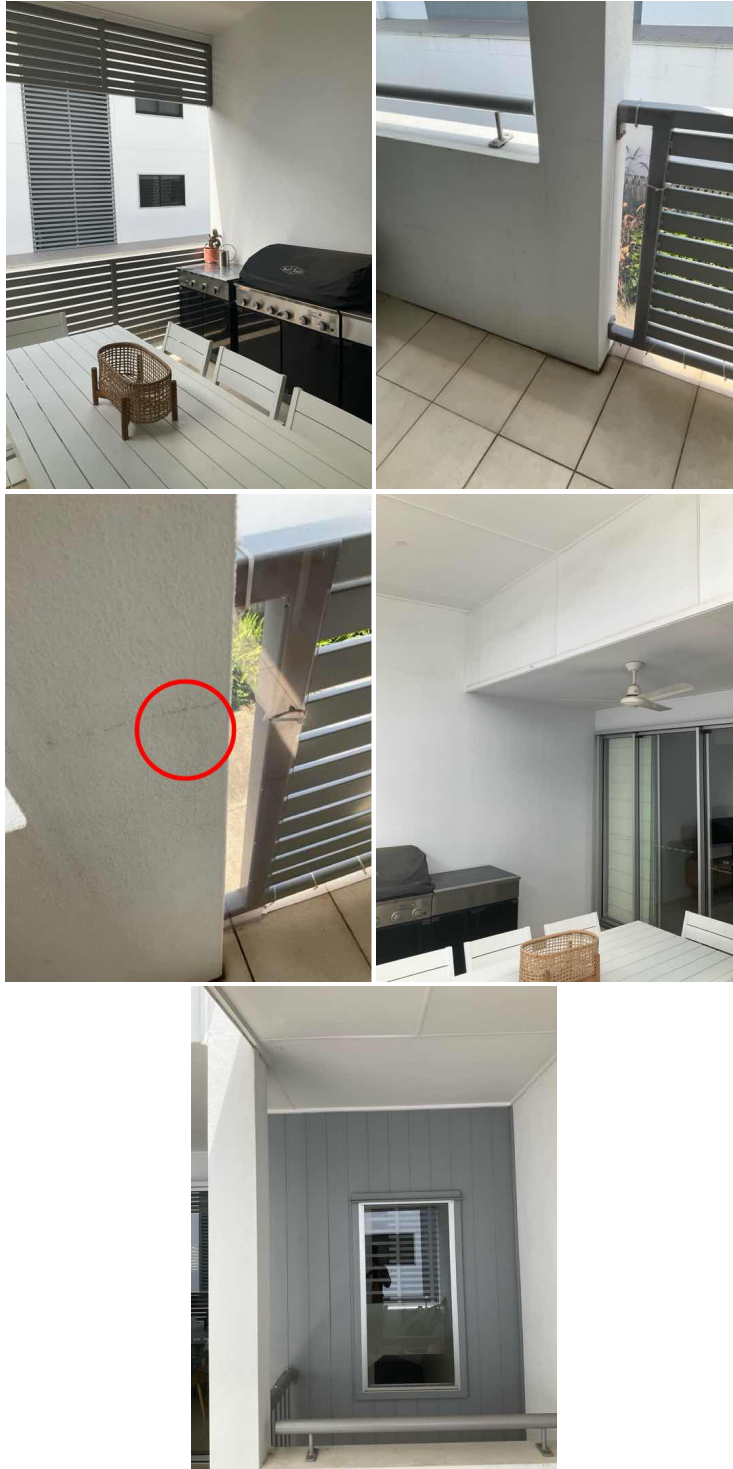
Though we are not structural engineers the balcony/s appear to be in a serviceable condition.

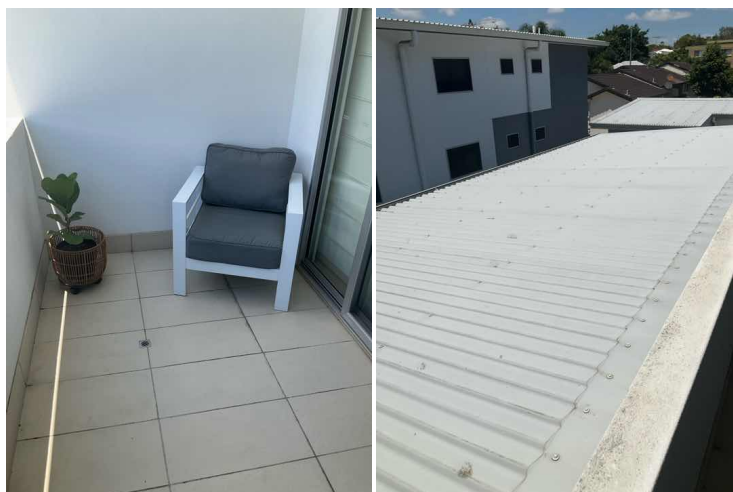
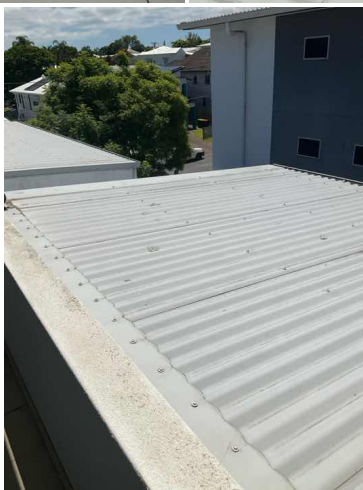
Though we are not structural engineers the veranda/s appear to be in a serviceable condition.

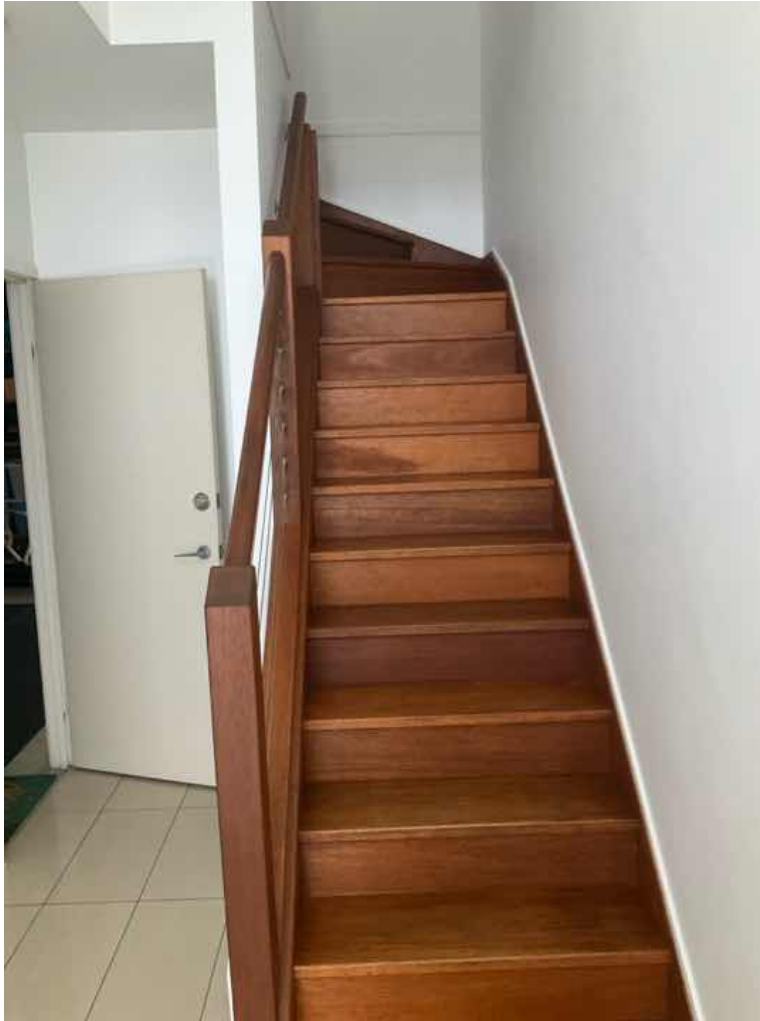
The internal staircase and components appear to be in a serviceable condition for the age with no notable defects sighted.

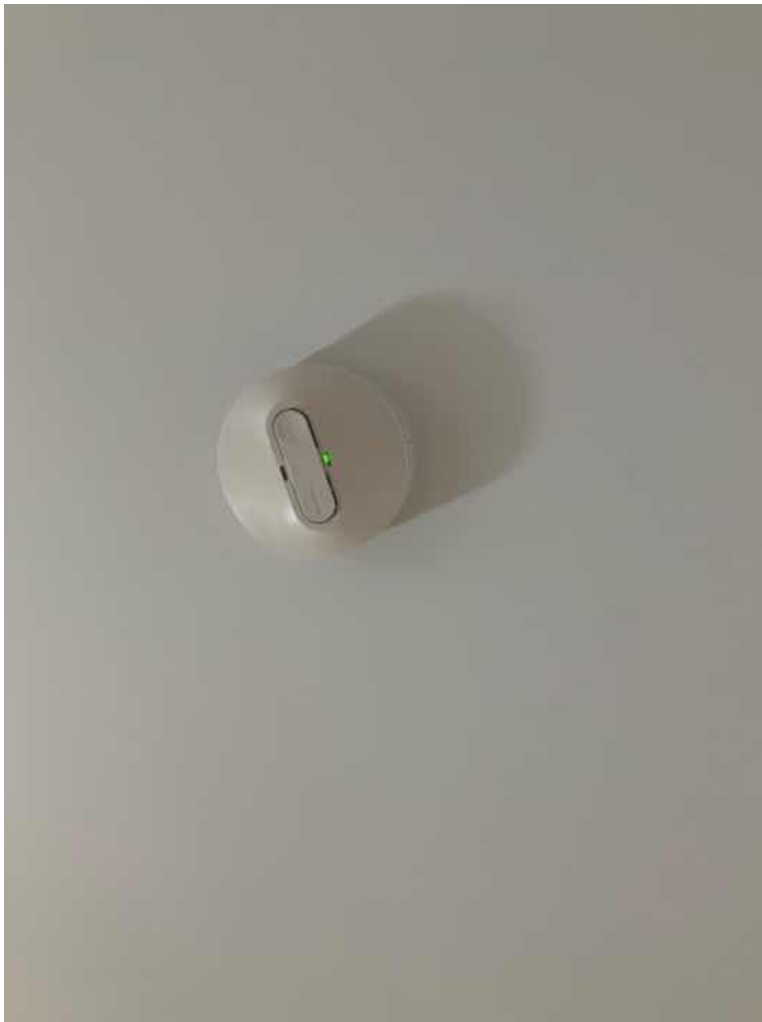
Yes 4 smoke alarms were sighted but not tested.

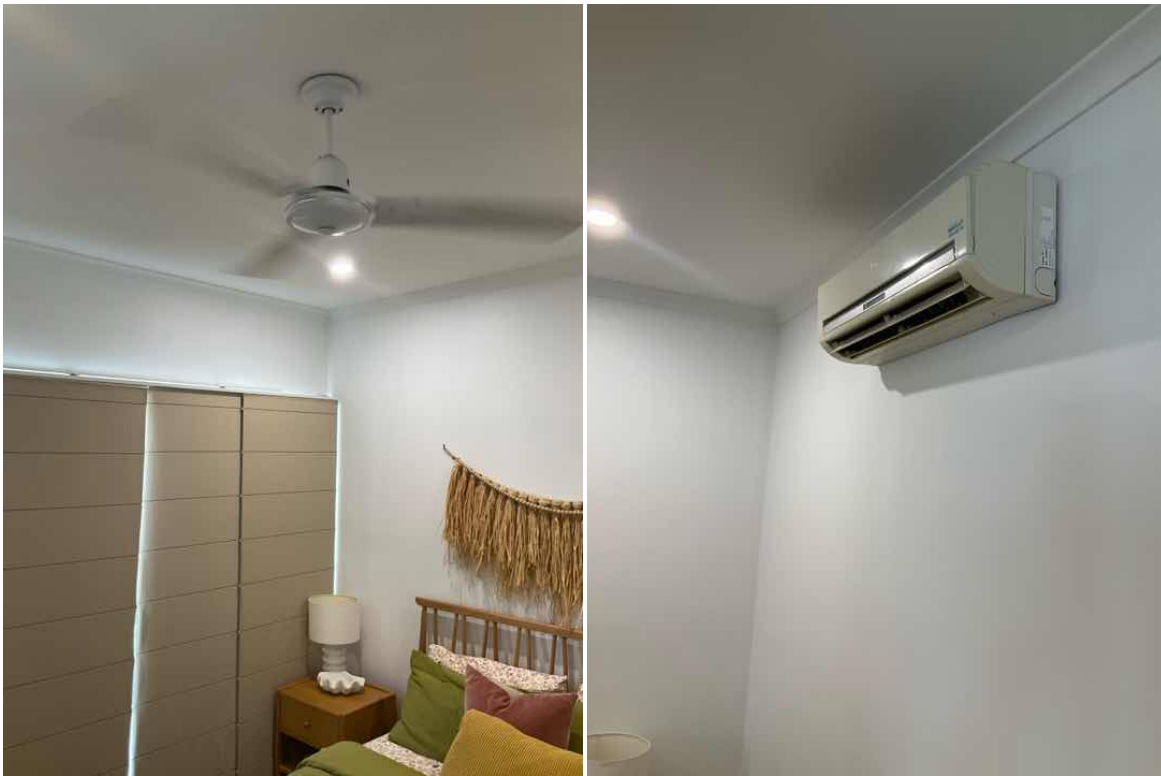
## **Bedroom 1**

From the visible and accessible areas, this bedroom appears to be in a serviceable condition for the age of the property with no notable structural defects sighted.

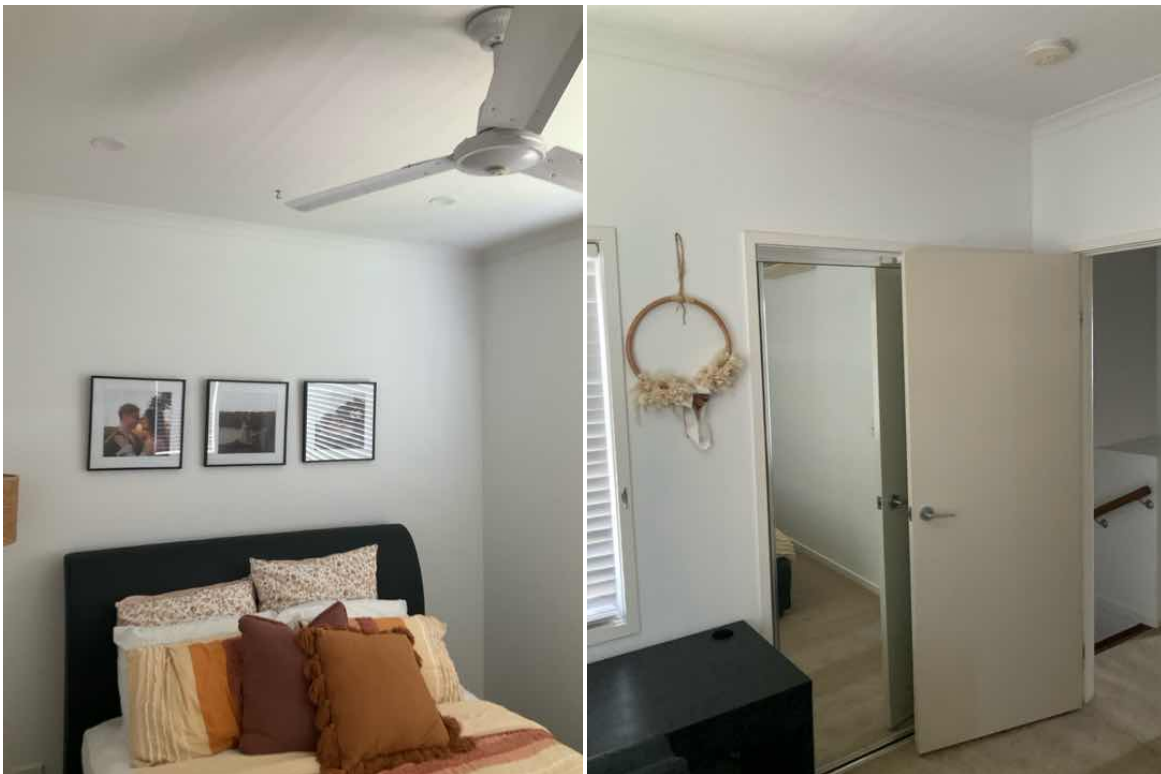
**Bedroom 2**

From the visible and accessible areas, this bedroom appears to be in a serviceable condition for the age of the property with no notable structural defects sighted.

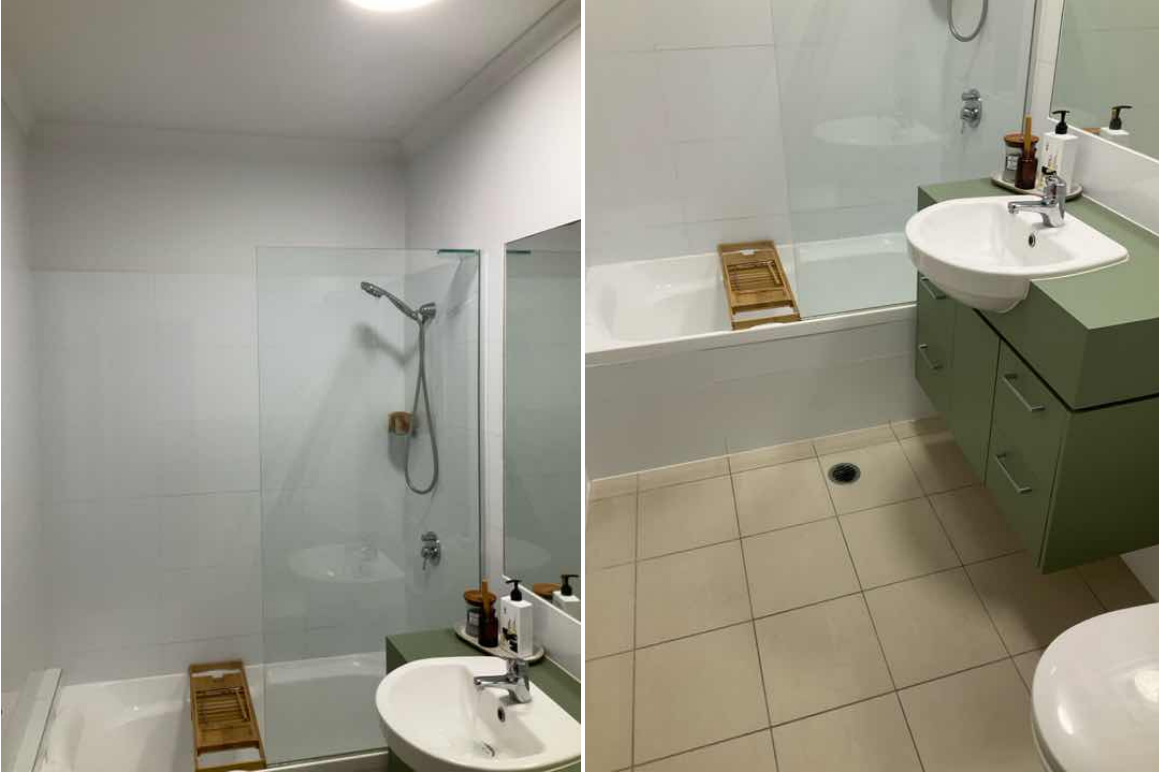
Of the visible areas, the general condition of this bathroom is serviceable or in reasonable condition for age of dwelling.

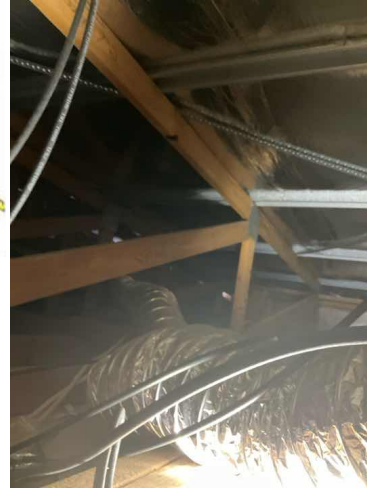
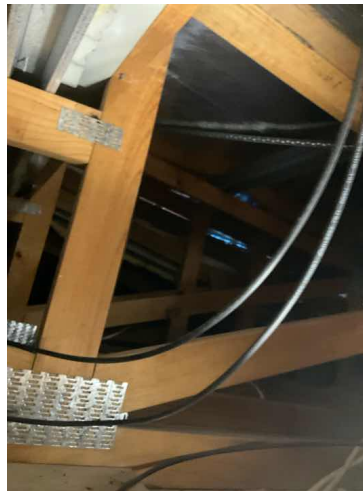
The roof frame is a truss timber frame.

Visible sections of the roof void is in a serviceable condition for age of this dwelling.

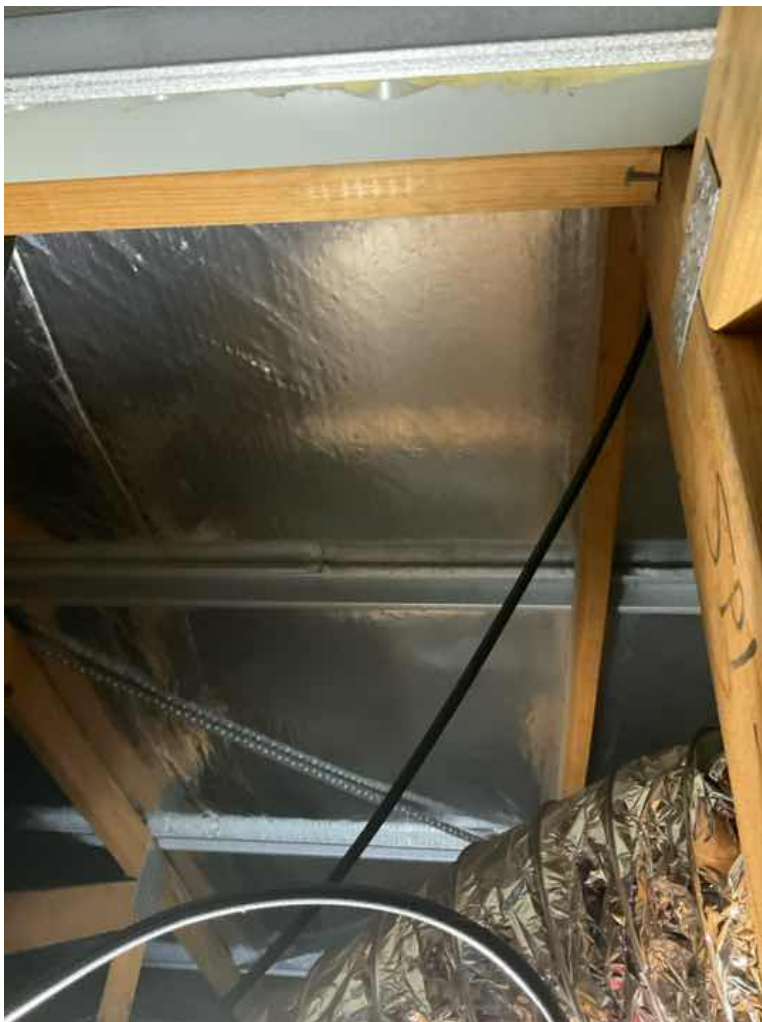
The roof space is insulated with reflective fibreglass batts under the roof cladding.

Where visible and accessible, the insulation appears to be in a serviceable condition.
