Inspection Report

Dedant Building And Pest Inspections

3/8 Corrie Street, Norman Park, Qld, 4170

Inspection, Residential Pest And Building Report

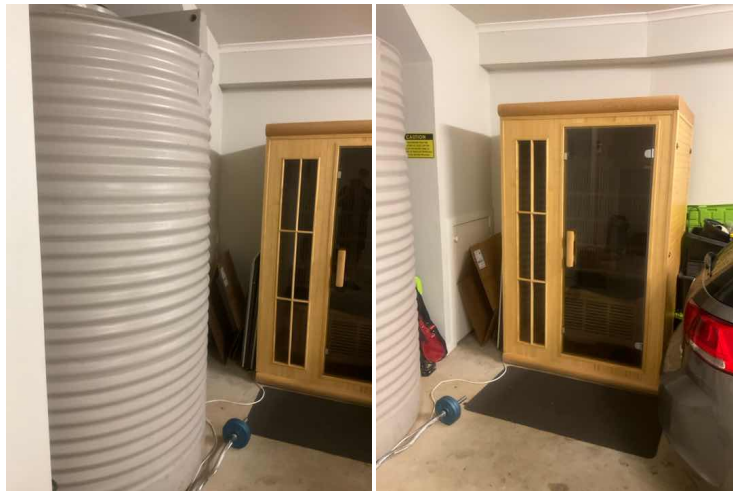
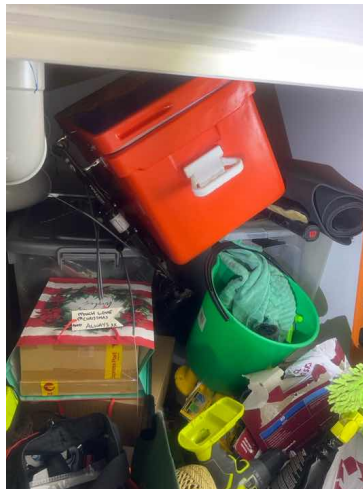
Storage items restricted a full and thorough inspection of this area. Defects may exist in the inaccessible areas. It is strongly recommended that full access be granted to enable a thorough inspection as there may be timber pest activity, damage or defects. Note: Where vehicles and storage has restricted a full inspection it is advised that this area be cleared so a full and unobstructed inspection can be carried out.

On inspection, defects were present that will require further assessing and recommendations by licensed and qualified trades persons, please read below for details.

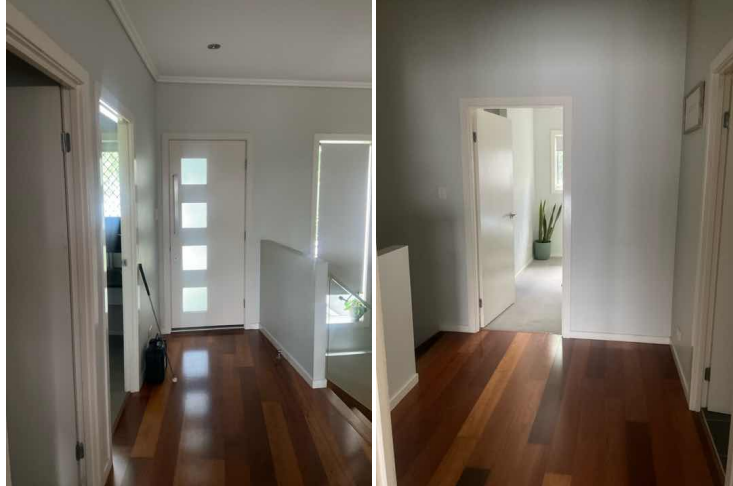
Door

On inspection, defects were present that will require further assessing and recommendations by suitably licensed and qualified trades persons, please read below for details.

Binding door - Doors that bind on the frame can relate to some differential settlement in the footings, frame movement, age, expansion, shrinkage and the like. It can also be seasonal where it may bind for some months and then open and close sufficiently. Monitoring over time or a more invasive inspection is only method of ascertain cause. Recommendations: A qualified carpenter should be engaged for advice and recommendations.

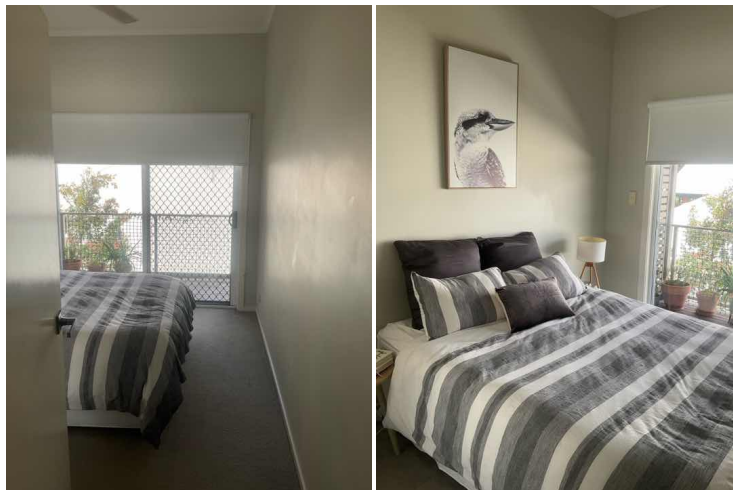
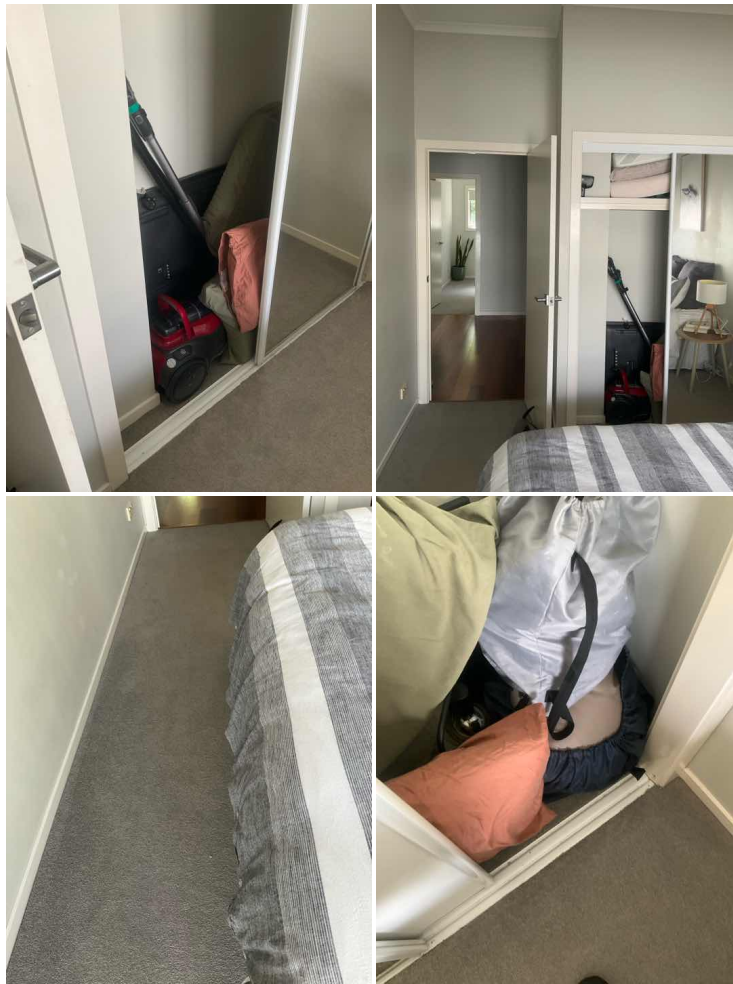
Bedroom 2

On inspection, defects were present that will require further assessing and recommendations by suitably licensed and qualified trades persons, please read below for details.

Squeaky floor boards noted. Re-fixing the floor boards may fix this issue.

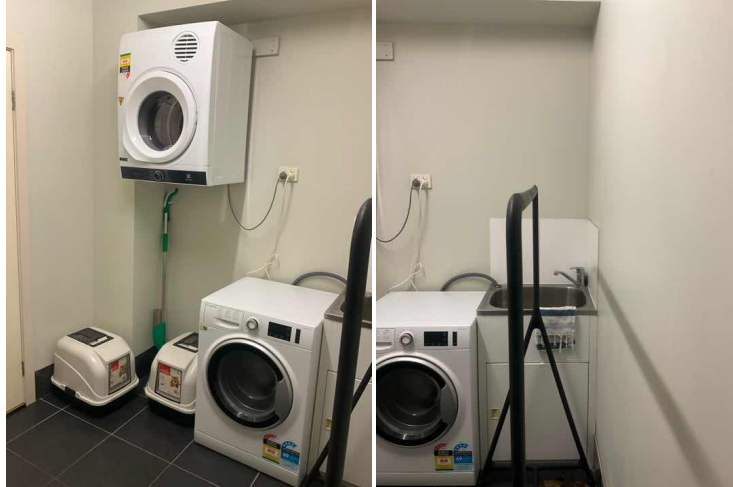
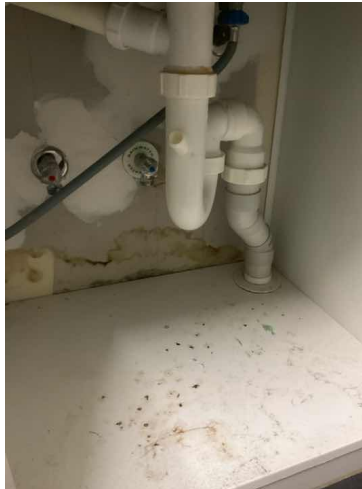
Appliances in the laundry restricted full and unobstructed view. Defects may exist.

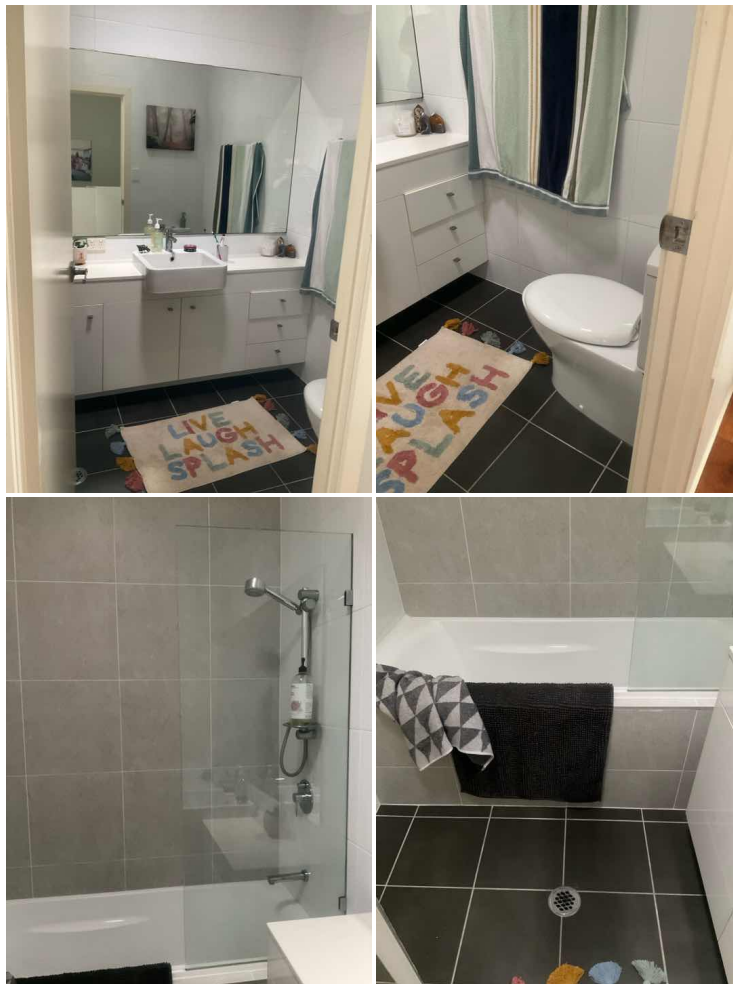
Main bathroom

On inspection, defects were present that will require further assessing and recommendations by suitably licensed and qualified trades persons, please read below for details.

The vanity mirror is desilvering at edges. Replacement recommended.

Shower head is leaking. A qualified plumber should be engaged for advice and recommendations.

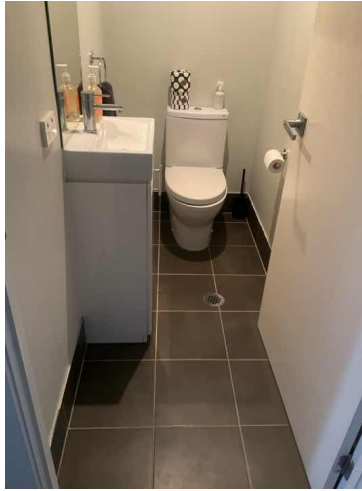
Toilet

Of the visible areas, the general condition of this bathroom is serviceable or in reasonable condition for age of dwelling.

An exhaust fan is present and operable in the bathroom - Regular cleaning advised.

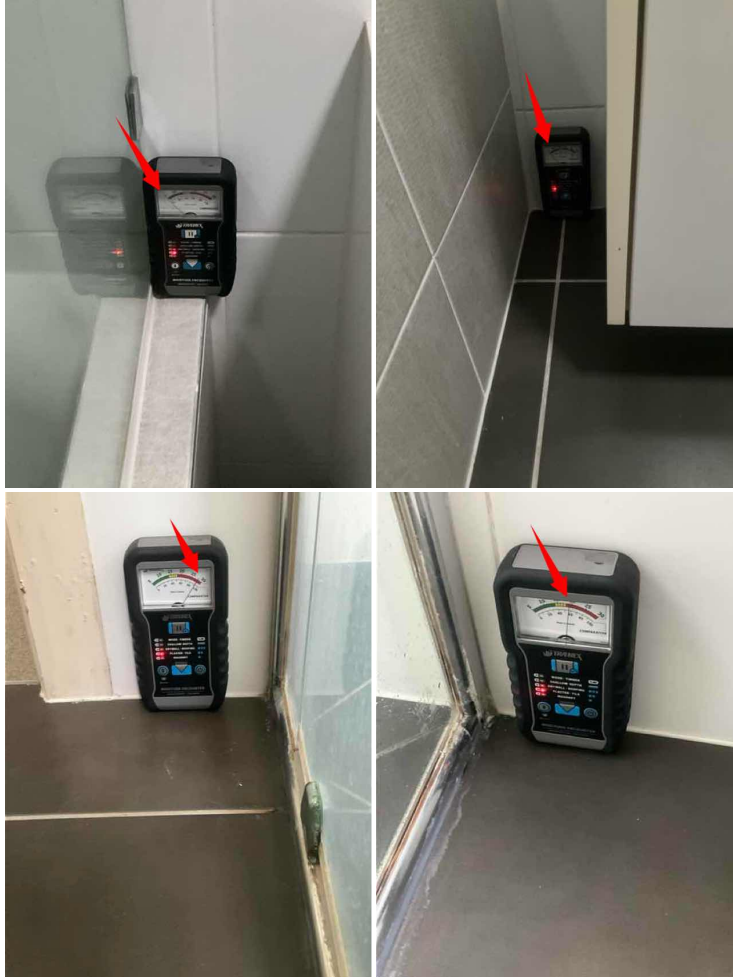
At the time of the inspection, our electronic moisture meter readings were normal main bathroom upstairs

At the time of the inspection moisture readings were high upstairs master bedroom ensuite

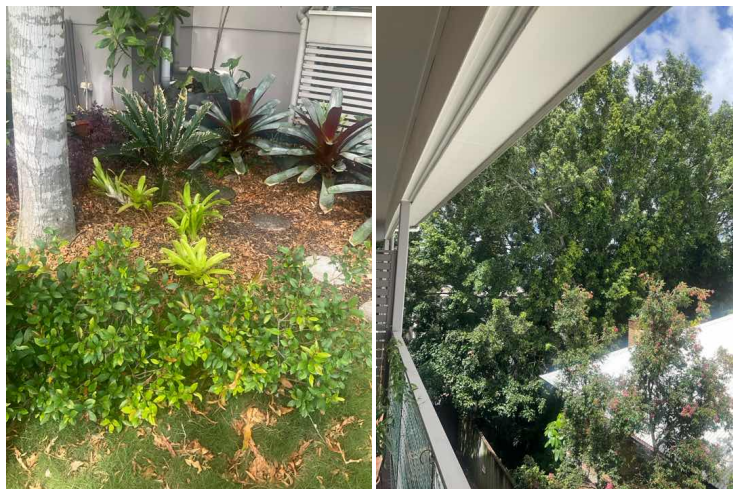
Tree/leafy environment: The house is located in a suburb which is high risk due to the environmental surrounds. It is close to large gum trees and parkland. The degree of risk is moderate to high and therefore a termite management plan/treatment is strongly advised.

There is mulch and garden beds located close to the house throughout the site. These garden beds are regularly watered and provide conducive conditions for termites to nest. These garden beds should be removed or relocated further away from the house. The degree of risk is moderate to high.
