Inspection Report

One Call Building and Pest Inspections

113 Beelarong St Morningside , Brisbane , QLD

Pest And Building Inspection

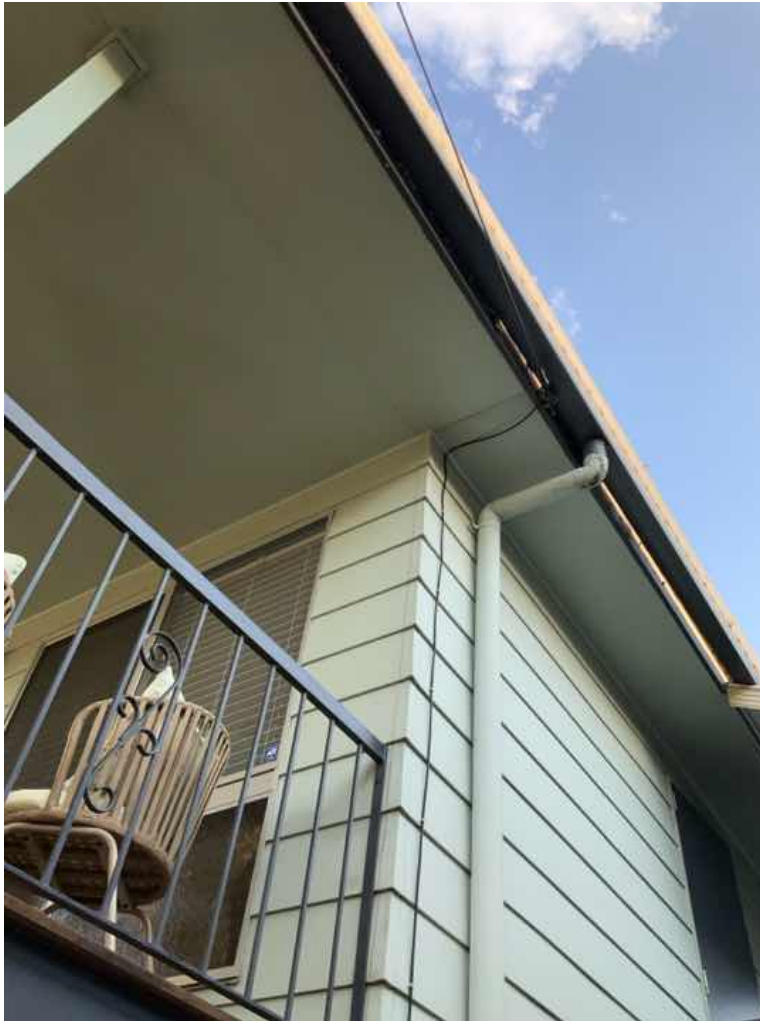
On inspection, defects were noted that may require further assessment and recommendations by licensed roofer.

Not inspected as too high to reach by ladder. Viewed from a distance.

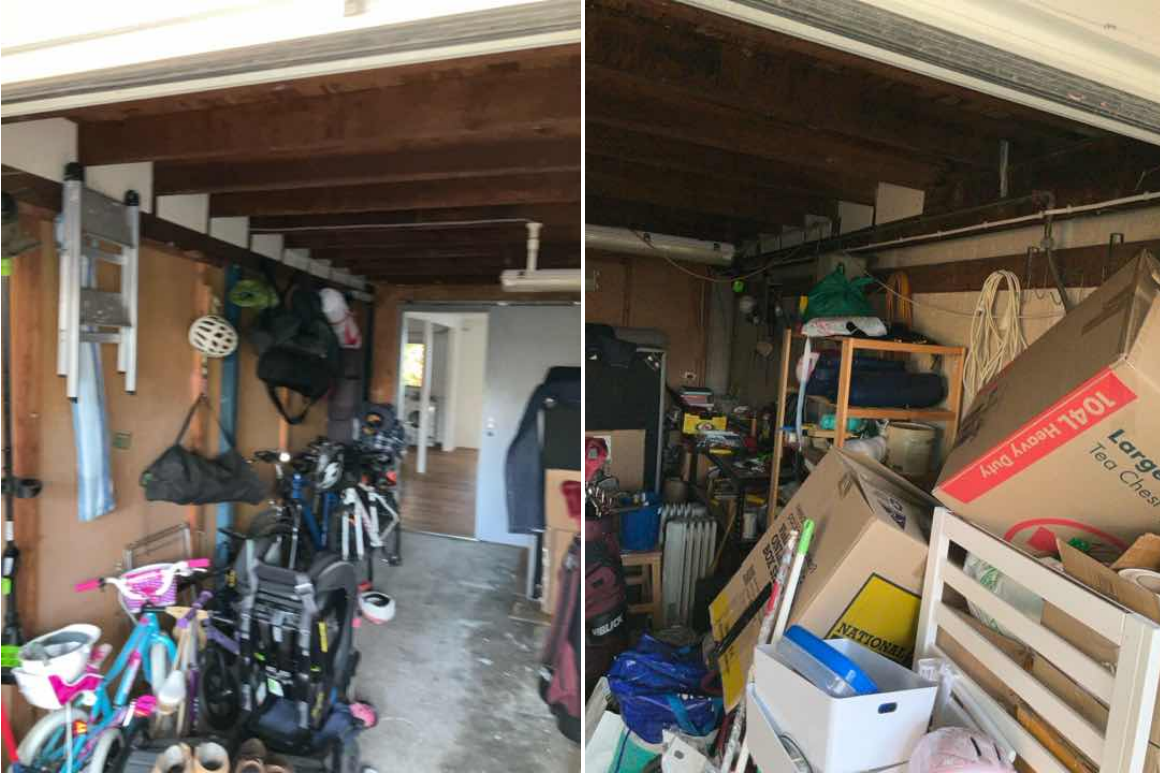
Stored items restricted a full and thorough inspection of this area. Defects may exist in the obstructed and inaccessible areas. It is strongly recommended that full access be granted to enable a thorough inspection as there may be timber pest activity, damage or defects. Note: Where vehicles and storage has restricted a full inspection it is advised that this area be cleared so a full and unobstructed inspection can be carried out.

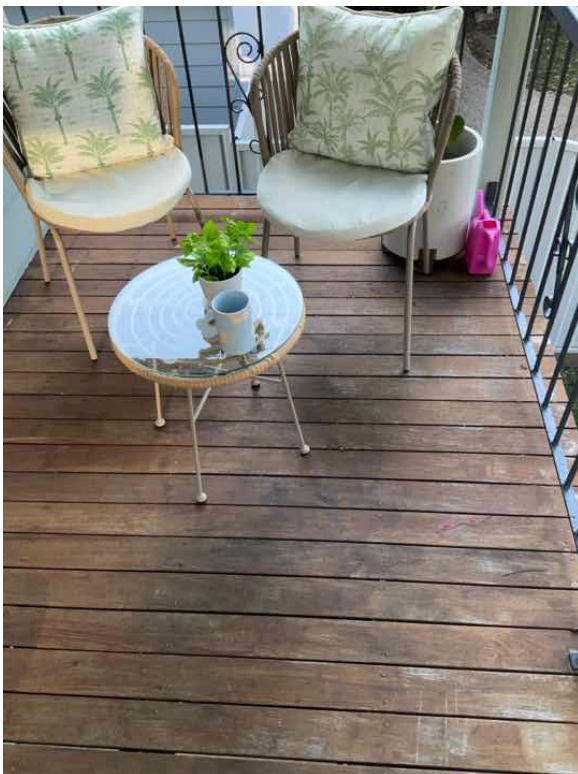
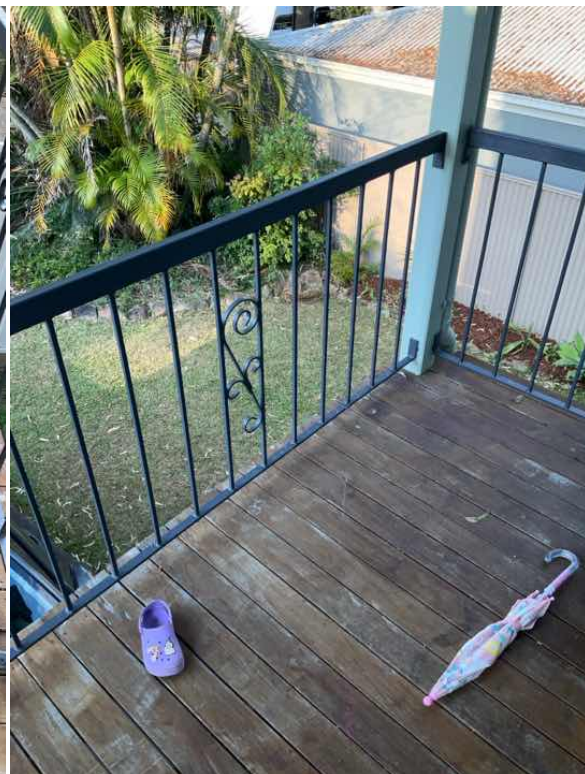
Balustrade and Rails

Balustrade rail height- should be 1 m in height from deck/balcony/patio floor. In some circumstances this regulation was non-existent dependent on the age of the dwelling and technically there is no requirement to rectify. Recommendations: We strongly advise you rectify to comply for safety concerns.

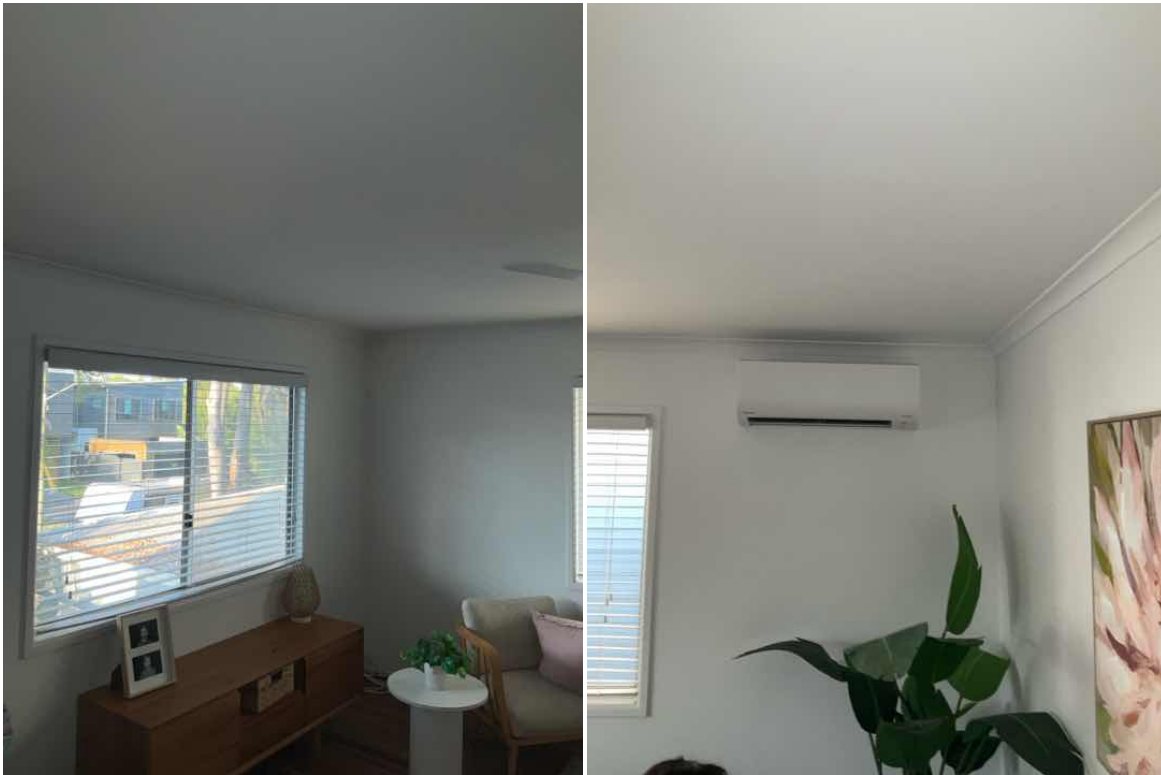
Ceiling

Settlement Cracks Noted. These are typical and generally patch and paint will suffice, however monitoring these cracks is advised for 12 months and if they become worse, further investigation by a suitably qualified professional is advised.
